# **FINAL REPORT**

## **BOEING 737-400, REGISTRATION HS-KMC MAIN LANDING GEAR TORSION LINK DAMAGE DURING LANDING**

**5 June 2019**

AIB/AAI/CAS.180

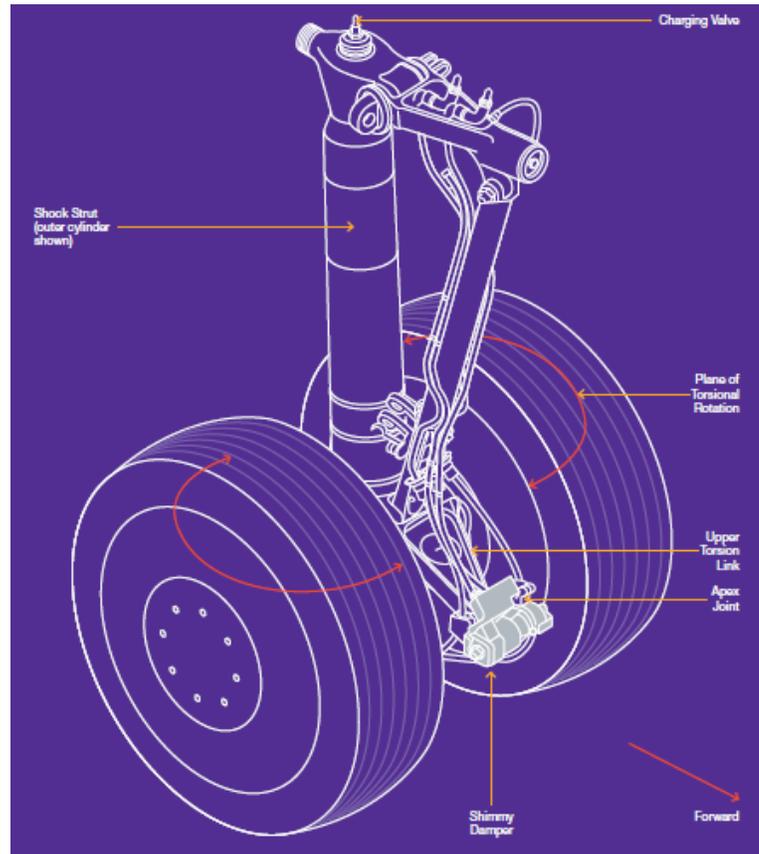
Figure 8: Torsion forces experience by a MLG during landing

to perform its function for a longer time period, especially in an asymmetric wheel spin up situation<sup>21</sup> (see **Figure 12**).
