Final Report

Boeing 737-8 (MAX), Registration 9V-MBF Tyre Damage on Landing, Singapore Changi Airport

3 December 2021

TIB/AAI/CAS.202

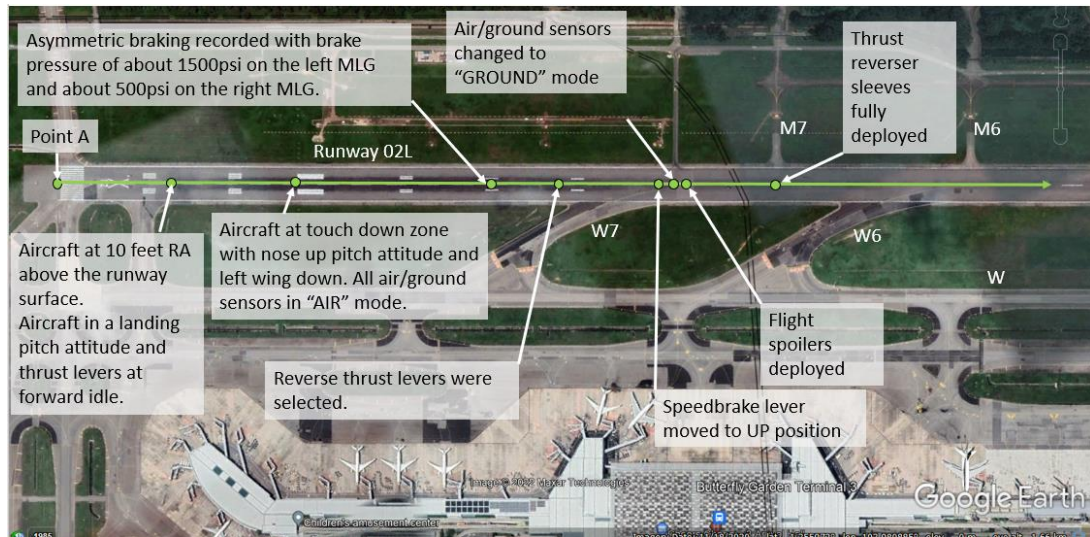
Time	Aircraft position (distance in metres from Runway 02L threshold (Point A))	Event description (See Figure 4 for positions of aircraft)
14:36:07	205	The aircraft was at about 10 feet radio altitude (RA) ¹¹ above the runway surface. The aircraft was in a landing pitch attitude and thrust levers were at forward idle.
14:36:10	414	The aircraft was at the touch down zone with nose up pitch attitude and left wing down. Normal load factor peak was 1.1 g. All air/ground sensors of the landing gears were

Figure 4 – Positions of aircraft (Source: Google Earth, annotated by TSIB)

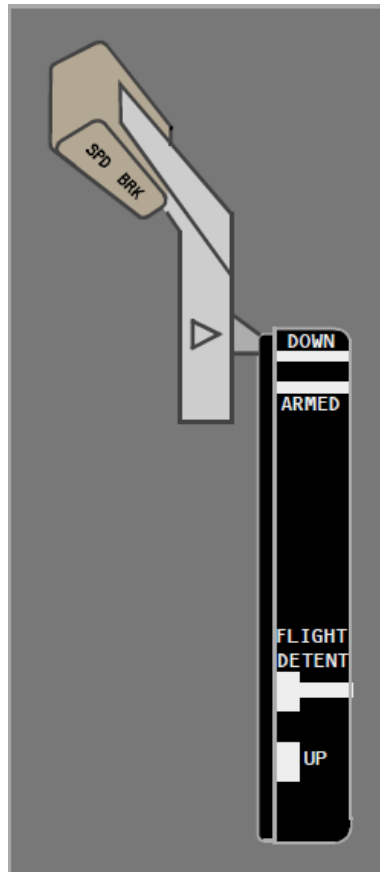
Position	Functional description
DOWN (detent)	All flight and ground spoilers in stowed position.
ARMED	Automatic speedbrake system is armed.
FLIGHT DETENT	All flight spoilers are extended to their maximum position for inflight use.
UP	All flight and ground spoilers are extended (or deployed) to their maximum position for ground use.

Figure 5 – Speedbrake lever positions and corresponding functions
