FINAL REPORT

RUNWAY INCURSION INVOLVING B777 AND TWO DEPARTURES IN CHANGI AIRPORT 29 JUNE 2017

AIB/AAI/CAS.149

**Transport Safety Investigation Bureau
Ministry of Transport
Singapore**

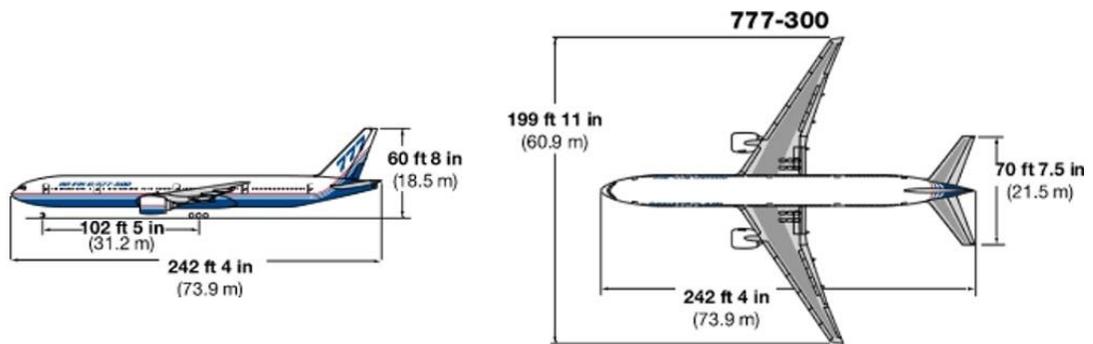
Figure 6. Dimensions of B777

1.5.1 The aircraft stuck on E6 was a -300 variant of the B777. The length of the aircraft was about 74m (see **Figure 6**). The distance between the nose wheel and the main undercarriage was about 31m. The wing span was about 61m.
