Final Report

BOEING B777-300ER, REGISTRATION 9V-SWQ IN-FLIGHT ENTERTAINMENT SMOKE INCIDENT

27 MARCH 2023

TIB/AAI/CAS.221

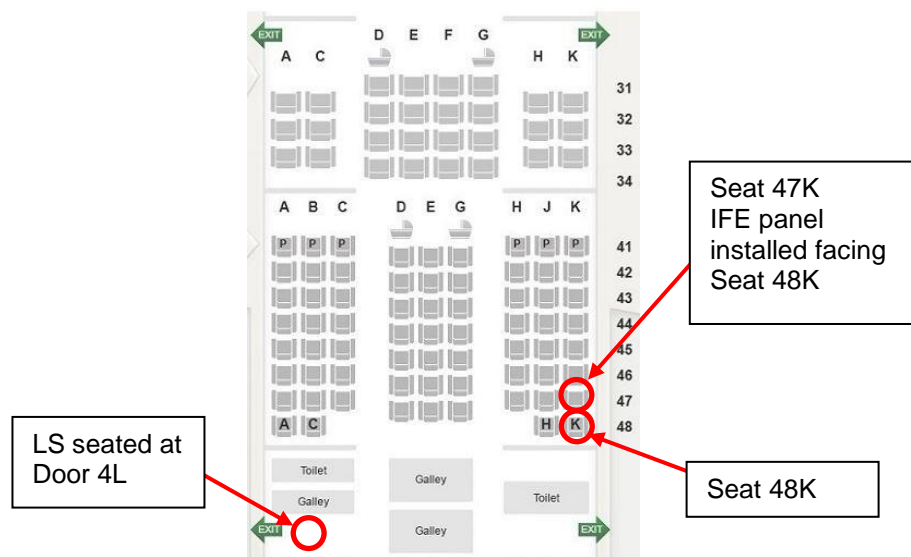
1.1.2 During descent to Los Angeles, a passenger from Seat 48K reported to the Leading Steward (LS) seated at Door 4L that the In-Flight Entertainment (IFE) panel at the back of Seat 47K (i.e. the IFE panel in front of Seat 48K) was emitting smoke. The LS went over to Seat 48K and saw that smoke was emitting from the USB port of the IFE multiport jack¹ (MPJ). Another Flight Steward (FS) who was present then proceeded to switch off the seat power module (SPM) maintenance switch under Seat 47H to turn off the power supply to the seatback IFE equipment for seats at rows 47 (i.e. H/J/K).

Figure 1: Seat location of IFE

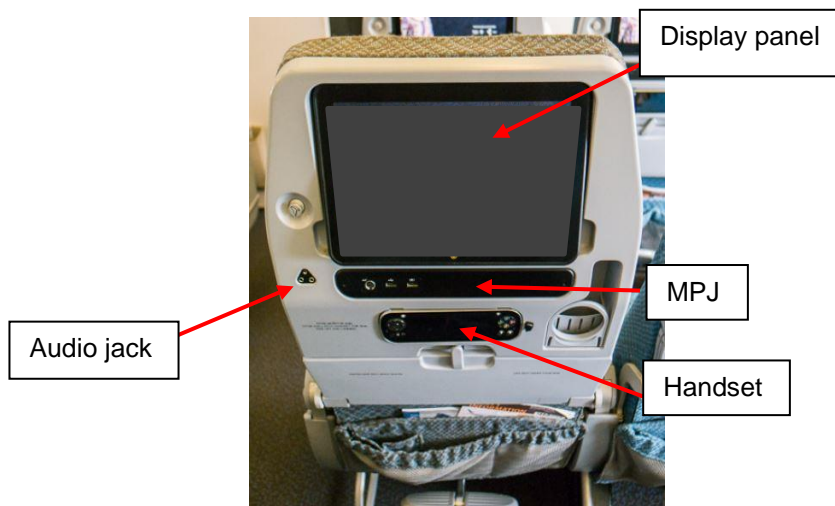
Figure 2: IFE components
