# **Final Report**

## **BOEING B747- 400F, REGISTRATION B-18719 TYRE BURST DURING TRANSIT**

AIB/AAI/CAS.169

Transport Safety Investigation Bureau  
Ministry of Transport  
Singapore

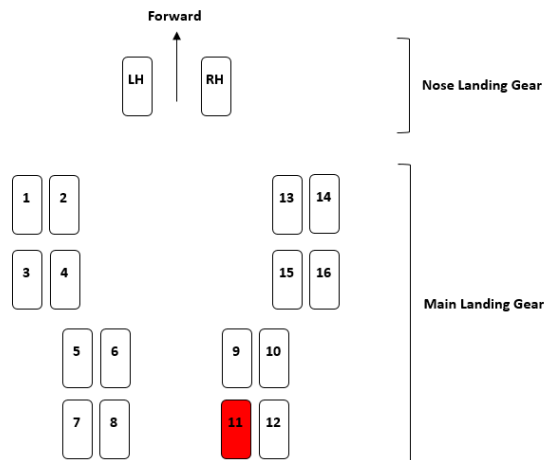
Figure 1: Wheel numbering system for B747-400F

1.1.2 At about 0500LT, one Licensed Aircraft Engineer (LAE) and one technician (hereinafter referred to as Technician A) of the aircraft maintenance service provider contracted by the airline operator performed a walk-around inspection of the aircraft. The LAE suspected that the pressure of the right body landing gear rear inboard tyre (No.11 tyre, see **Figure 1**) was low. After assessing by touch that the tyre was not hot, he tasked Technician A to measure the tyre pressure while he himself went to the cockpit and noted that the brake temperature was indicated as "0" on a scale of 0 to 9 on the wheel synoptic page of the aircraft's Engine Indicating and Crew Alerting System (EICAS)<sup>1</sup>.

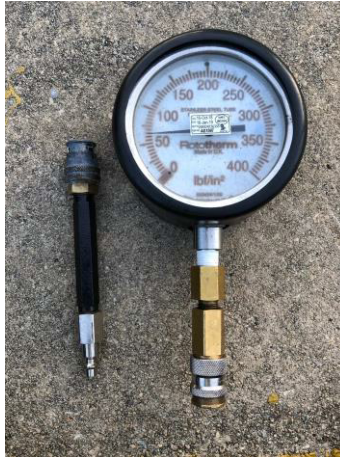
Figure 2: Manual tyre pressure gauge

1.1.3 Technician A used a manual tyre pressure gauge (see **Figure 2**) to measure

the tyre pressure of the No. 11 tyre<sup>2</sup> and obtained a reading of 170 pounds per square inch (psi).

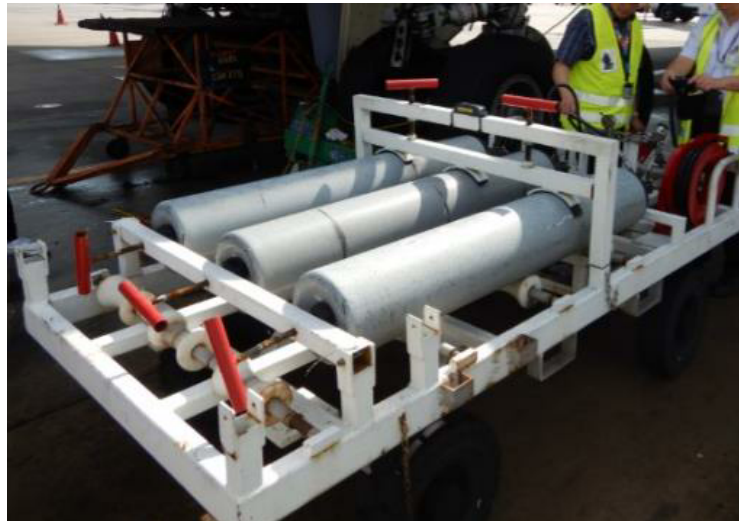
Figure 3: N<sub>2</sub> servicing cart

1.1.9 At about 0600LT, Technician B arrived at the bay with a Nitrogen (N<sub>2</sub>) servicing cart (see **Figure 3**). He used his manual tyre pressure gauge to measure the tyre pressure which indicated 170 psi, same reading as Technician A's earlier measurement. He then put his manual tyre pressure gauge on the top of the tyre and proceeded to service the tyre.

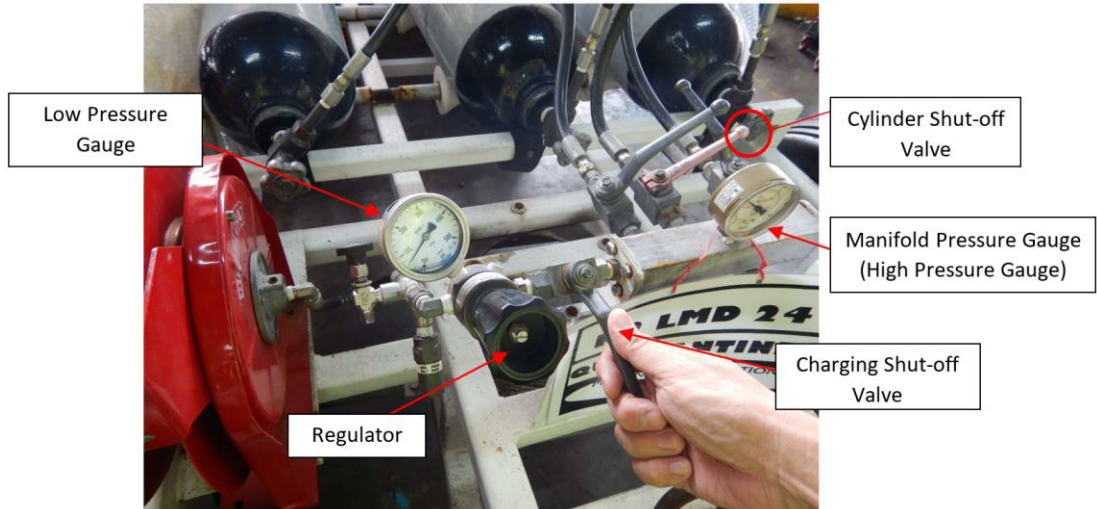
Figure 7: Gauges on the N<sub>2</sub> servicing cart

- Connect the hose from the N<sub>2</sub> servicing cart to the tyre inflation valve and verify that the reading on the low pressure gauge (see **Figure 7**) of the N<sub>2</sub> servicing cart is the same as the reading obtained from the manual tyre pressure gauge.
- Open the N<sub>2</sub> cylinder shut-off valve to supply N<sub>2</sub> to the manifold and check that the reading on the manifold pressure gauge (high pressure gauge) is the same as that of the N<sub>2</sub> cylinders (of the order of 1,500 psi).
- Turn the charging shut-off valve lever ON to allow N<sub>2</sub> to flow from the manifold to the tyre.

- Turn the regulator until the low pressure gauge shows the target pressure.
- Cycle the charging shut-off valve lever OFF and ON slowly and repeatedly. At each OFF position, read the tyre pressure from the low pressure gauge. When the low pressure gauge indicates the target pressure, disconnect the hose.
- Verify using the manual tyre pressure gauge that the tyre pressure has reached the target pressure.

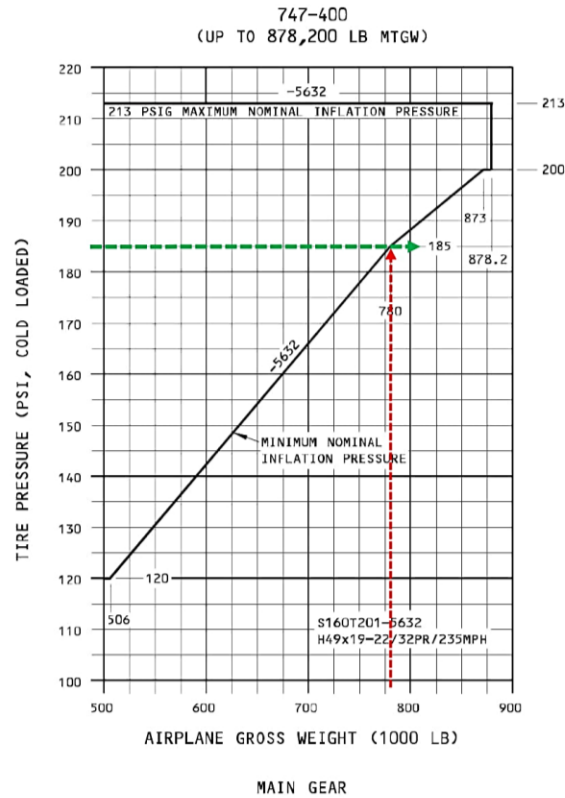
**747-400  
AIRCRAFT MAINTENANCE MANUAL**

- 1.1.6 The Cold Tyre Pressure Check required the LAE to compare the measured pressure (i.e. 170 psi) with the pressure to be found in the Tyre Pressure Limits Chart (see **Appendix 1**). He referred to this chart and thought that he should compare the measured pressure with the minimum nominal inflation pressure (MinNIP) for the tyre corresponding to the take-off weight (TOW) of the aircraft, i.e. 780,000 pounds (lb). The LAE determined that the MinNIP for the tyre was 185 (+5/-0) psi and that the difference ( $\Delta p$ ) between the measured pressure and the MinNIP was 8.1% below the MinNIP.
