Final Report

BOEING B777-200, REGISTRATION 9V-SQK TOW TUG FIRE

29 NOVEMBER 2017

AIB/AAI/CAS.155

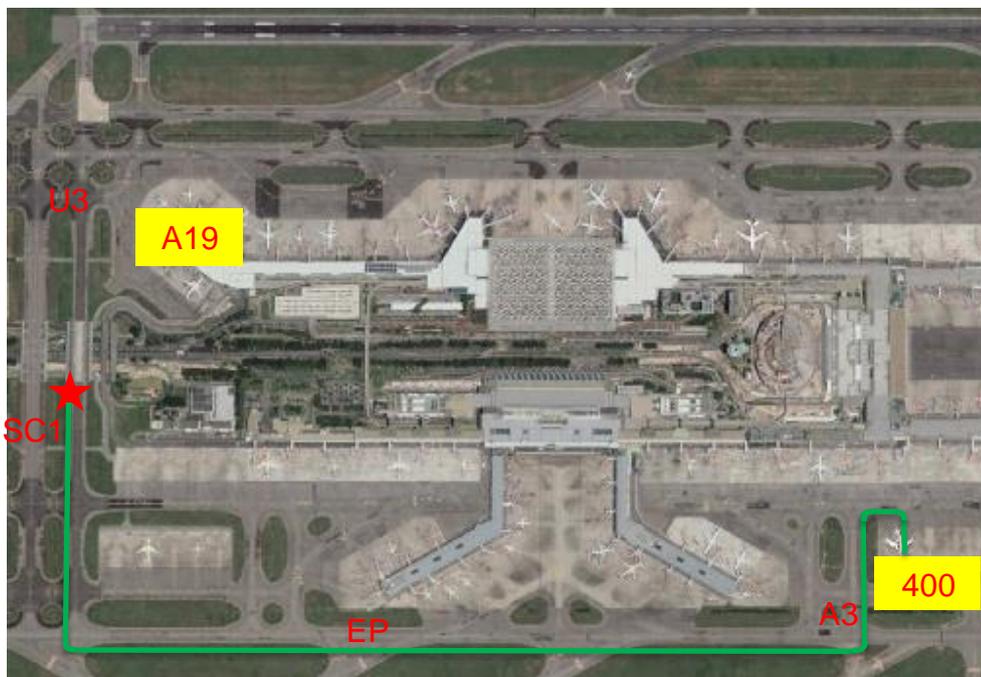
Figure 1. Tow route of the aircraft

- 1.1.1.3 At about 0401LT, the towing party was approaching a taxiway bridge (marked ★ in **Figure 1**) on SC1. When the towing party reached the bridge, the headset man and the driver felt vibrations. Then the engine stopped and they looked back and noticed a fire at the area of the engine which was located directly behind the driver's cabin². The driver and headset man quickly evacuated the driver's cabin.

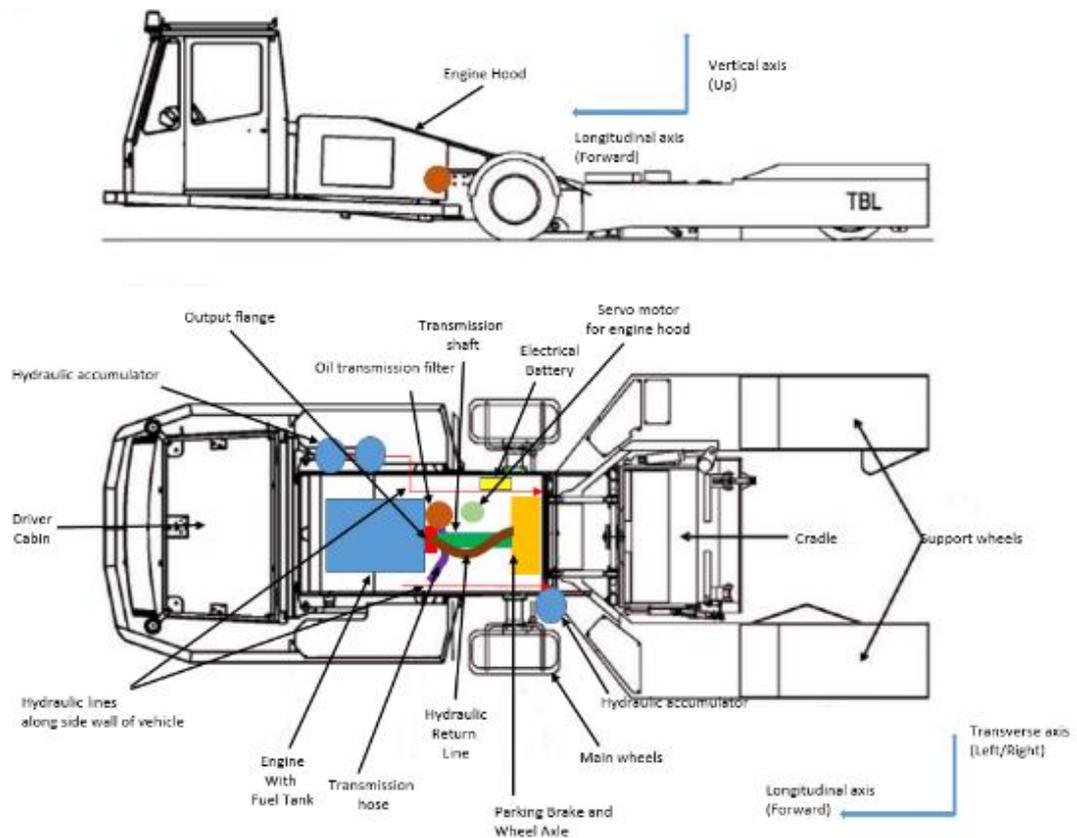
Figure 6: Tow tug schematic

1.6.1.1 The tow tug involved in the incident was a diesel-powered Kalmar Towbarless 190 (TBL190) model.

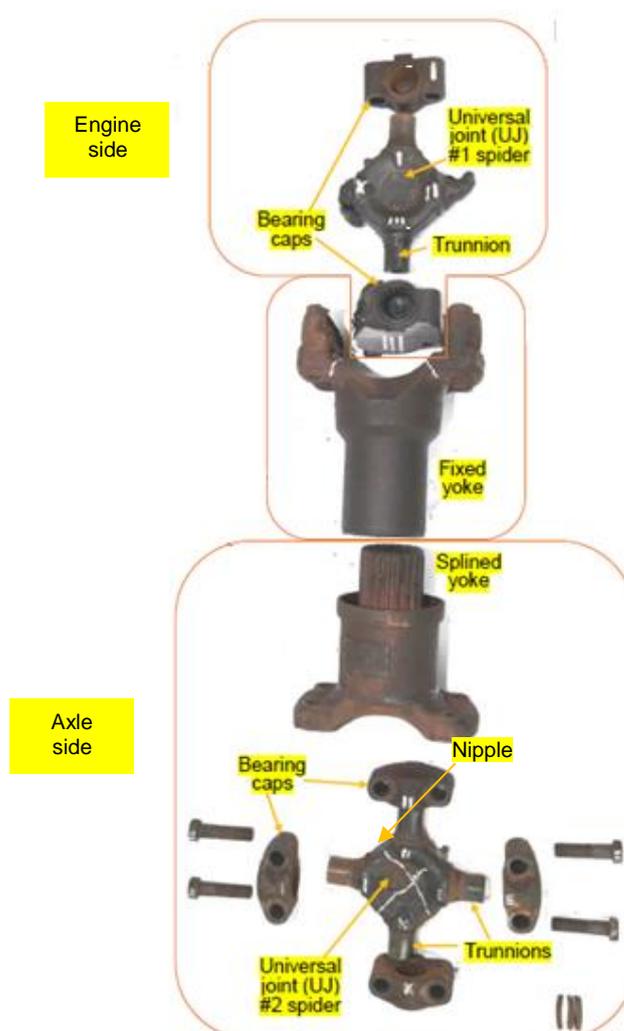
Figure 7: Transmission shaft assembly

1.6.2.1 The tow tug’s engine gearbox drove the front wheel axle system via a transmission shaft assembly. For the purpose of this investigation report, the transmission shaft assembly is termed as comprising four elements, viz. a fixed yoke, a splined yoke and two universal joints (see **Figure 7**).

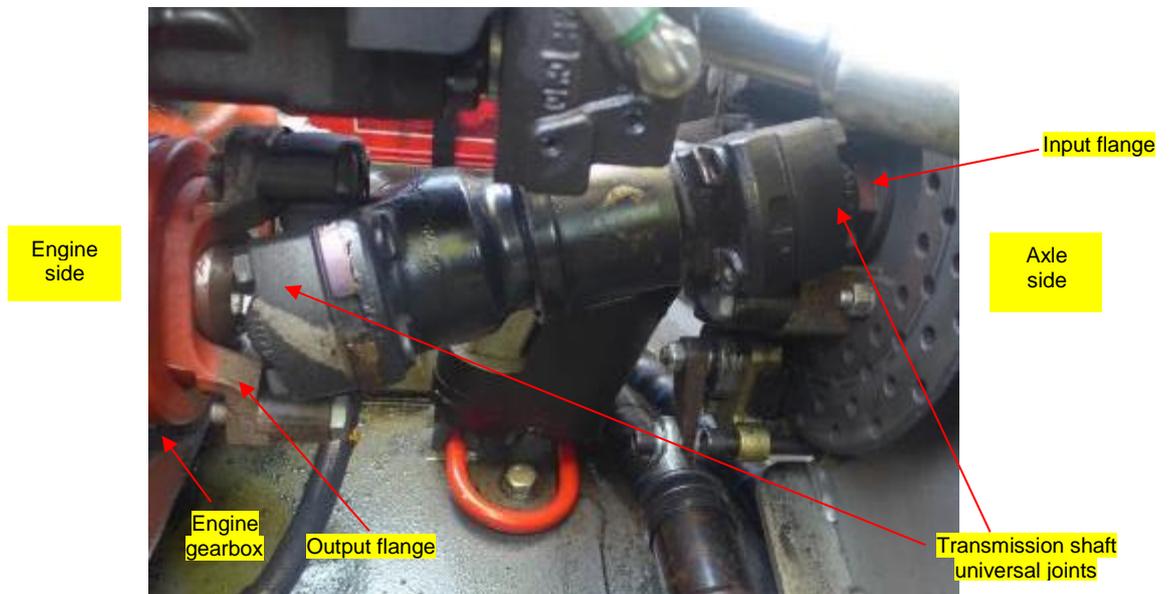
Figure 8: Transmission shaft assembly in situ

1.6.2.2 The fixed yoke was connected to the engine transmission (the “engine side”) by one of the two universal joints. The splined yoke was connected to the front axle input flange (the “axle side”) by the other universal joint (see **Figure 8**). Each universal joint comprised four bearing caps (with needle bearings) and a spider (with four trunnions). The LMSP’s practice of

lubricating the transmission shaft assembly involved injecting grease into the nipple of each universal joint spider until the grease flowed out from the trunnions of the universal joint spider into the bearing caps.

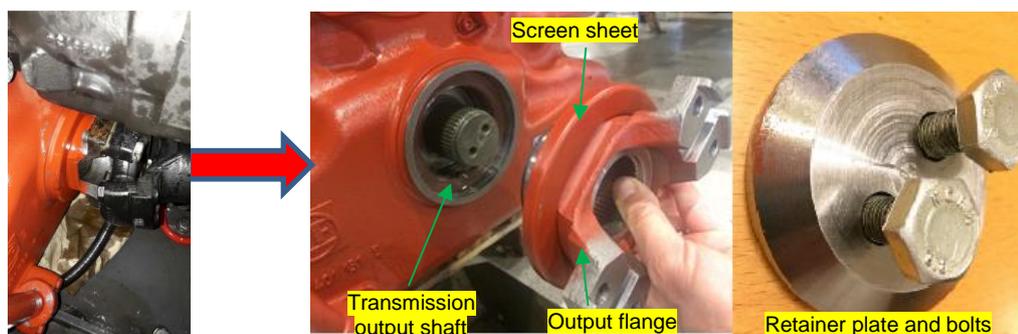
Figure 9: Retainer plate holding output flange (illustration picture only)

1.6.3.1 The engine transmission output flange (including its screen sheet) was held onto the output shaft of the engine transmission by a retainer plate and two bolts that were screwed into threaded holes at the end of the transmission output shaft (see **Figure 9**).

1.9.3.3 The needle bearings in the corresponding pair of bearing caps on the fixed yoke were missing. The two retainer plate bolts were found to be loose from the threaded holes of the output shaft (see **Figures 15 and 16**). As a result, the retainer plate was not fully secured against the output flange.
