Final Report

FATALITY OF CREW ON BOARD NOZOMI IN BANGKA STRAIT, INDONESIA 1 APRIL 2022

TIB/MAI/CAS.122

Transport Safety Investigation Bureau
Ministry of Transport
Singapore

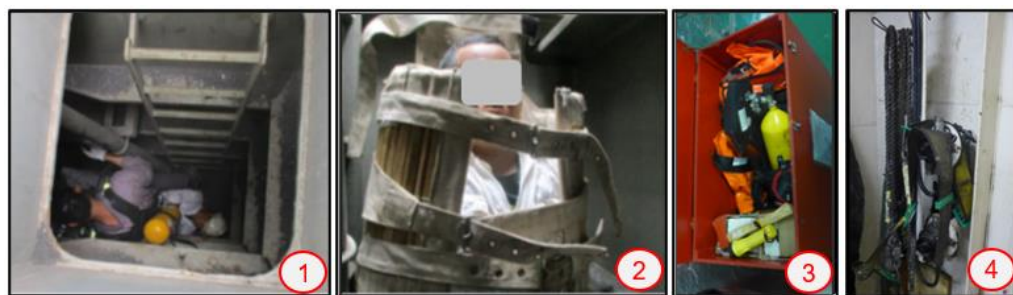
1.7.2 According to the records obtained by the investigation team, a physical enclosed space entry drill was conducted at the duct keel on 10 October 2021, where the pre-entry checks and risk assessment were carried out, the SCBA, stretcher and other equipment (See **figure 7**) were deployed, the rescuing operation was simulated, and the outcome of the drill was documented as satisfactory. All the crew listed in the table (paragraph 1.3.2) participated in that drill.

Figure 7 – Deployment of the SCBA, stretcher, rope and harness for the rescue drill (simulated at ship's duct keel)
(Source: photographs 1&2 from the Company, 3&4 from the TSIB)
