FINAL REPORT

CAPSIZE AND SINKING OF THE AGGREGATES CARRIER CAI JUN 3 IN SINGAPORE TERRITORIAL WATERS ON 13 MARCH 2017

MIB/MAI/CAS.015

Transport Safety Investigation Bureau
Ministry of Transport
Singapore

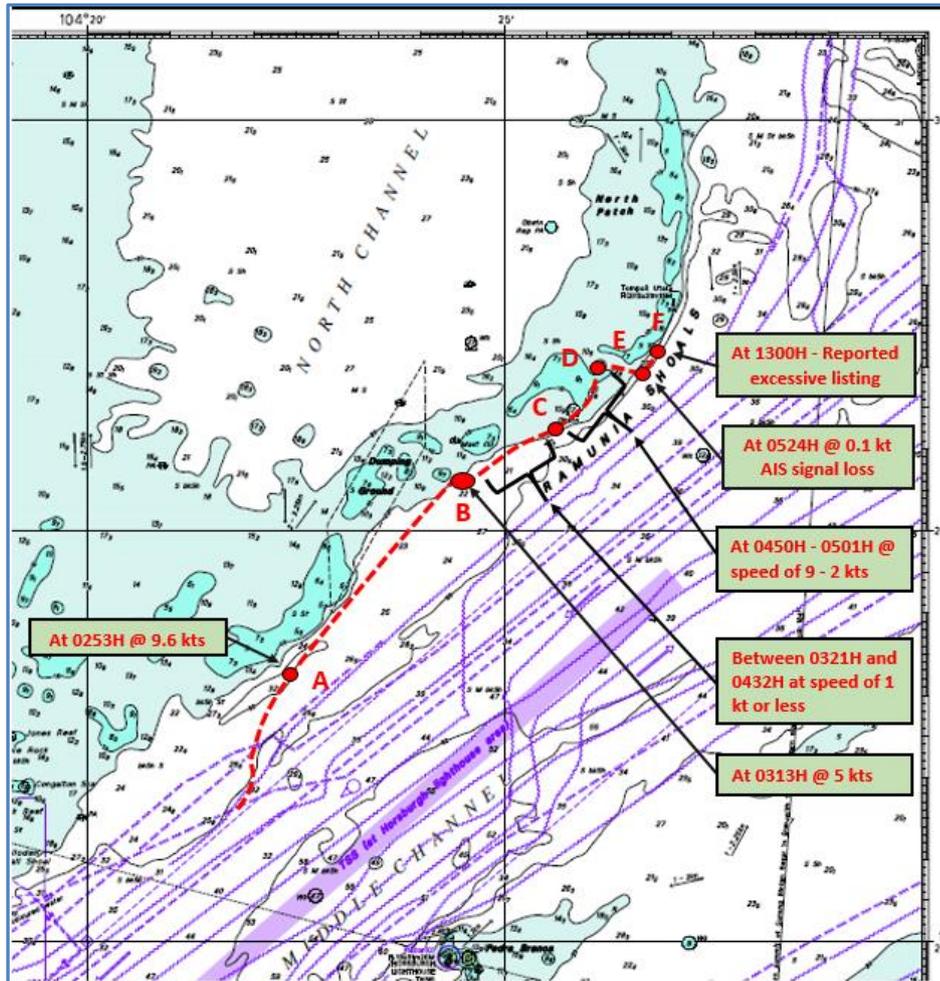
- 1.1.2 At about 0243H, on 13 March 2017, CJ3 cleared the Singapore Strait at a speed of about 9.3 knots.
- 1.1.3 At 0313H, Singapore Vessel Traffic Information Service's (VTIS) AIS track plot showed CJ3 to be in position B (see **Figure 1**) and moving at less than 5 knots. Between 0321H and 0432H, she was moving at about 1 knot in approximate position Latitude 01°25.670' N and Longitude 104°24.519' E (between positions B and C as shown in Figure 1). Thereafter, at about 0452H, she moved further north-east at about 9 knots to positions C, D and E as shown in Figure 1. Her last AIS⁷ transmission was at 0524H.

Figure 1 – BA (Dual badge) Chart 503 Ed. 5 annotated to indicate CJ3’s passage prior to capsize
(Source: Maritime and Port Authority of Singapore)

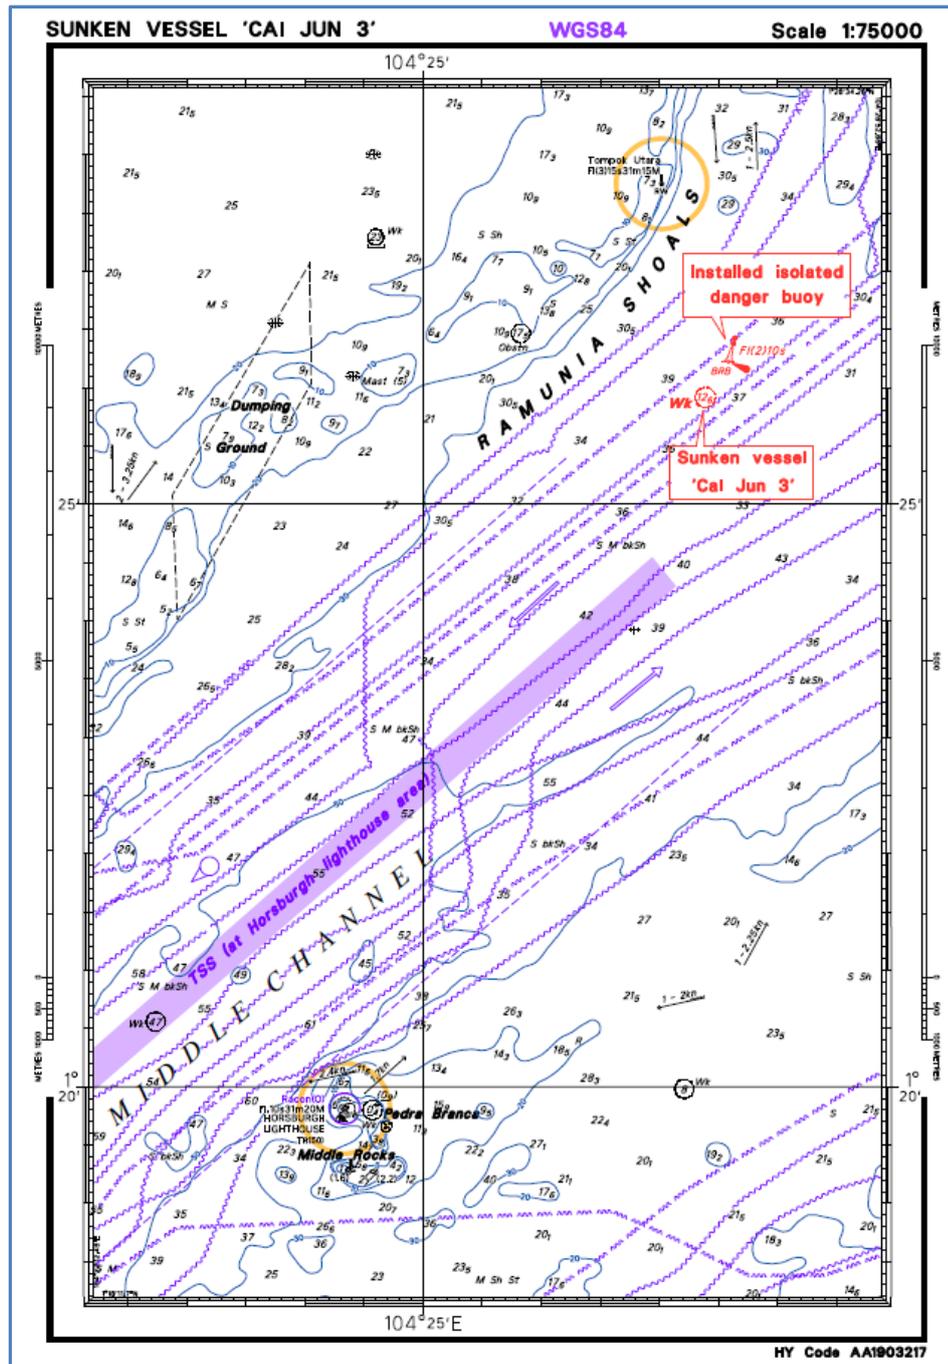
- 1.1.17 By about 1155H on 15 March 2017, the capsized CJ3 had sunk, at approximate location Latitude 01°25.915' N and Longitude 104°27.389' E, about 7.8nm NNE of Horsburgh Lighthouse in Singapore Territorial Waters.
- 1.1.18 The Maritime and Port Authority of Singapore (MPA) installed an Isolated Danger Mark¹³ for the safety of navigation. MPA also issued notices on the sunken CJ3 for safety of navigation (see **Figure 5**).

Figure 5 – Sunken CJ3, as marked on Singapore Notices to Mariners, Edition No. 3B/2017 (Source: MPA Hydrographic Department, Singapore)

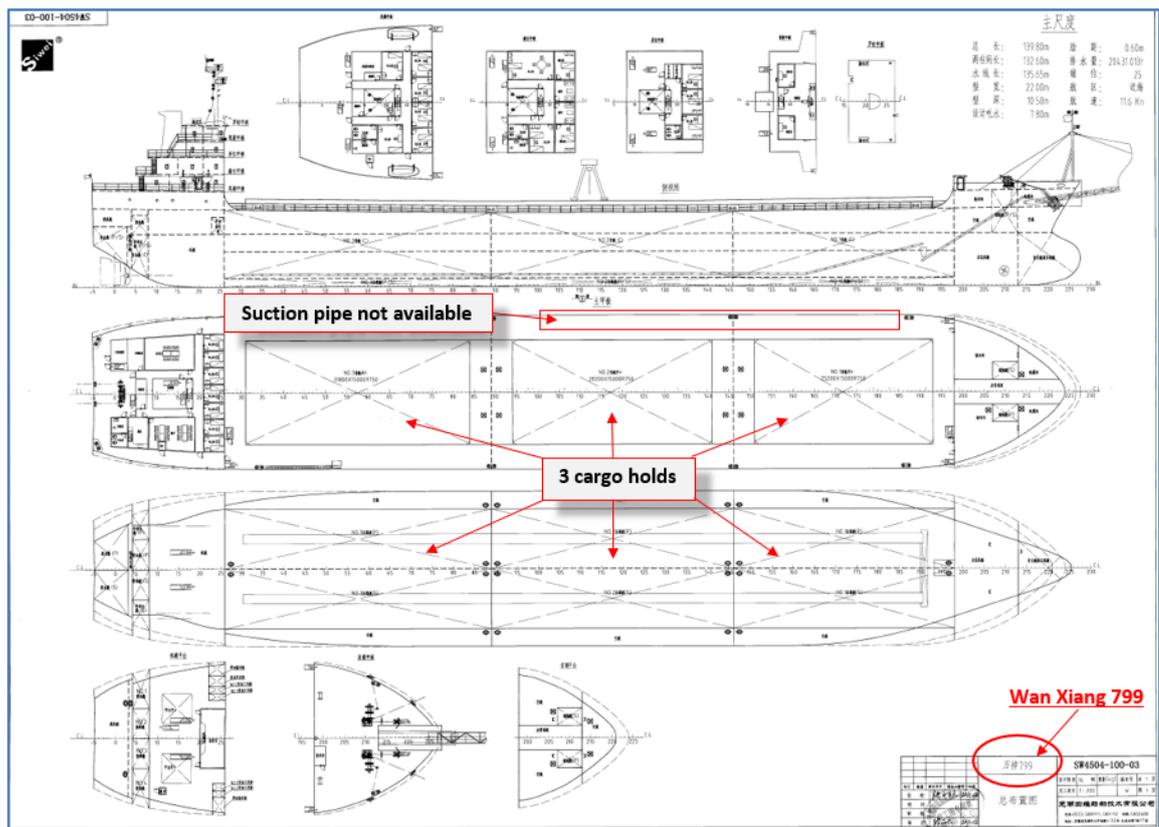
1.2.1 CJ3 was previously called Wan Xiang 799. It was built at Chaohu Yingjiang Shipbuilding in China, and was delivered in March 2012 to its then-owner Boyu Investment Co. Limited. She had three cargo holds and was designed and fitted with a conveyor belt system, giving her the capability to self-discharge sand cargo from the three cargo holds. She had a double bottom hull below the cargo holds, and 12 ballast tanks equally distributed on both sides (see **Figure 6**).

Figure 6 – Plans of Wan Xiang 799
(Source: The ISM Manager)

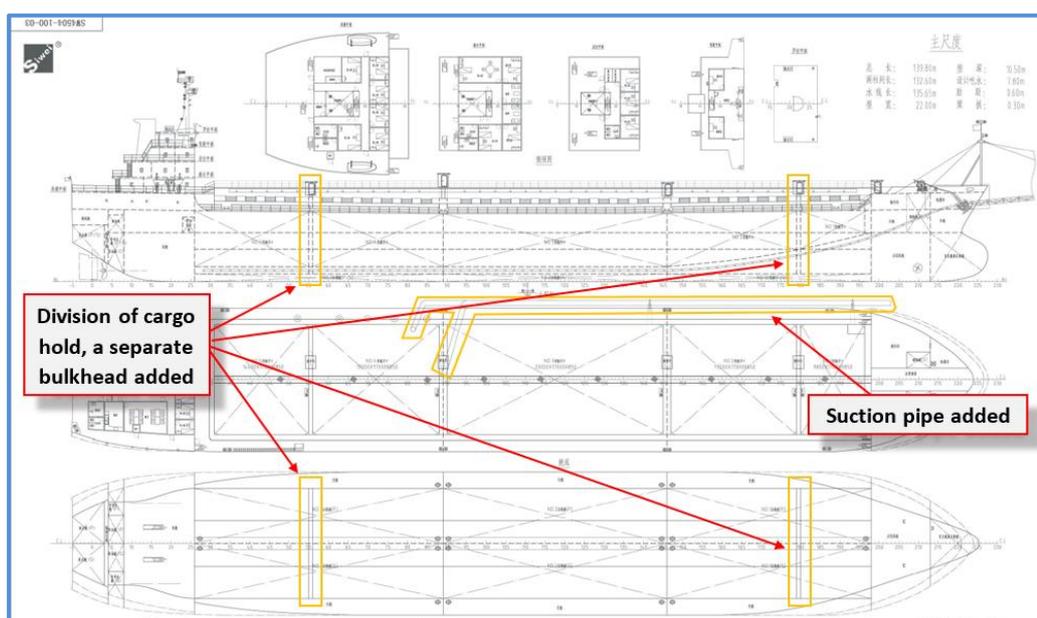
1.2.9 During its survey on 6 February 2017, ClassIBS noted that CJ3 had been issued with stability/loading information in the form of a ship stability booklet¹⁸ at the time of the vessel's delivery. ClassIBS was not aware that CJ3 had undergone modification in 2016¹⁹. The owner had submitted plans and drawings of Cai Jun 5 (CJ5), another sister ship of CJ3, which had five cargo holds, for ClassIBS' reference (see **Figure 8**). However, ClassIBS did not notice that CJ3 stability booklet showed only three cargo holds. ClassIBS issued the interim certificates based on the owner's information that CJ3 and CJ5 had the same plans with regard to cargo holds.

Figure 8 – Plans of CJ3 showing modifications
(Source: ISM Manager)

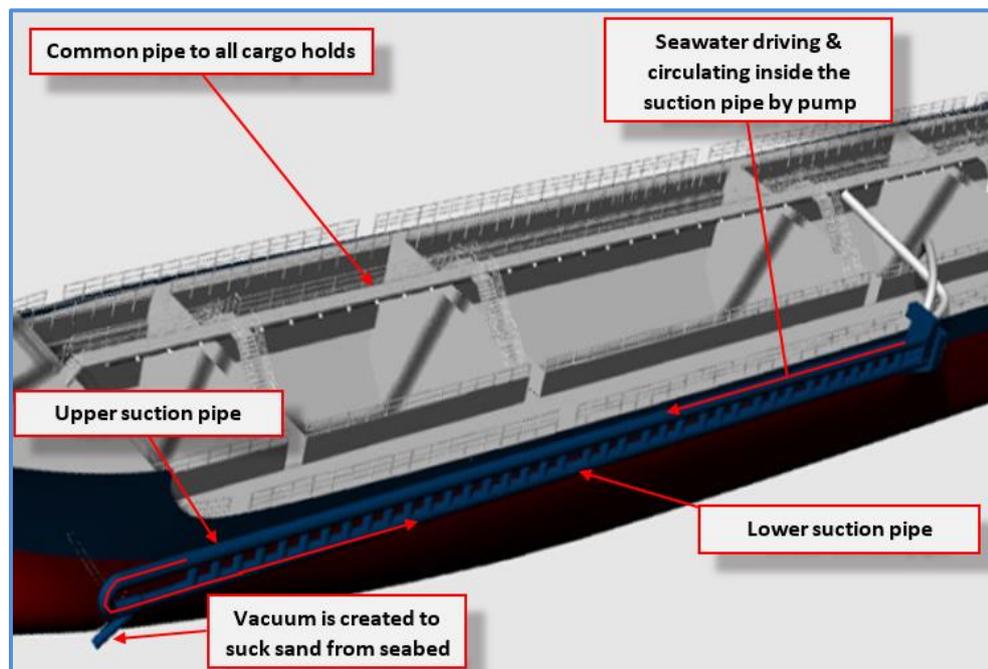
1.7.1.1 Typically for dredging, the suction pipe would be lowered into the sea using the winches. As the pipe's end neared the sea bed, a pump (capable of being started remotely or locally) would pump seawater through the suction pipe, thus causing the sand and water mixture from the sea bed to be sucked in due to the vacuum³⁴ created at the end of the pipe (see **Figure 9**).

Figure 9 – Illustration of CJ3's suction pipe's working – annotated by TSIB

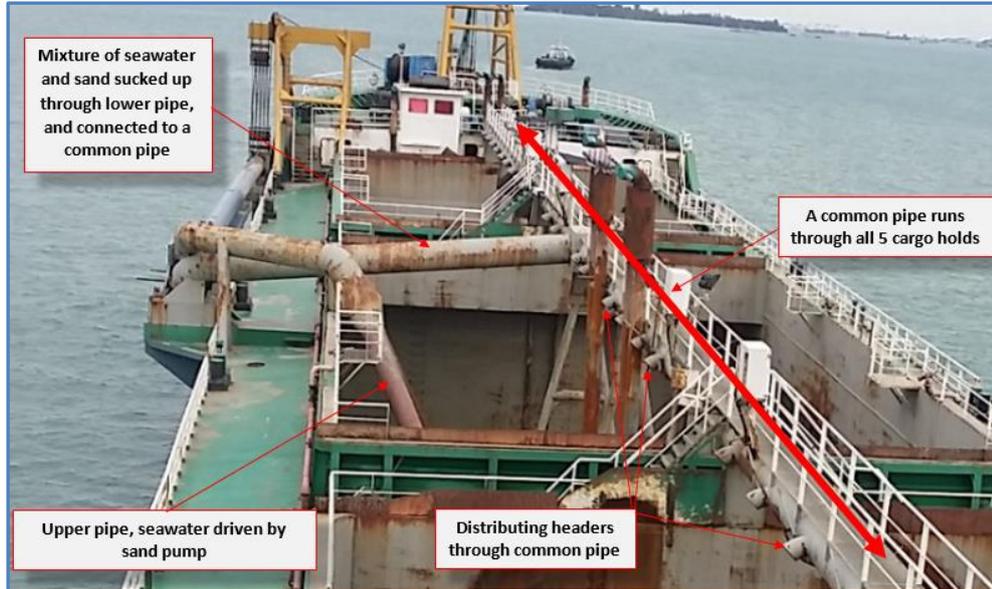
- 1.7.1.2 The sand and water mixture would be fed into a common and large-diameter pipe running above and along the length of all cargo holds (see **Figure 10**). The common pipe had distributing header disc valves to discharge the sand and water mixture into the cargo holds.

Figure 10 – Layout of suction system on CJ2 (CJ3's was similar)

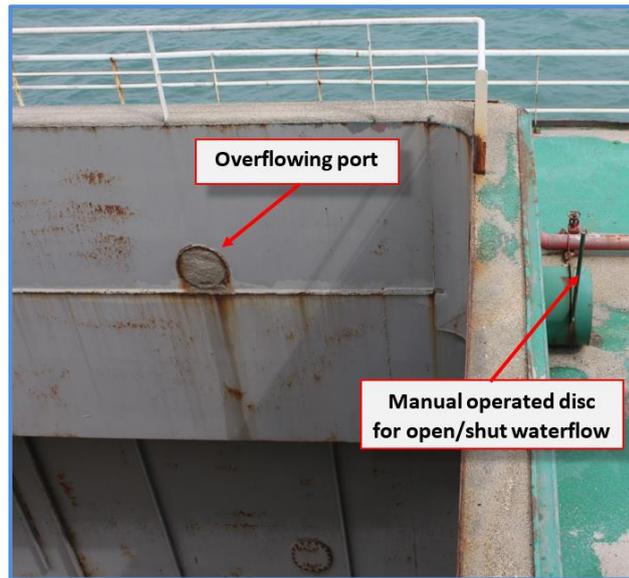
- 1.7.1.3 The deck crew would use these manually operated distributing header disc valves to control the amount of sand and water mixture to be discharged. They would monitor the operation and would open or shut them based on instructions from the Chief Mate. The ship would be considered fully loaded when all cargo holds were almost full and when water flowed out from the overflowing ports³⁵ (see **Figure 11**) at the main deck level.

³⁵ CJ2 was provided with eight overflowing ports for each cargo hold which, like the distributing headers, were manually operated disc valves. The ports were located at the main deck and about 1.5 metres below the coaming of the cargo hold.

Figure 11 – Overflowing port on CJ2 seen from inside and outside the hold

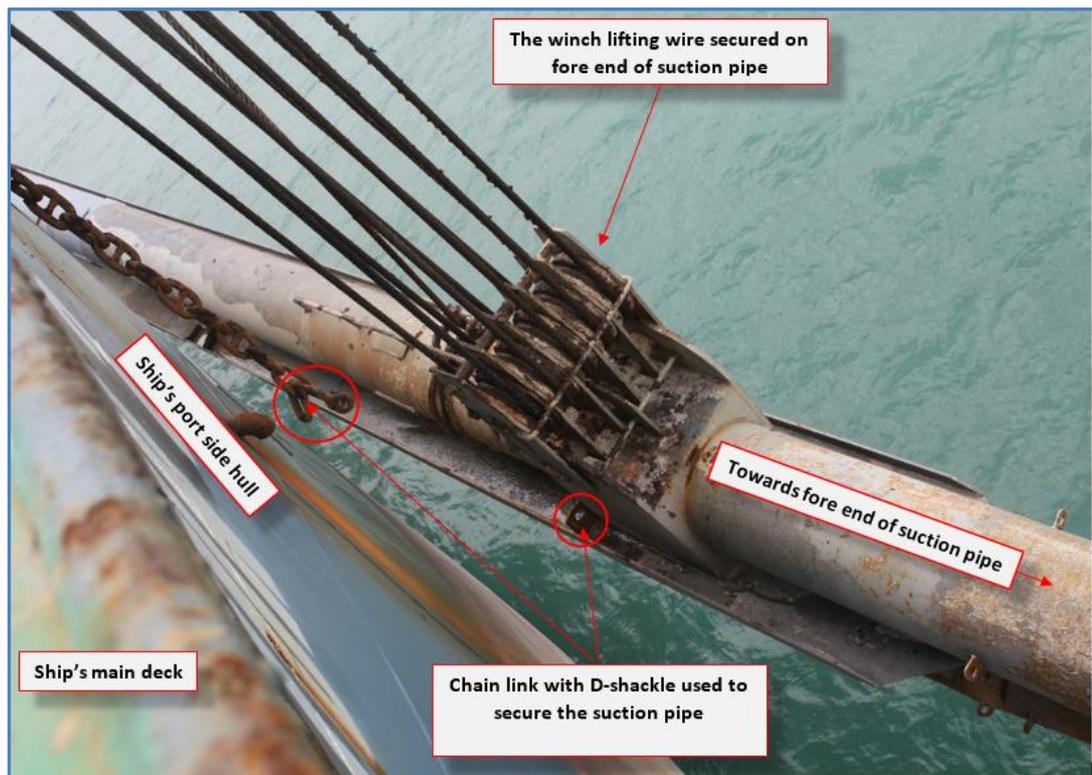
- 1.7.2.1 Once the dredging operation was completed, the suction pipe would be heaved up by winches and brought up to the deck level. Winch brakes would be applied and a chain link with a D-shackle would be secured to a pad-eye on the suction pipe and connected to the main deck (see **Figure 12**).

Figure 12 - Suction pipe securing arrangement on CJ2
(CJ2 had one lifting davit support whereas CJ3 had two as seen in Figure 7)

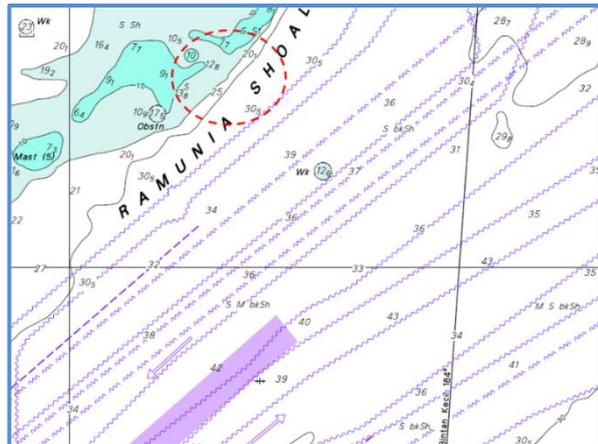
- 1.9.1 At the time of the accident, the weather was fair, visibility was good, and the sky partly cloudy. The wind was light and the sea was calm.
- 1.9.2 The area (circled in **Figure 19**) where CJ3 heeled had depth contours of 30 metres, 20 metres and 10 metres. Shallow patches existed in the area within the 10 metre contour. The shallowest being about 8 metres.

Figure 19 – BA (Dual badge) Chart 502 Ed. 5,
Red dash circled to indicate possible location of heel and capsizing
(Source: Maritime and Port Authority of Singapore)
