# **Final Report**

## **Capsize of Barge CB100-01 towed by ASL Osprey off the Indian Coast on 7 July 2022**

TIB/MAI/CAS.128

Transport Safety Investigation Bureau  
Ministry of Transport  
Singapore

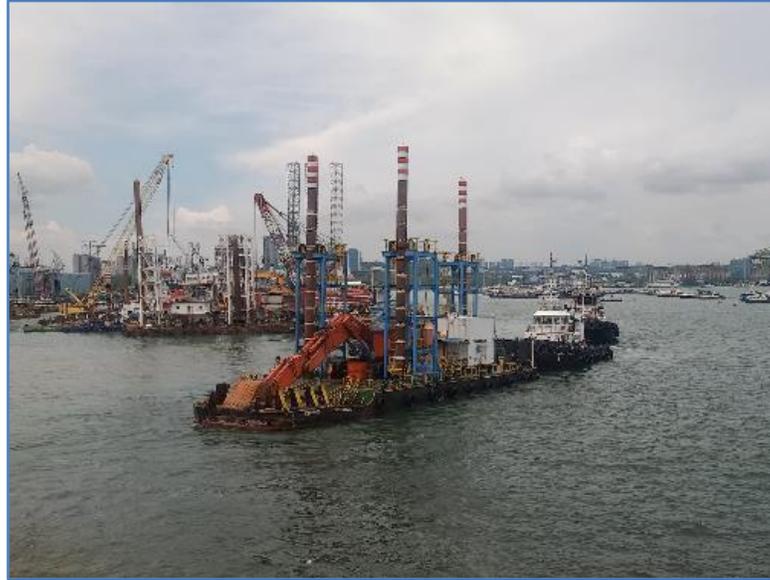
1.1.2 On 30 April 2022 a survey<sup>9</sup> was conducted by a marine warranty survey (MWS) company appointed by the insurer. Thereafter, on 1 May 2022 at 1355H (UTC + 8H), AO departed ASL Shipyard, Singapore, towing CB which was drawing a draught<sup>10</sup> of 0.8m (forward) and 1.5m (midship) with 2.2m (aft as calculated). AO's Master estimated the arrival at Djibouti to be on the 3 June 2022 at about 1600H (UTC + 3H) with the average towing speed of 5.5 knots. **Figure 3** shows the condition of the tug and tow at the time of departing Singapore.

Figure 3 – The tug and tow departing ASL Shipyard with an escort tug before commencement of the tow, Singapore (*Source: the Operator*)

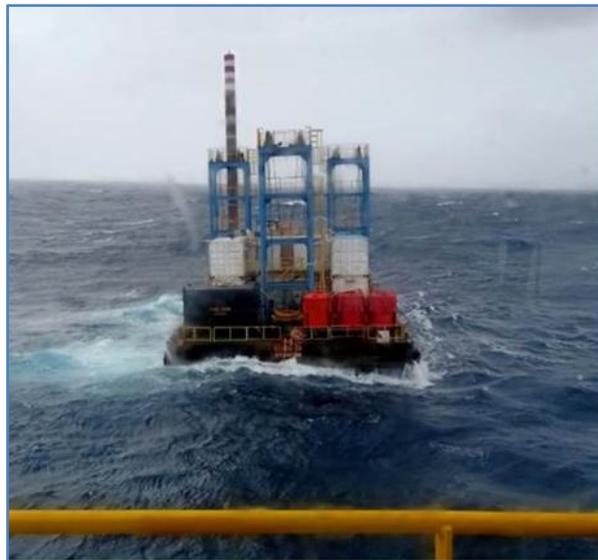
1.1.12 The Master advised the Operator at about 1535H that CB was adrift, and that AO was standing close by to monitor CB's movement (see **figure 7**).

Figure 7 – View of CB's stern as viewed from AO (*Source: the Operator*)

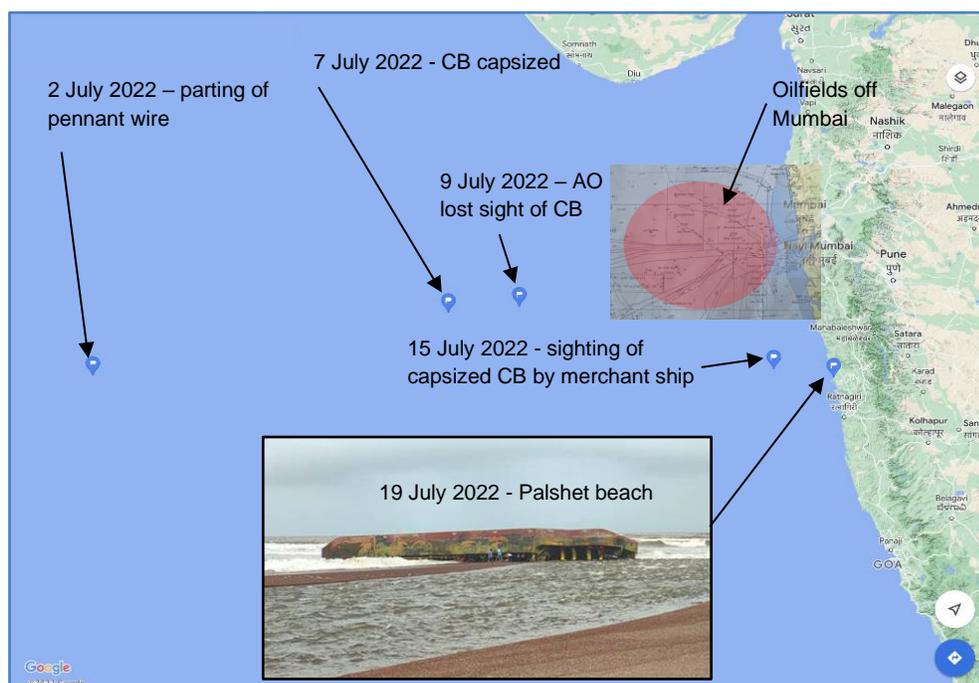
- 1.1.18 On 10 July 2022 at about 0930H the search for CB was called off by the Operator and AO was instructed to proceed to Mumbai for further instructions. On 15 July 2022 the Operator received information from Mumbai MRCC that a merchant ship had sighted the capsized CB at 1540H approximately 165nm from the location where CB was lost and 93nm southwest of Mumbai.
- 1.1.19 On 18 July 2022, AO's P&I Club initiated the sourcing of a suitable tug that could hold CB in position. On 19 July 2022, the Operator was notified by Mumbai MRCC, that CB had washed up ashore at Palshet beach on the Indian west coast [about 291.5km south of Mumbai (see **figure 11** showing approximate locations of events)].

Figure 11 – Events after towing pennant wire rope parted and movement of CB (*Source: photo by the Operator – annotated by the TSIB. Not to scale*)

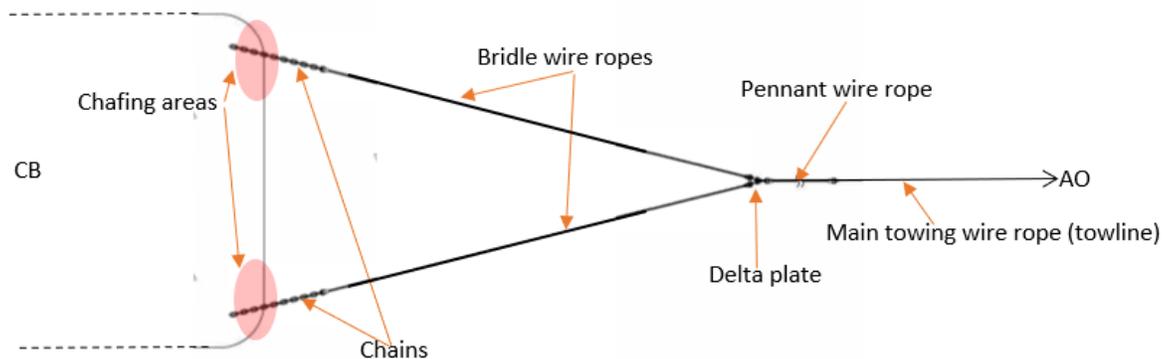
- 1.2.6 The main towing wire rope was of a Left-Hand Ordinary Lay (LHOL)<sup>31</sup>, i.e., the strands of the wire are wound in counter-clockwise spiral around the core. The bridle wire ropes were connected to the pennant wire rope by a delta plate forming a bridle apex (see **figure 18**). Both the bridle wire and the pennant wire ropes were of a Right-Hand Ordinary Lay (RHOL)<sup>32</sup>, i.e., the strands are wound in clockwise spiral around the core.

Figure 18 – Towing arrangement (not to scale) (*Source: the Operator – annotated by the TSIB*)

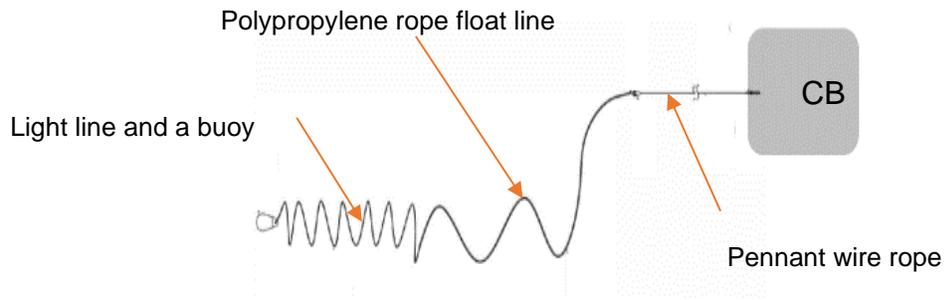
- 1.2.8 An emergency towing arrangement comprising another towing bracket at the centreline, aft of CB was connected using a shackle to another wire pennant rope of 52mm diameter and 18m in length. Attached to this pennant wire was a 12-inch polypropylene rope float line 50m in length, which was then connected to a 24mm diameter light line of 20m length connected to the Norwegian buoy (see **figure 19**).

Figure 19 – The emergency towing arrangement on CB (*Source: the Operator – not to scale*)

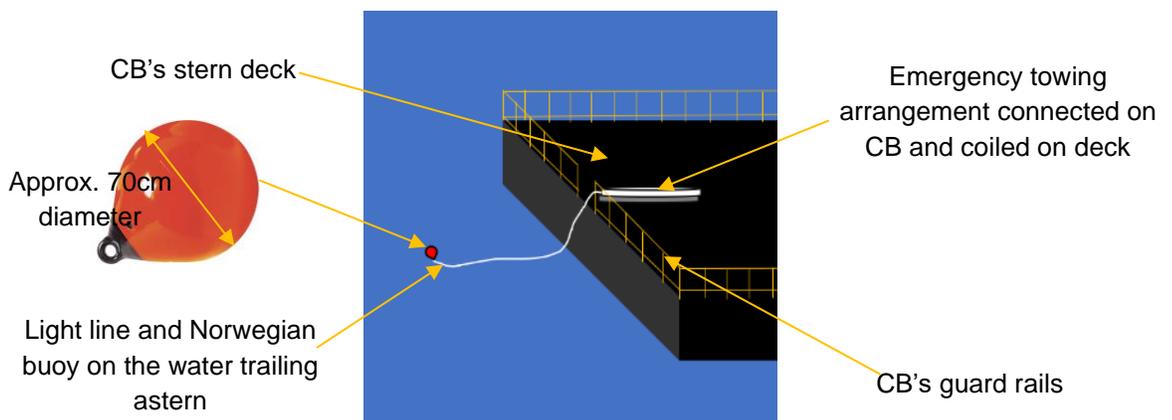
1.2.9 According to the MWS company and the Operator, before departing Singapore, the emergency towing arrangement had been coiled on deck leaving the light line and Norwegian buoy in the water trailing astern of CB for retrieval in an emergency (see **figure 20**). The status of the Norwegian buoy prior to departing Colombo could not be established<sup>37</sup>.

Figure 20 – The Norwegian buoy and the light line from CB (*Source: the Operator – not to scale - For illustration only*)

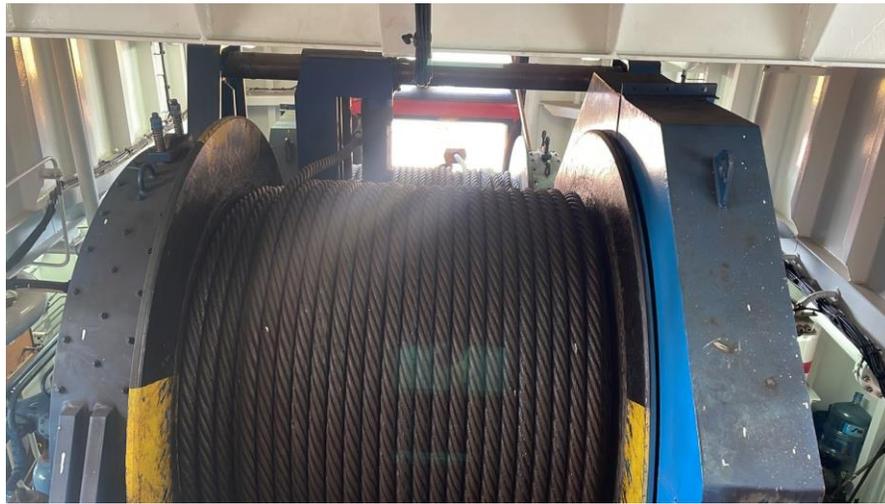
Figure 21 – Main towing wire rope on the main towing winch drum (Source: AO)

- 1.3.3 The investigation team gathered from records on AO, that at the time of the incident the maximum towing wire length onboard AO was about 836m<sup>39</sup>. It was further established that in 2021, the towing wire rope had been cut and the effective length was reduced from the original length (1000m) of towing wire.
- 1.3.4 It was also observed that when AO was not engaged in towing operation, the bridle and pennant wire ropes onboard were coiled and secured onto the ship's railing on the open deck above the towing winch compartment and covered with

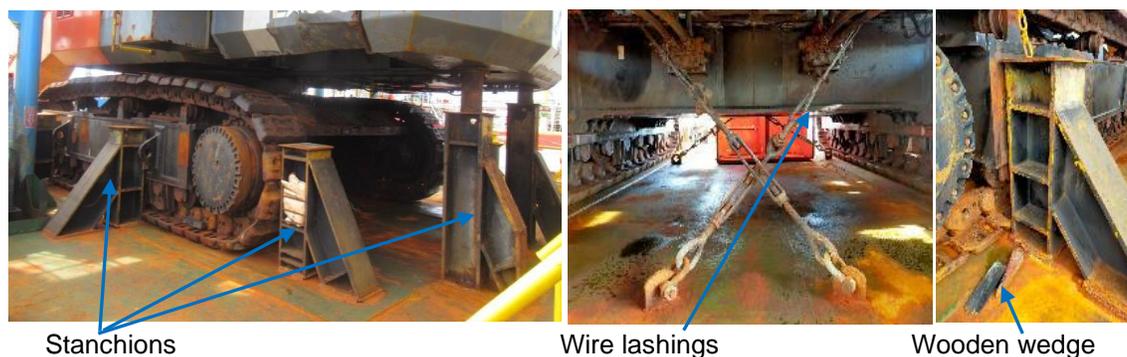
1.5.2 The excavator was stowed onboard against two 1.2m stanchions placed on each side, two at the front and two at the rear with the gaps between them shored up with wooden wedge. The undercarriage of the excavator was secured with wire lashings onto pad eyes welded on deck with the rear protruding engines supported by stanchions (see **figure 24**).

Figure 24 – (Source: the Operator – annotated by the TSIB)

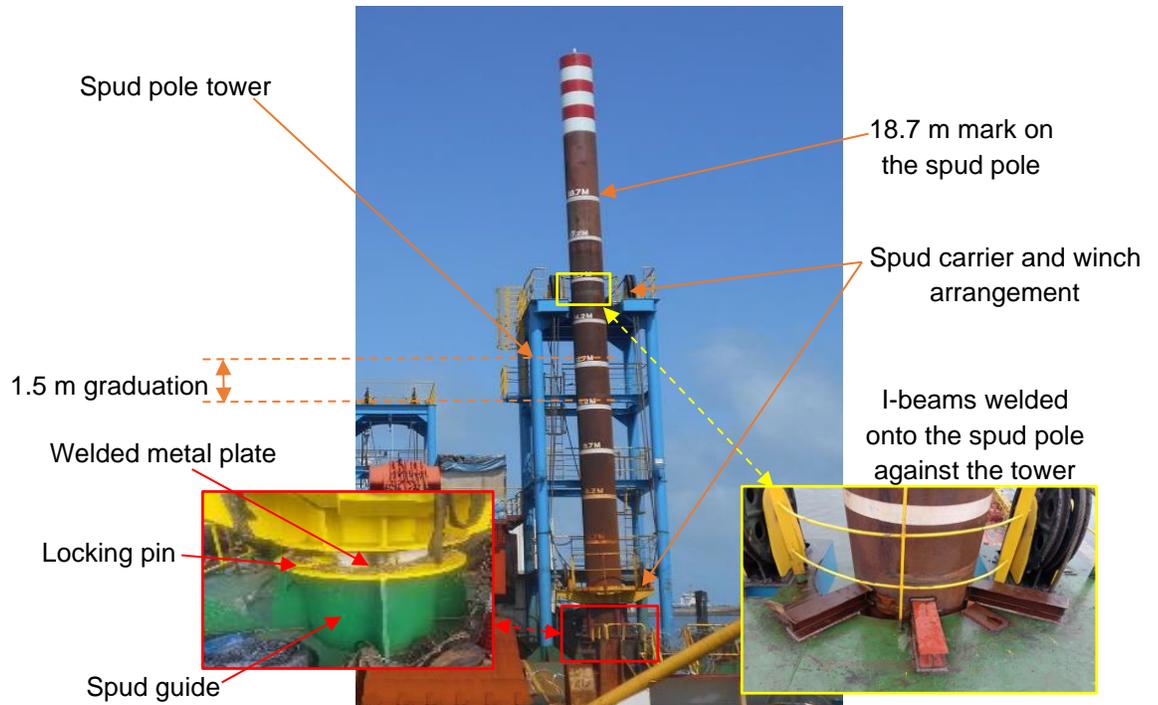
1.5.3 The three spud poles were stowed vertically onto their tower. For the voyage, the hydraulic powered spud carrier was clamped onto the spud pole with the spud pole locked into position with locking pins and welded onto the spud guide with metal plate. At the top platform of the tower, I-beams<sup>46</sup> were welded onto the spud pole against the tower (see **figure 25**).

<sup>46</sup> Two outermost I-beam were the initial securing when CB departed Singapore. The photo shows the middle I-beam added in Colombo with the outermost I-beams rewelded after they had broken off during the voyage to Galle.

Figure 25 – Description of spud pole (Source: Operator – annotated by the TSIB)

2.4.1 During the damage survey at Colombo, it was evident that two I-beams welded (see **figure 25**) prior departure Singapore had dislodged and together with the failure of the spud carrier clamp and locking pins, two out of three spud poles were lost. The dislodging and the failures were likely caused when CB was subjected to the motions<sup>85</sup> in sea state BF 6.

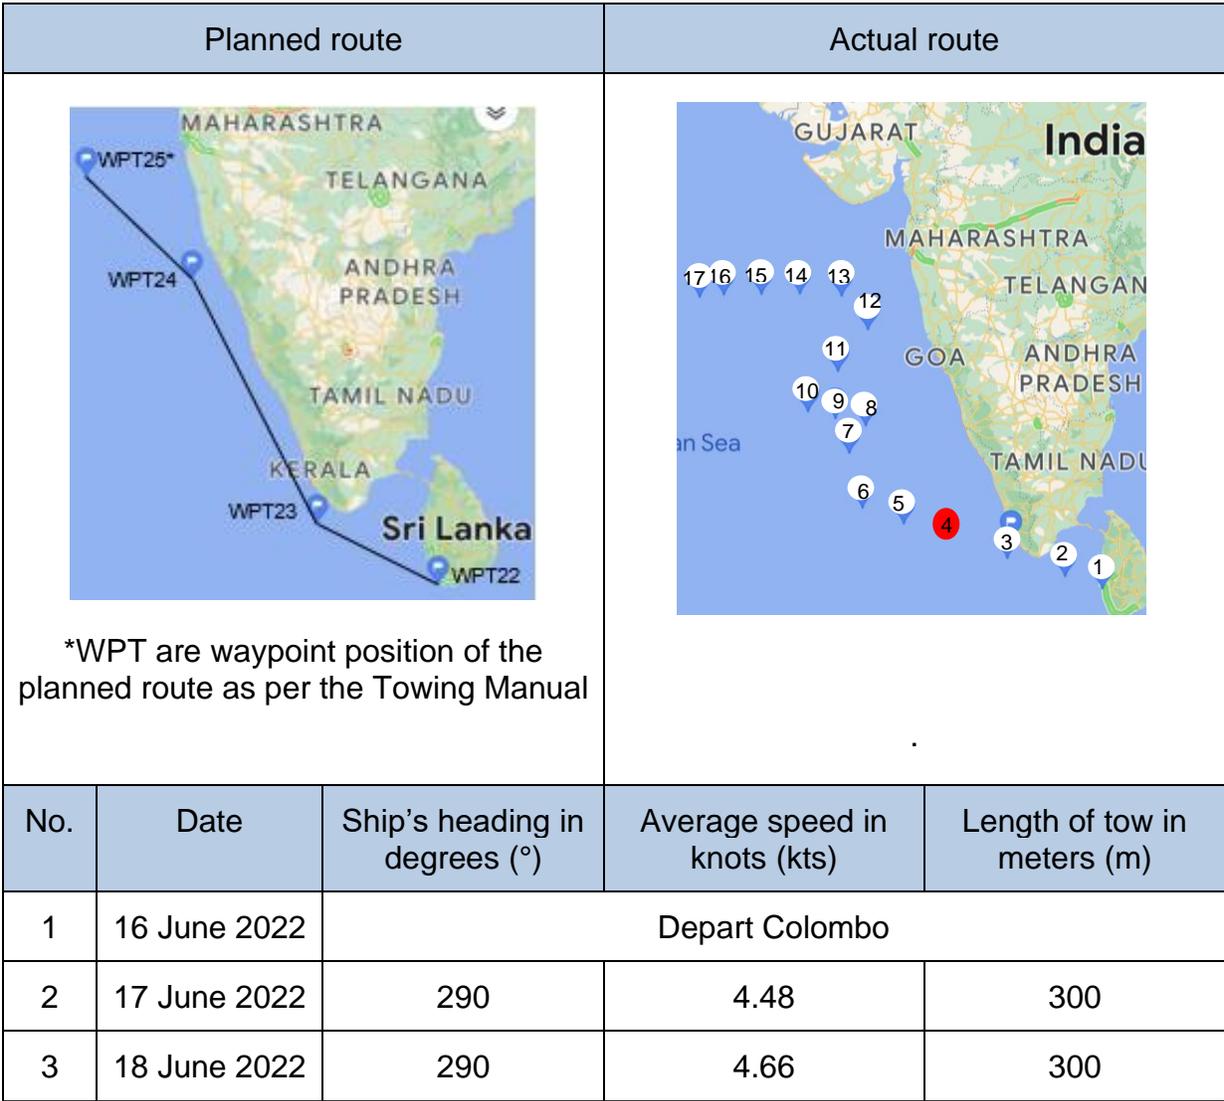
1.7.1 The investigation team reviewed the logbook of the AO and the DPR of the route taken by the tug and tow after the departure from Colombo till the location where the towing pennant wire rope parted and plotted the approximate positions. The positions<sup>69</sup> of the tug and tow and the planned route are indicated **figure 29**.

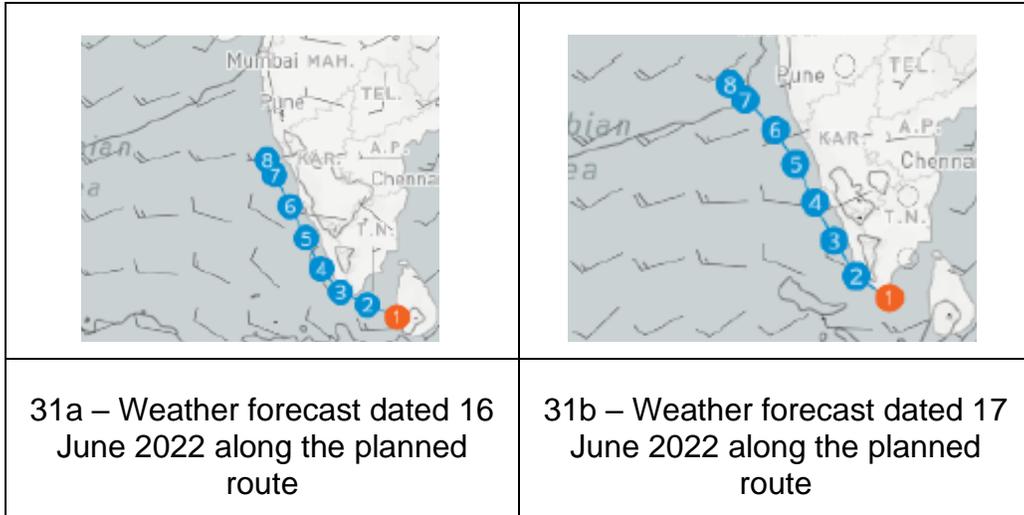
Figure 31 – Weather forecast provided by DTN, which was available onboard AO (Source: the Operator).

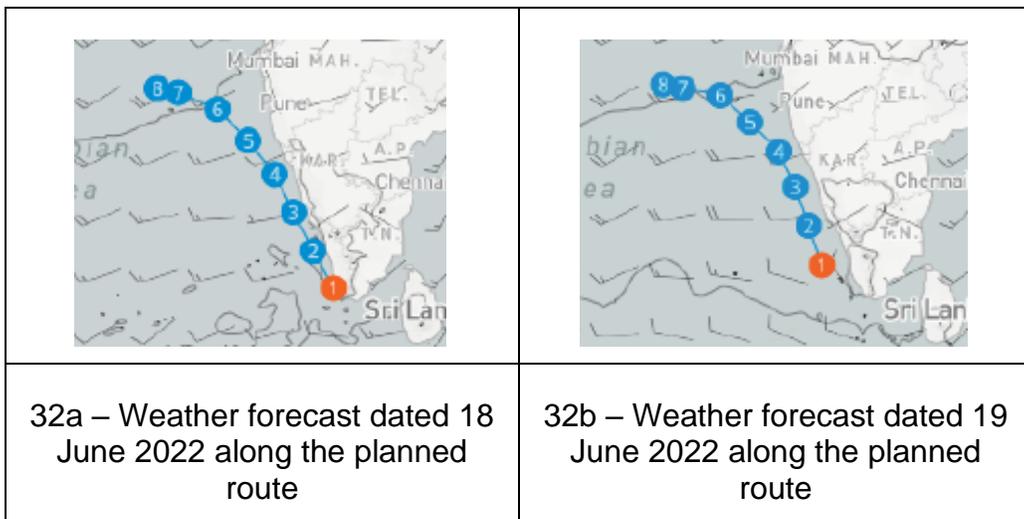
1.7.5 The forecast dated 18 June 2022, for the period 19 June till 25 June 2022, indicated the maximum wind and sea state to be BF 4/5 along the planned route (see **figure 32a**). The forecast dated 19 June 2022, for the period 20 June till 26 June 2022, indicated the maximum wind and sea state to deteriorate to BF 5 along the planned route (see **figure 32b**).

Figure 32 – Weather forecast provided by DTN, which was available onboard AO (Source: the Operator).
