Final Report

FATALITY OF CREW ONBOARD CHEMICAL TANKER CONCERTO AT SEA ON 1 JUNE 2022

TIB/MAI/CAS.126

Transport Safety Investigation Bureau
Ministry of Transport
Singapore

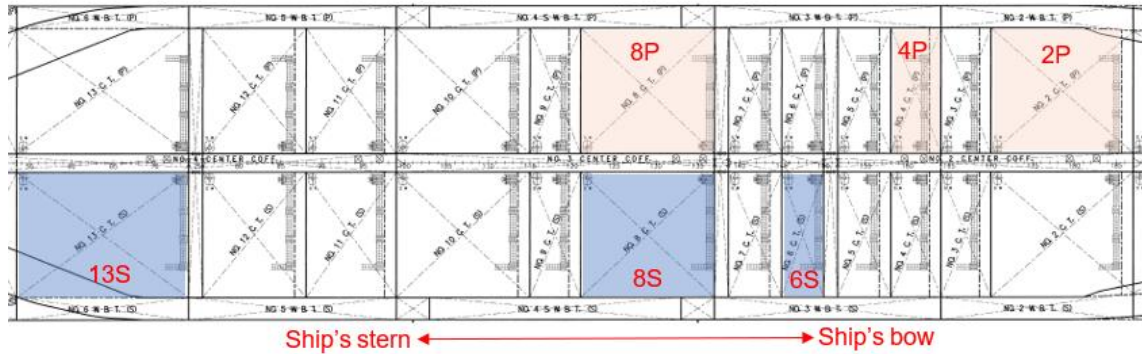
Figure 1 – Gas-freeing of six COTs indicated on ship's General Arrangement plan (Source: the Company, annotated by the TSIB)

1.1.5 At about 2350H, an Able Seafarer Deck (ASD1), who was the in-coming watchkeeper⁶ met up with the out-going watchkeeper⁷, another Able Seafarer Deck (ASD2) on the bridge. Both went on deck to change-over the portable air chute from 2P to 13S (see **figure 1**) as tasked by the Jr 3O.

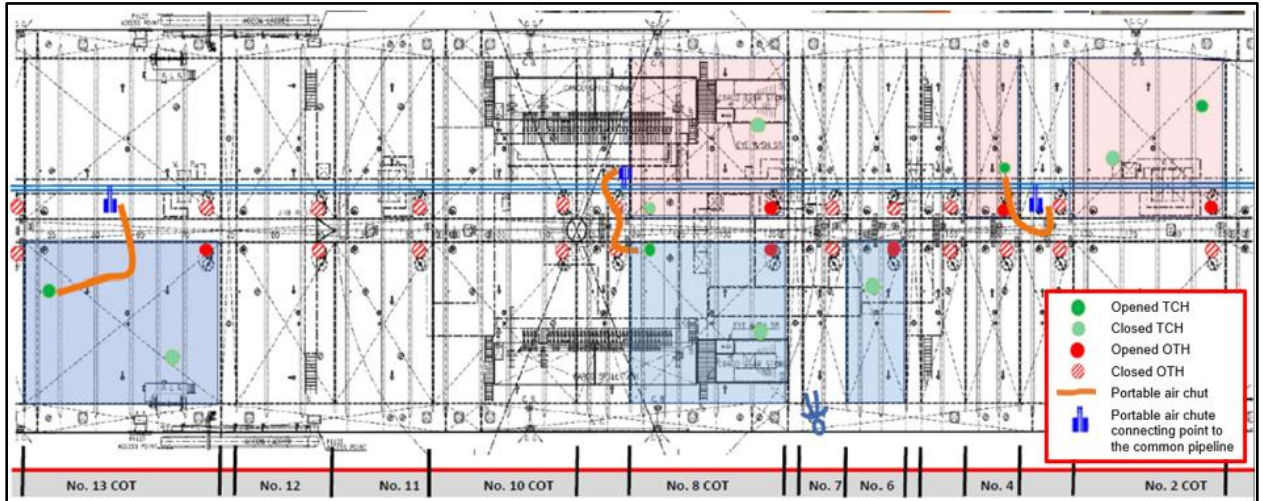
Figure 4a – Status after line-up of six COTs indicated on the General Arrangement Plan (*Source: the Company*)

- 1.7 The gas-freeing operation
- 1.7.1 As per the instructions of the CO, this operation was to be carried out in two batches with each batch involving three COTs. The first batch included COTs 2P, 4P and 8P and the remaining three COTs were for the second batch.
- 1.7.2 Prior to commencing the gas-freeing operation, the line-up of six COTs was completed at about 1830H on 31 May 2022 (see **figure 4a**), where the respective COT gas-freeing flap and tank cleaning hatch (TCH) were kept open. The oil tight hatch (OTH) of each COT was also cracked open by loosening four bolts and nuts (see **figure 4b**). According to the Company, gas-freeing operation of a COT can be safely performed with the PV valve and the gas-freeing flap open and there is no need to open the OTH or the TCH, in the initial stage of gas-freeing operation.

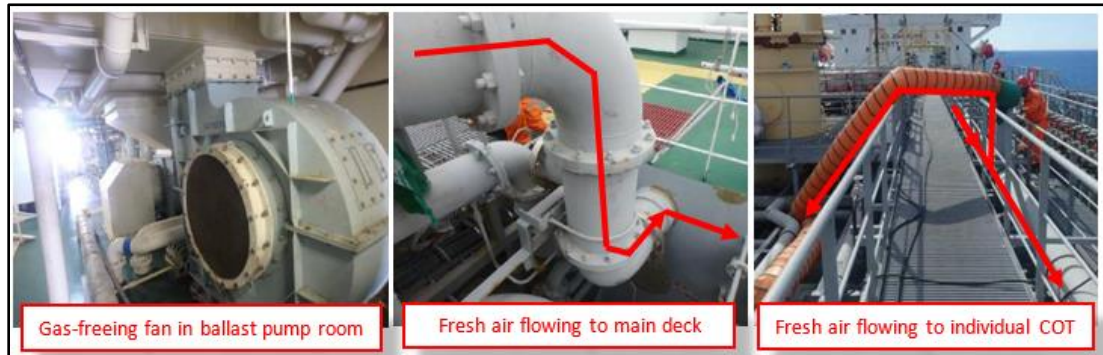
Figure 5 – Flow of fresh air driven into the individual COT from the fixed gas-freeing fan (red annotated by the TSIB; Source: the Company)

1.7.3 The fixed gas-freeing fan (see **figure 5**) used onboard Concerto is a centrifugal type and solely for gas-freeing purpose with a working capacity of 400m³ per minute. It is directly connected to a common pipeline longitudinally at the center of deck to supply fresh air to the port and starboard sides COTs through portable air chutes connected to the respective COT.

1.7.6 The CO also added that for operational convenience, when changing over the portable air chute from one COT to another, the fixed gas-freeing fan would not be stopped.

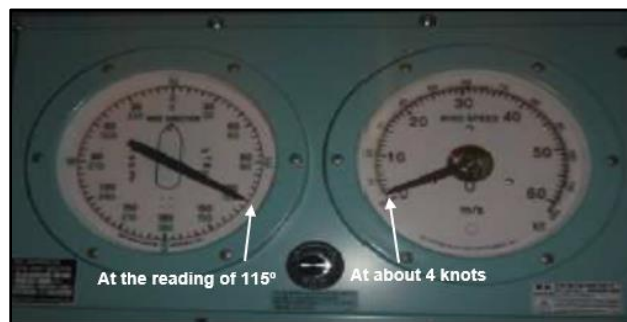
Figure 8 – Wind direction & speed shown on the wind indicator at 0400H, 1 June 2022 (Source: the Company, annotated in white by the TSIB)

- 1.12.4 At about 0400H on 1 June 2022, the ship resumed back to the original course (053°), the wind direction was from starboard side about 115° relative to the ship's heading and speed was about 4 knots as per wind indicator on the bridge (see **figure 8**).

⁵⁶ The gentle breeze was relatively from the ship's starboard quarter.
