# **Final Report**

## **FATALITY OF CRANE OPERATOR ONBOARD JACK-UP RIG WEST COURAGEOUS IN THE GULF OF MEXICO ON 24 NOVEMBER 2022**

TIB/MAI/CAS.136

Transport Safety Investigation Bureau  
Ministry of Transport  
Singapore

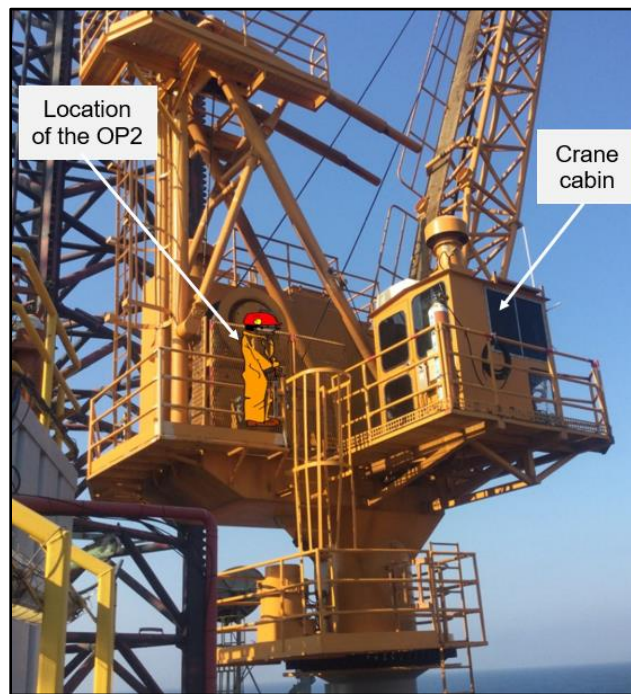
- 1.1.3 The OP2, who was standing outside the crane cabin and about to make his descent from the vertical ladders (see **figure 2**) was also thrown into the sea.

Figure 2 – location of the OP2 referencing to the crane cabin  
(Source: the Company)

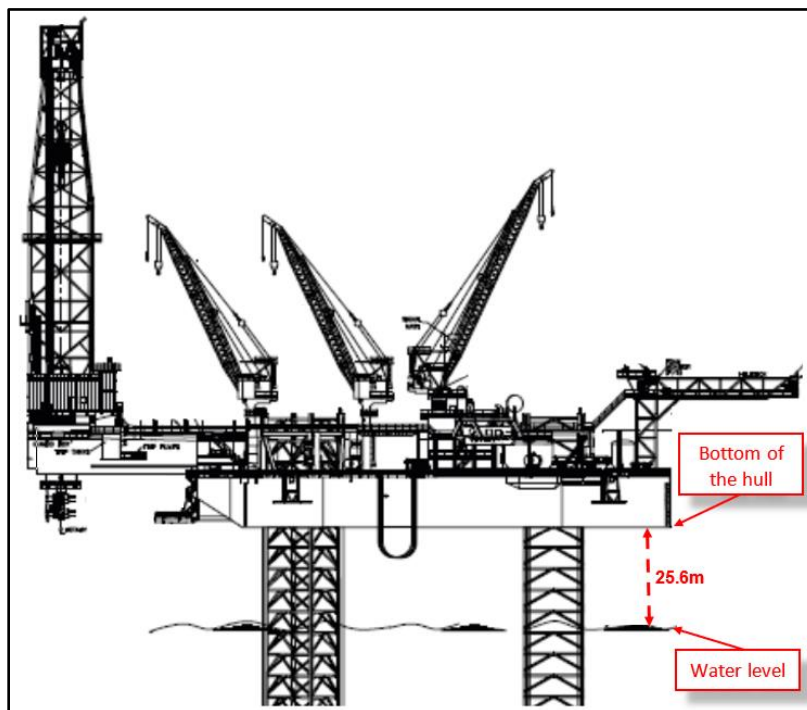
Figure 3 - Side view of the WC taken from the “Outboard Profile Starboard Elevation” plan showing the air gap (from water level to the bottom of the hull)  
 (Source: the Company, annotated by TSIB)

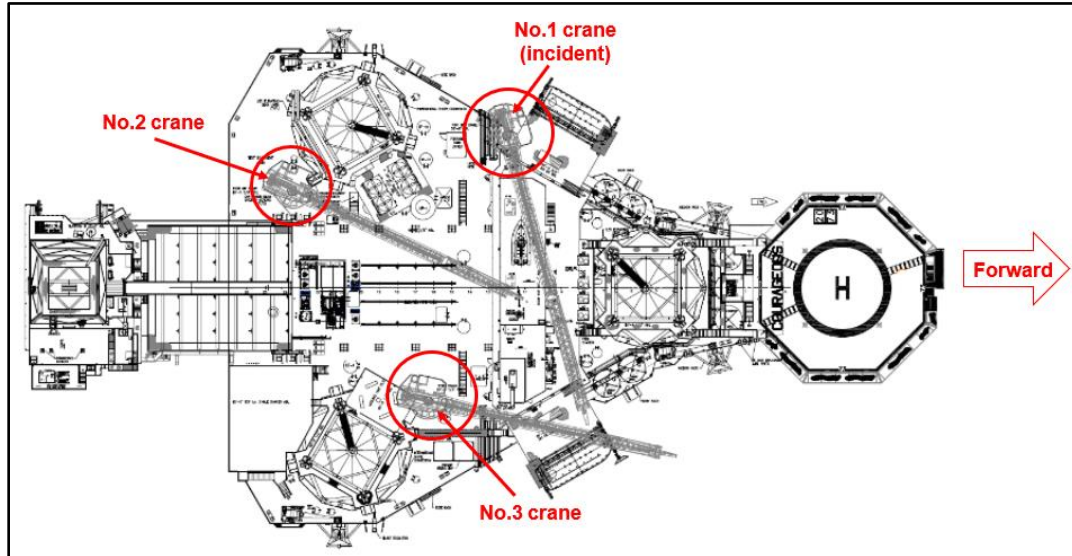
1.4.2 The three cranes were installed at the time of its construction by the shipyard. Two were located on the port side main deck, each at the forward (no.1 crane) and aft (no.2 crane) positions, and the third was at mid-starboard side (no.3 crane) (see **figure 4**).

Figure 4 – Deck view of the WC taken from the “General Arrangement Top Plan” (Source: the Company, annotated by TSIB)

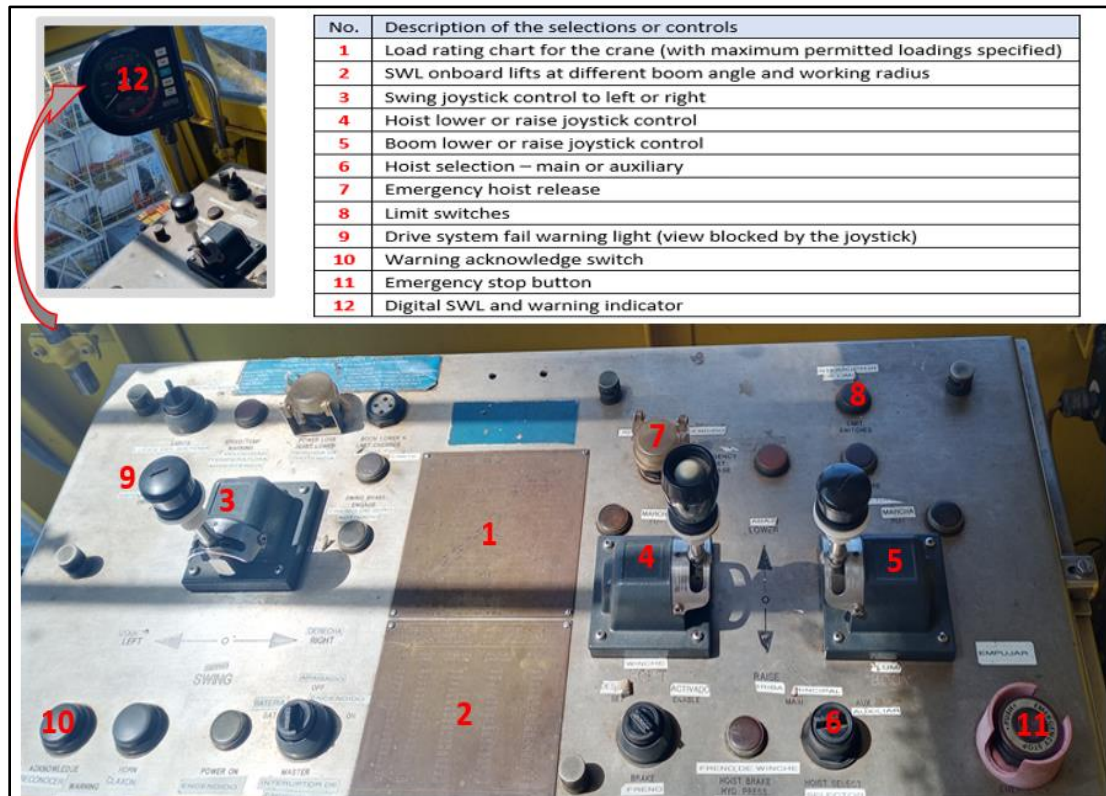
1.4.5 The crane cabin was provided with an alarm system which included electrical power failure and limit switch indication<sup>21</sup>. The control panel for no.2 crane (same design as the incident crane) is shown in **figure 5**, which included an emergency stop button (11) and an emergency hoist release button (7) to immediately stop the lifting operation. Limit switch alarm indicator would provide aural warning to the crane operator, e.g. boom angle radius and boom limit switch activated.

Figure 5 – Layout of the control panel (inside the no.2 crane cabin)  
(Source: the Company)

1.4.6 A digital safe working load (SWL) and warning indicator (12 in **figure 5**)

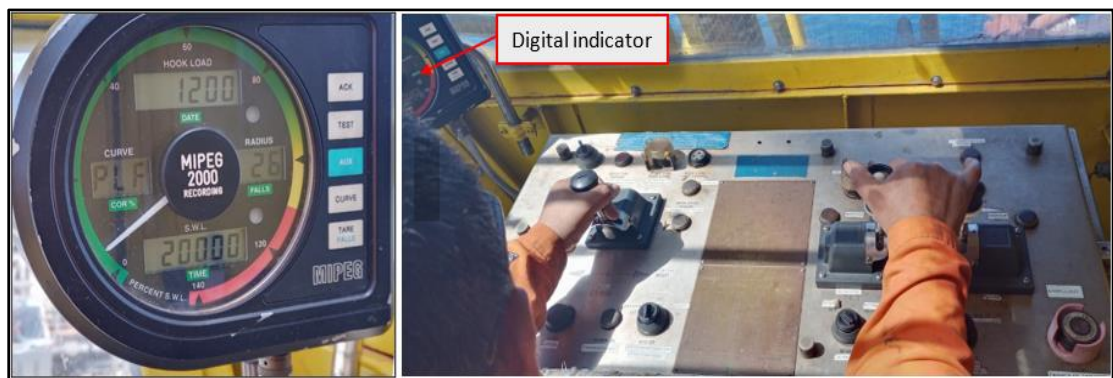
installed on the left raised post next to the control panel was directly facing the crane operator. The SWL and warning indicator provided digital readings of hook load, curve, radius and SWL (see **figure 6**) to the crane operator. The crane operator could compare the digital readings with the load rating chart (1 and 2 in **figure 5**) to see if they were within limits. The white needle within the SWL and warning indicator provided direct analog indication on whether the lift was within or exceeded the SWL, e.g. the white needle in green zone (within SWL) and the white needle in red zone (exceeded SWL). The actual readings, or any alarms, preceding the occurrence were unknown to the investigation team as the cabin sank after falling into the water and had not been recovered by the time of publishing this report.

Figure 6 – View of the digital SWL and warning indicator (on the left) and reenactment of crane operator operating the crane while checking the indicator readings  
(Source: the Company)

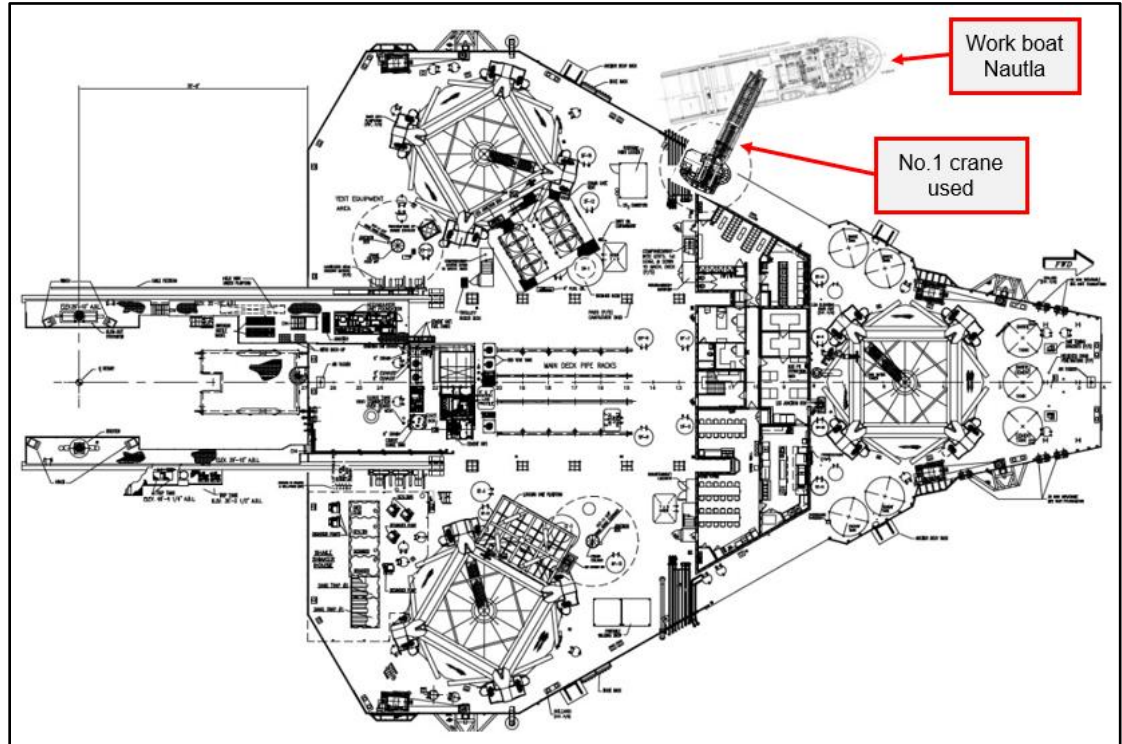
- 1.5.1 At the time of occurrence, the Nautla was positioned at the port side of the WC (see **figure 7**).

Figure 7 – Annotation of the Nautla's approximate position during the lifting operation using no,1 crane of WC (Source: the Company)

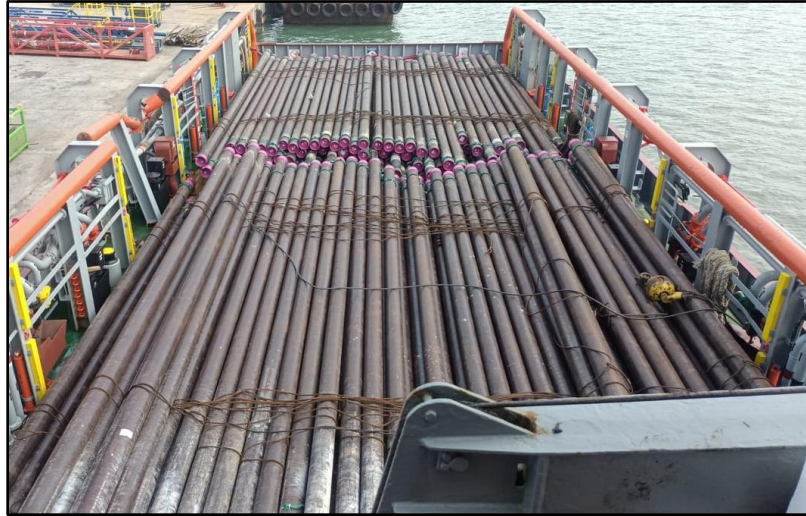
- 1.5.2 There were 266 pieces of casings to be lifted from the work boat onto the WC. The lifting arrangement was made to lift in bundles of three casings each time. Each pipe was about 0.3m<sup>22</sup> diameter x 14m<sup>23</sup> in length and weighed about 1500 Kg. The total weight of one bundle was about 4500 Kg. The whip line was used for the lifting operation.
- 1.5.3 The bundle of three casings were tied together by two wire slings at the ends (see **figure 8**), and the wire slings were then connected to the hook of no.1 crane for lifting onto the WC.

Figure 8 – View of the casing bundles stowed onboard the Nautla  
(Source: the Company)
