FINAL REPORT

CESSNA 350, REGISTRATION N1222G

WHEEL FIRE

AIB/AAI/CAS.131

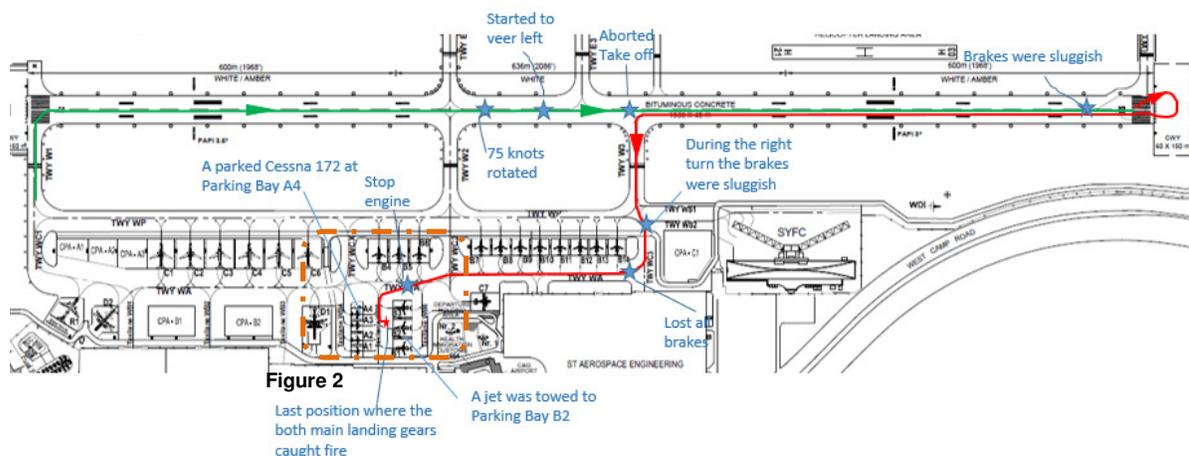
Figure 1. Cessna 350's taxi route during and after the aborted take-off

brakes when the aircraft had slowed to about 50 knots. However, he felt that the brakes were sluggish. The pilot thought that the sluggishness was due to the brakes' being hot, so he started to tap on the brakes intermittently to avoid stepping too hard on the brakes. The aircraft ended up going off the runway and stopping about 30 metres into the clearway (see **Figure 1**).

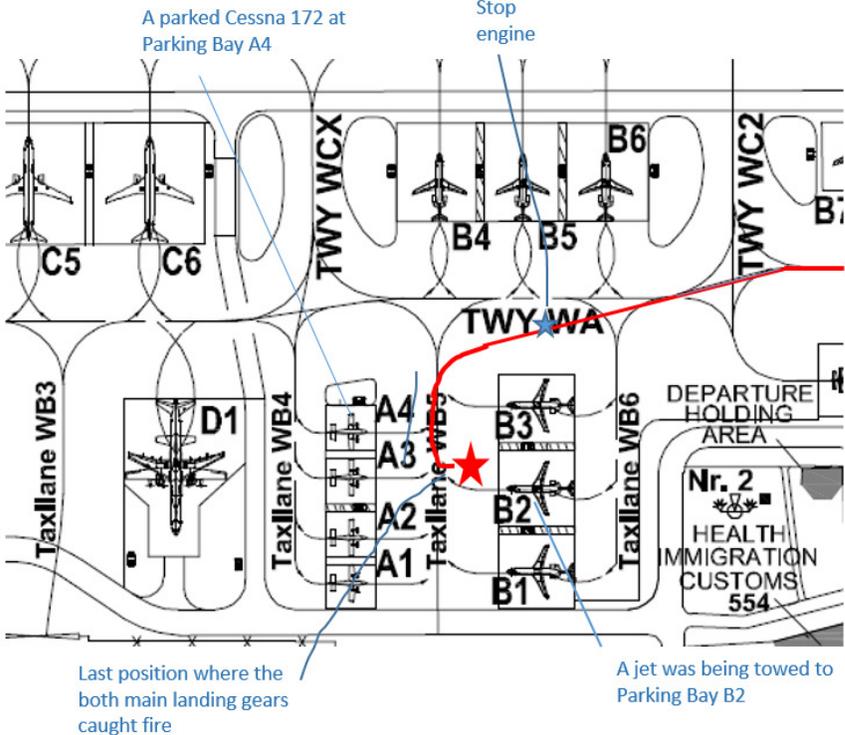
Figure 2: Final resting position of Cessna 350

the middle of Taxilane WB5 and facing parking bay B2 (see **Figure 2**), with the nose gear at 60° to the left.

1.1.11 After the aircraft had stopped, there was smoke from the main landing gears. The tow crew of the jet aircraft that was being towed into parking bay B2 saw a fire on the right main landing gear of the Cessna 350 and quickly brought a powder extinguisher over to the aircraft and discharged it at the main landing gears. The fire was not extinguished. At about the same time, the pilot noticed a burning smell in the cockpit and ordered an evacuation. After the pilot and the A&P mechanic had evacuated from the aircraft, both main landing gears caught fire, which generated black smoke (see **Figure 3**).
