# **Final Report**

**COLLISION  
BETWEEN  
CHEMROAD MEGA AND SINICA GRAECA  
OFF HORSBURGH LIGHTHOUSE  
SINGAPORE TERRITORIAL WATERS  
17 AUGUST 2017**

MIB/MAI/CAS.020

Transport Safety Investigation Bureau  
Ministry of Transport  
Singapore

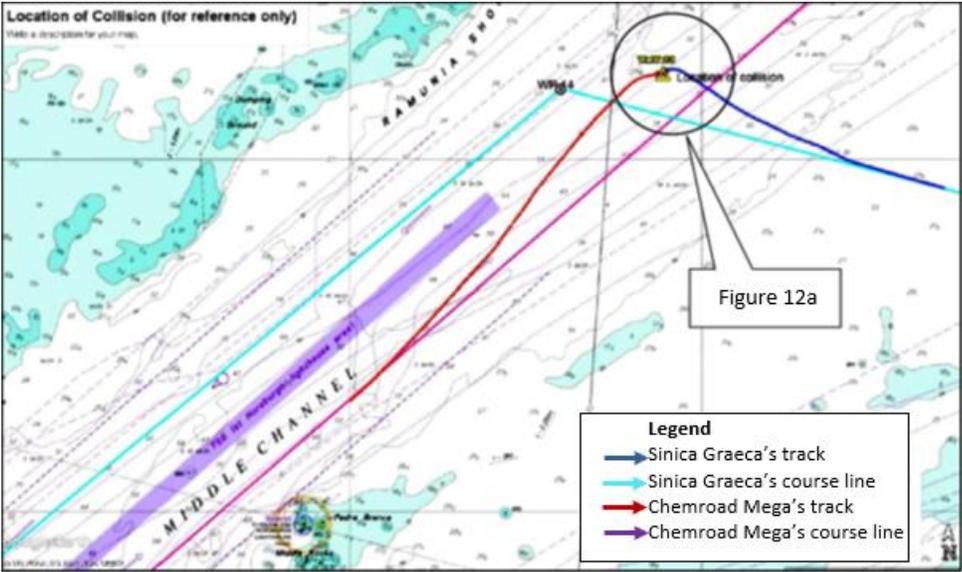
Figure 12: Location of collision

1.8.2 Within this area, high traffic density and numerous crossing situations were expected, where vessel traffic exiting the northeast bound lane of the TSS might encounter crossing traffic<sup>25</sup> joining the southwest bound traffic lane. (See **Figure 12 and 12a**).
