COLLISION BETWEEN OIL TANKER KARTIKA SEGARA AND SUCTION HOPPER DREDGER JBB DE RONG 19 IN SINGAPORE STRAIT ON 13 SEPTEMBER 2017

MIB/MAI/CAS.025

**Transport Safety Investigation Bureau
Ministry of Transport
Singapore**

7 November 2018

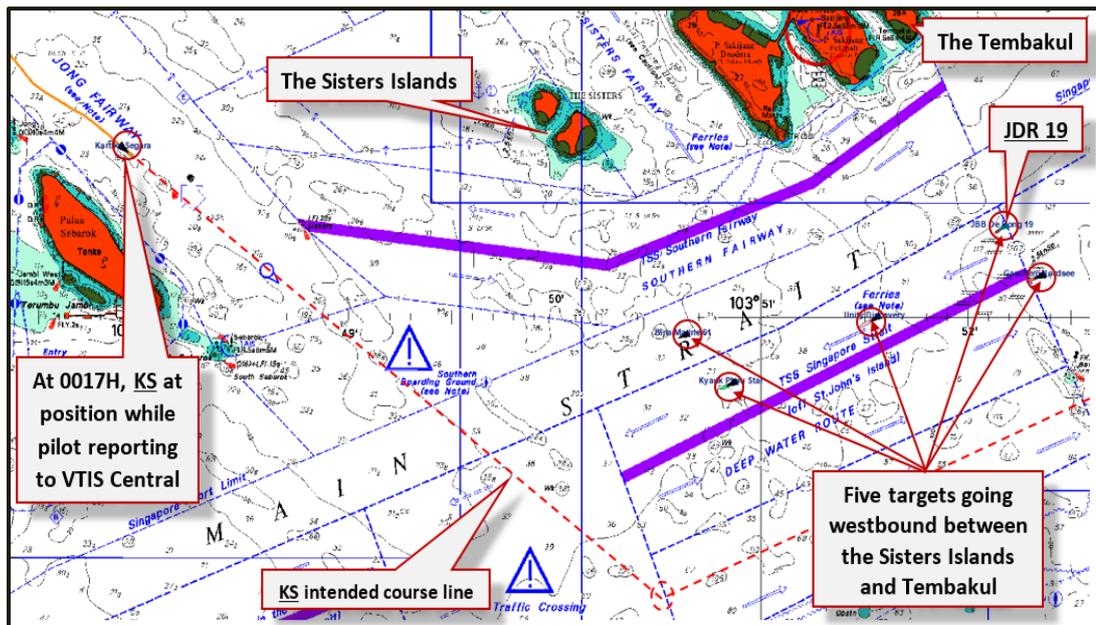
Figure 3 – Positions of five targets highlighted by the VTIS Central for illustration

- 1.1.11 Then, KS was displaying three all-round green lights¹⁶. VTIS Central operator provided navigational advice to the Pilot on the heavy traffic expected from the East between Sisters Islands (South of) to Tembakul light, five vessels¹⁷ (see **Figure 3**). The Pilot acknowledged by responding¹⁸, "Five, Sisters, Westbound, thank you".

- 2.1.5 KS' charted course as per the passage plan for departing Singapore and to join the eastbound lane was 128°(T), which was not a heading nearly as practicable at right angles to the direction of traffic flow, which was 067° (T) (see **Figure 3**). Although KS was expected by way of a recommendation to cross the Precautionary Area and TSS as nearly as practicable at right angles to the general direction of traffic flow, this may not have contributed to the collision.

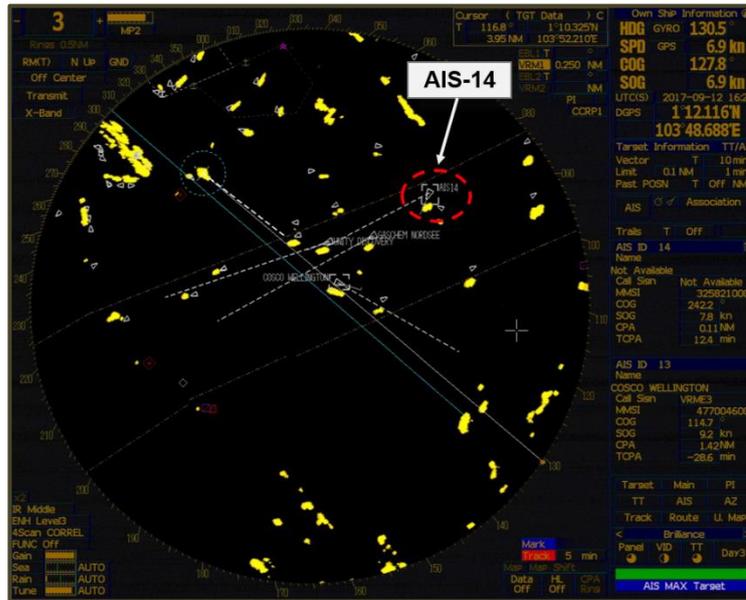
Figure 4 – JDR 19 (annotated with red circle) acquired on radar

- 1.1.14 At about 0027H, KS' engine telegraph was moved to Slow Ahead with an intention to cross the westbound lane, and then to Half Ahead. Her speed over ground (SOG) was about 7kts at this time, and she began to make good a course of 128°(T) while on a heading 130°(T). About this time, a target AIS-14 (later identified to be the JDR 19) was acquired on the X-band radar by the Second Officer, as were two other targets in the westbound lane ahead of AIS-14 (see **Figure 4**).

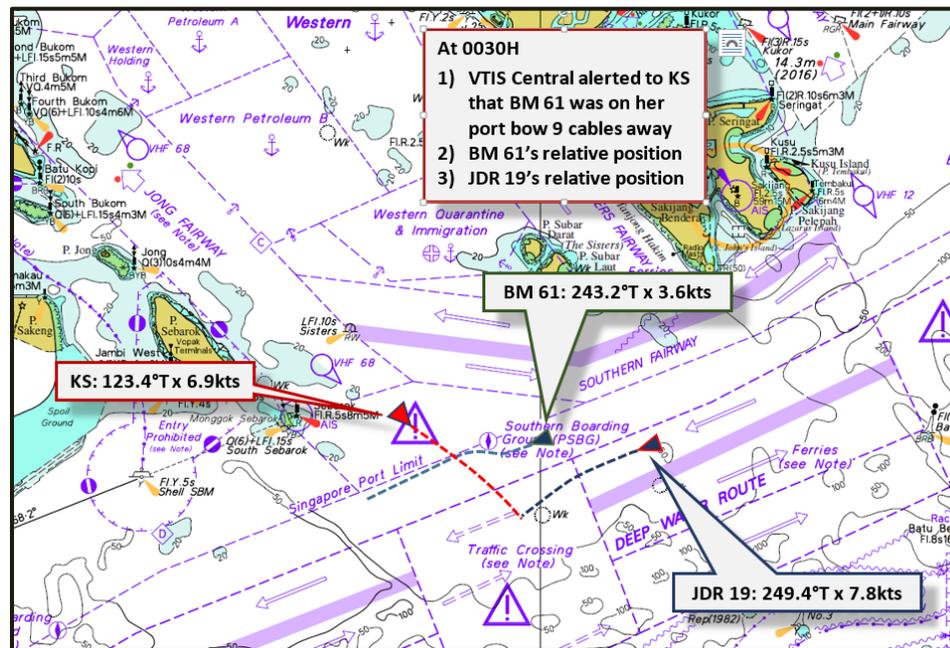
Figure 5 – Relative position of BM 61 and JDR 19 to KS, at 0030H

- 1.1.18 Soon after, WM also alerted KS of a nearby tug boat, the westbound Bina Marine 61(BM 61)¹⁹, which was about 9 cables²⁰ on KS' port bow, and for KS to keep lookout for her (see **Figure 5**). KS acknowledged the message and noting BM 61 was on KS' port side, decided to pass ahead of her. VTIS Central was informed, who then called BM 61 and informed her of KS'

- 1.1.19 By about this time, JDR 19 was about 1.4nm away from KS which was proceeding steadily at a speed of about 6.9kts towards the TSS. JDR 19 meanwhile, continued travelling at a speed of about 7.8kts in the westbound lane.

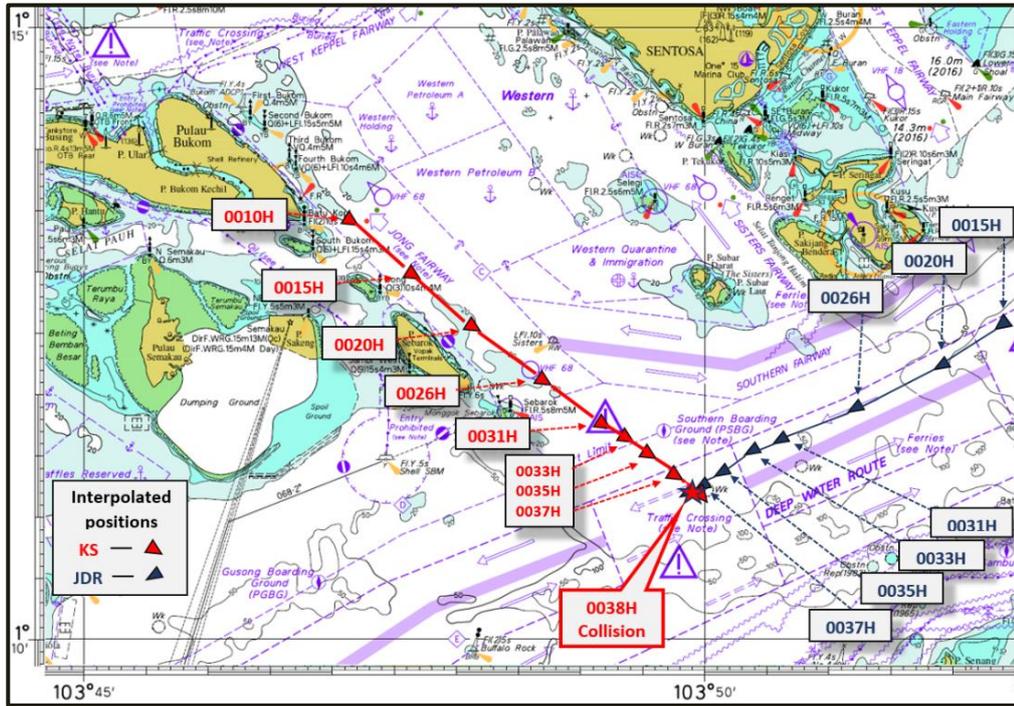
Figure 6 – Navigational data of KS and JDR 19

- 1.1.26 At about 0038H, KS and JDR 19 collided with each other in approximate position Latitude 01°11.11’N and Longitude 103°49.87’E, Precautionary Area²⁵ of the Singapore Strait TSS, about 1.7nm Southwest of the Sisters Islands within Singapore territorial waters (see **Figure 6**). There were no sound or other light signals²⁶ made or heard prior to the collision by either of the ships involved.

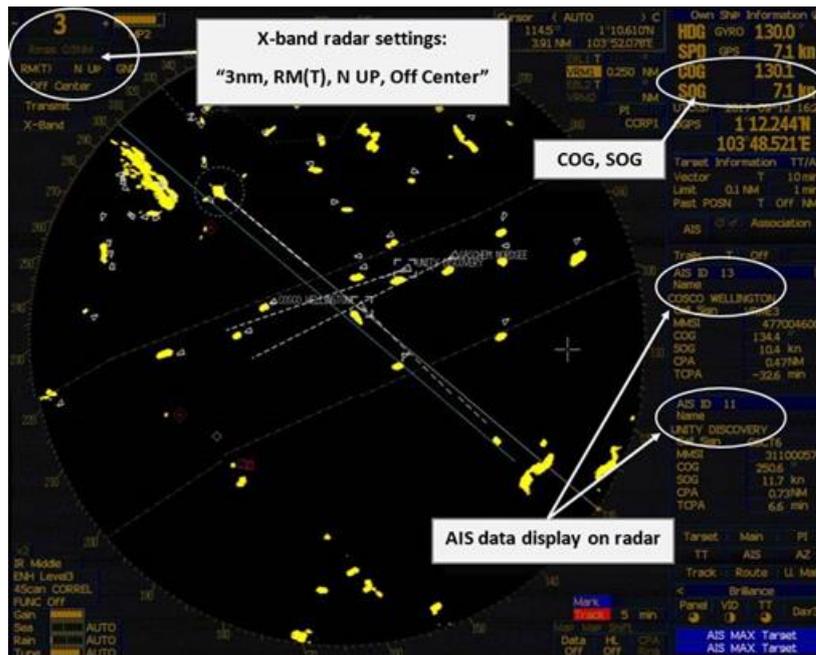
Figure 14 – X-band ARPA display setting on KS before crossing the TSS

1.3.3.5 Prior to the Pilot's disembarkation, the X-band radar's range scale was changed from 1.5 nm (off centered giving effective range of about 2.3 nm) to 3 nm. The radar displays also showed that the SOG and course over ground (COG) were in use at the time of the collision (see **Figure 14**).

1.3.3.6 Both radars were used with AIS integration function by the bridge team. During the interviews, the investigation team learned that it was a practice on-board to overlay the AIS data on the radar and rely on the AIS information for collision avoidance rather than ARPA target acquisition functions.

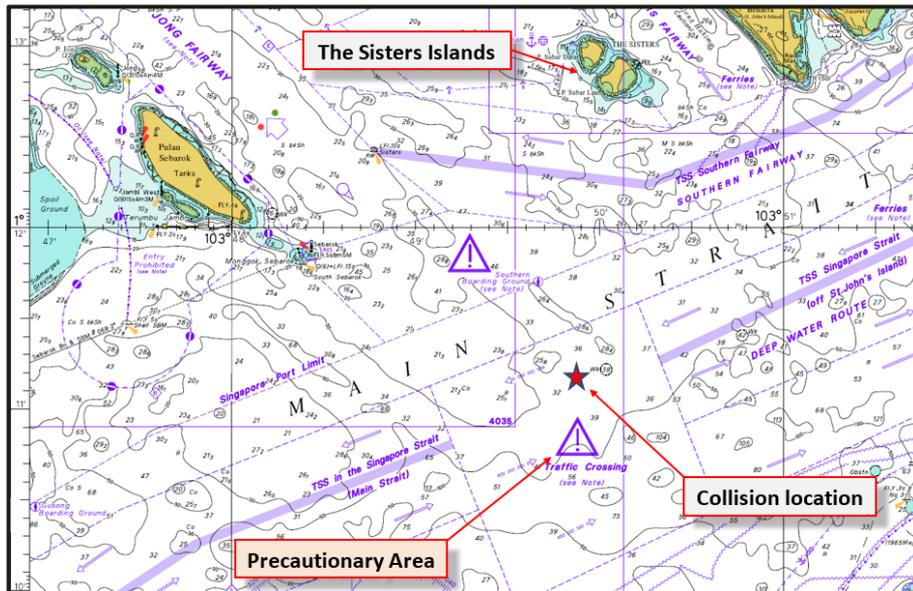
Figure 19 – Collision occurred at the Precautionary Area of the Singapore Strait TSS, about 1.7nm South-West of Sisters Islands

1.5.1 The collision occurred within the Precautionary Area of the TSS in the Singapore Strait which was about 1.7nm South-West of Sisters Islands (see **Figure 19**) within Singapore territorial waters.

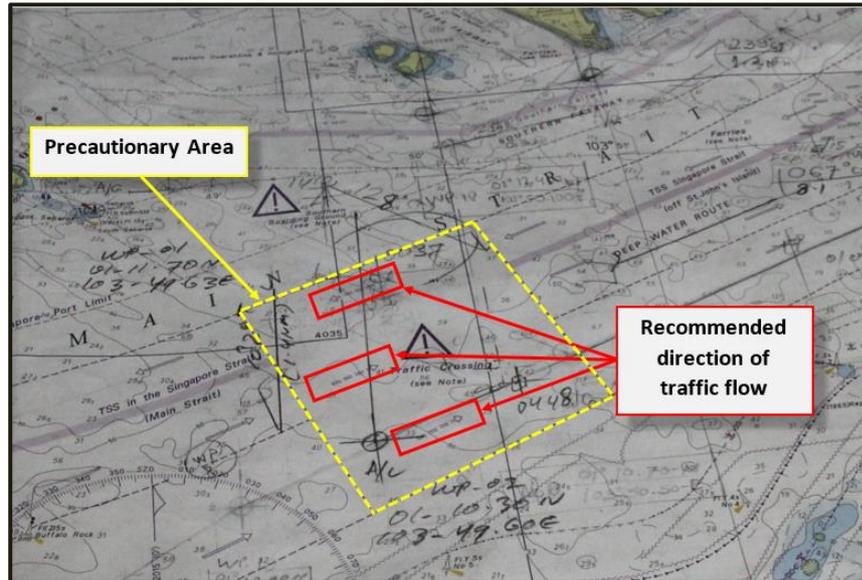
Figure 20 – BA 4041 used by KS overlaid with annotations indicating recommended direction of traffic flow within the Precautionary Area

- 1.5.4 On the nautical charts⁶⁷ used by KS, the Precautionary Area was printed with the recommended direction of traffic flow (see **Figure 20**). In some parts of the world, Precautionary Areas are not considered⁶⁸ as a part of the TSS and COLREGs Rule 10 is not generally applicable, however, ships should navigate with particular caution within such areas⁶⁹.

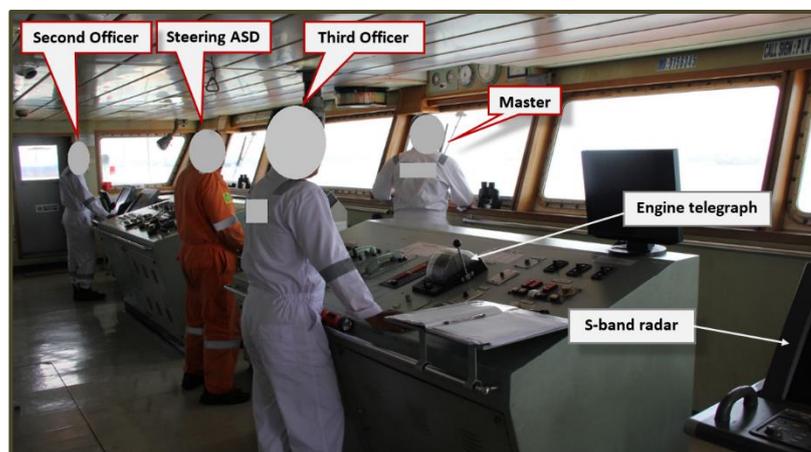
Figure 22 – Illustration of approximate position of the bridge team members prior to the collision

- 2.1.3 Despite ECDIS being KS' primary means of navigation, the Master's navigational audit stated that ECDIS was for reference. With none of the officers using the ECDIS as an important navigational aid to monitor their vessel's position in real-time, it is possible that the bridge team had not recognised KS' position with reference to the TSS and the transit traffic. The Master from where he was positioned (see **Figure 22**) throughout the transit, was likely to have been over reliant on visual cues to navigate his vessel out of Singapore. The Master could have consulted the other available navigational equipment such as the ARPA and ECDIS to have a better situational awareness.

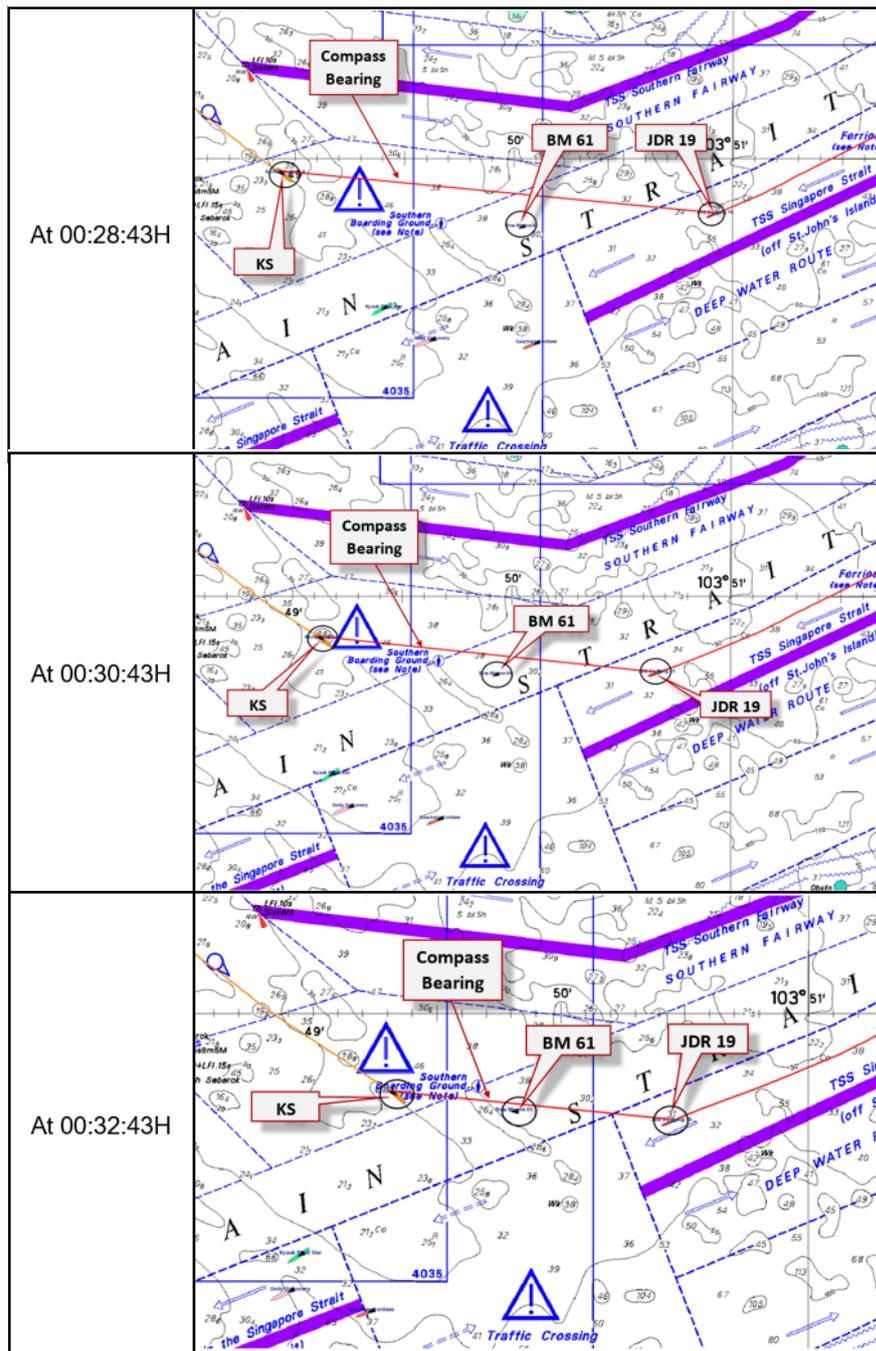
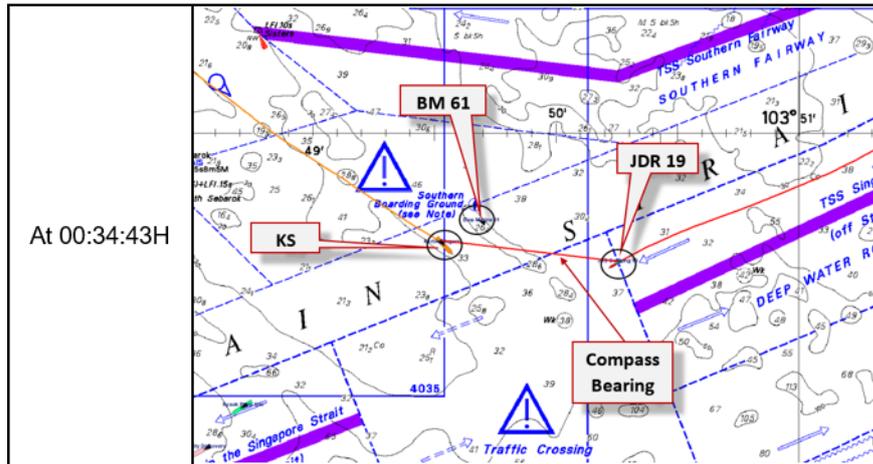
Figure 23 – Illustration of compass bearing between KS and JDR 19

- 2.4.2 Since the CO2 was steering the vessel from a position that was away from the radars or the compass, and the Radio Man was not using them either, the bridge team of JDR 19 did not determine if a risk of collision existed⁷⁹ and did not realise its obligation as the give-way vessel for KS (see **Figure 23**).

Time (HH:MM:SS)	Distance (n.m.)	Compass True Bearing (from KS/from JDR 19)
00:28:43	1.98	095.5° / 275.5°
00:30:43	1.55	096.0° / 276°
00:32:43	1.13	095.8° / 275.8°
00:34:43	0.74	096.7° / 276.7°

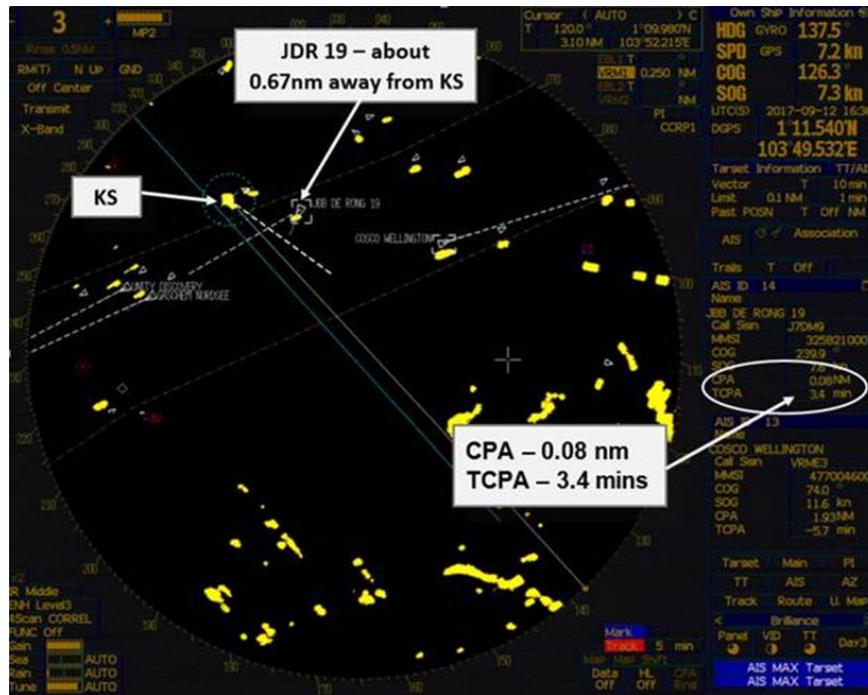
Figure 24 – At 0036H, JDR 19 relative position on KS' radar display

manoeuvre of astern propulsion⁸² on the whistle (three short blasts) supplemented by light signal (three flashes) as required by COLREGs. This was especially when JDR 19 did not respond to the VHF radio call by KS exclaiming the dangerous situation.

2.5.4 Notwithstanding the above, had KS observed timely that JDR 19 was not taking actions to avoid collision as expected of a give-way vessel, KS could have taken early actions to avoid collision.
