Final Report

COLLISION

**TANKER SHUN SHENG
AND
BARGE KOI 5 (TOWED BY TUG KOI 3)**

MIB/MAI/CAS.060

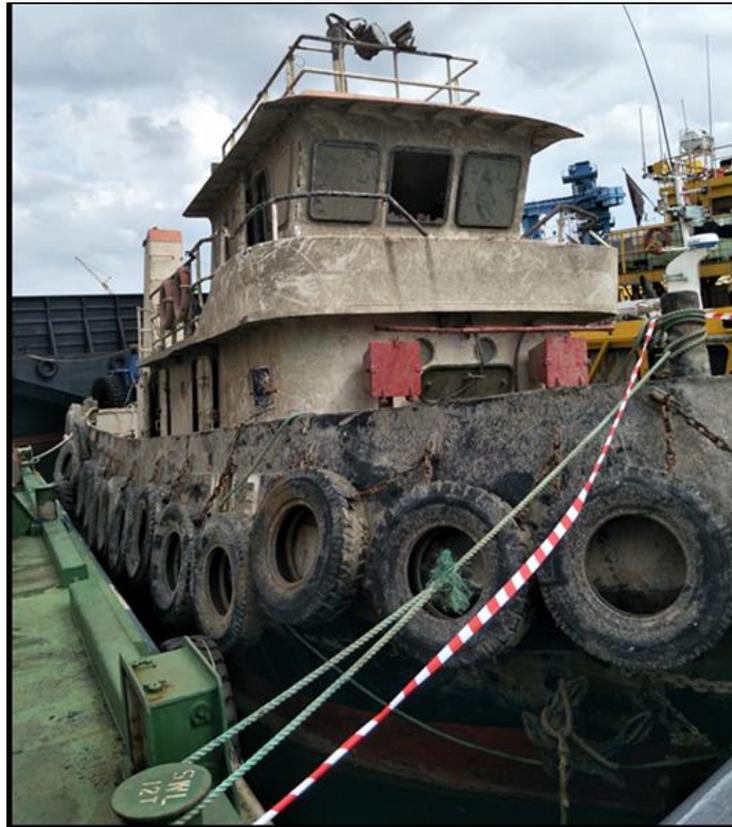
Figure 1 - Image of the tug Koi 3 at repair yard after salvaged (Source: TSIB)

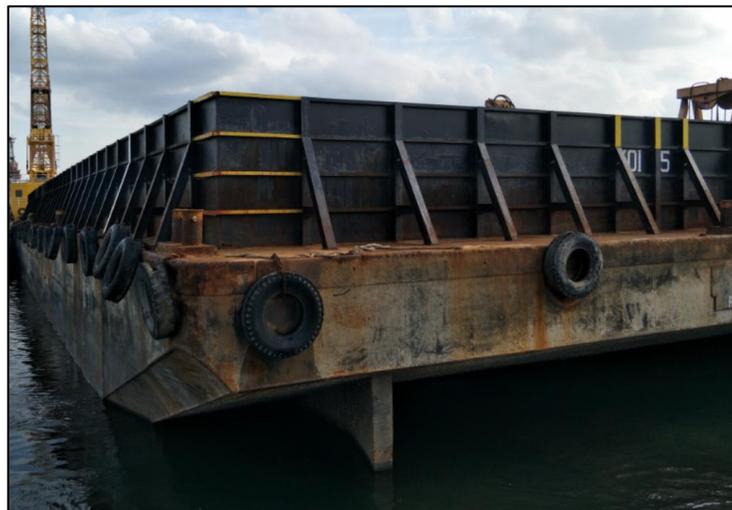
Figure 2 – Image of Barge Koi 5 viewed from the port quarter (Source: TSIB)

- III. The hull section on the forward starboard side was breached inwards, above and below the water line; and
- IV. There was a small red light fitted at the forward post of the ramp structure. There were no other light⁶⁷ fittings found on the barge.

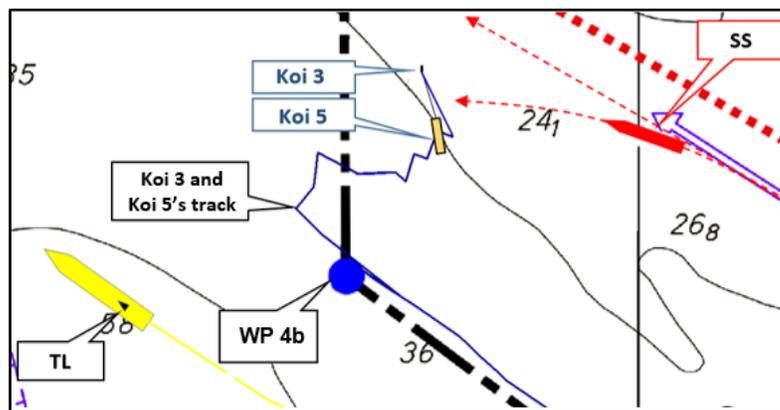
1.1.19 By about 0453H, when the speed of the tug and tow was about 1.3kt, the CO overheard VTIS West calling SS on VHF Channel 73, advising SS to keep a lookout for the tug and tow ahead. On hearing the conversation between VTIS West and SS, the CO looked over to the starboard side through the window of the tug, and saw SS which was about 0.2nm away displaying two masthead lights and a green side light, noting that SS had turned to port and was heading towards the barge (see **figure 13**).

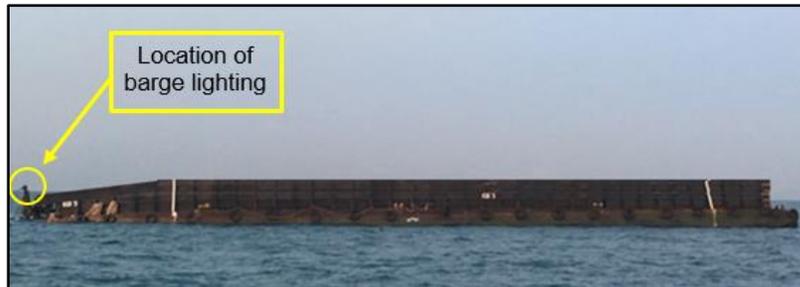
Figure 16 – Image of Koi 5 port side taken in daylight hours (Source: MPA)

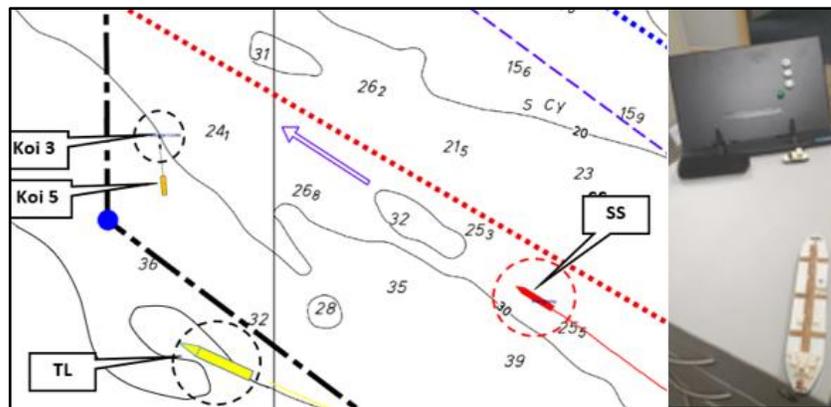
Figure 23 - SS' approximate position relative to Koi 3 at 0450H and the display light configuration sighted by the CO as shown during the interview
(not to scale)

- 1.1.41 According to the CO, there were no other lights on Koi 3 or astern of it. Furthermore, checking the ECDIS, the CO assessed that with Koi 3 moving northerly, there was a likelihood of crossing situation, and SS would be passing ahead of Koi 3's bow at a close range. The CO decided to alter SS' heading by about 15° to the port to place Koi 3 on SS' starboard bow. The CO informed the investigation team that the surrounding area was checked prior to alteration.
- 1.1.42 At about 0452H, the CO instructed the ASD-2, who had been performing the role of a lookout, to perform the role of a helmsman and to again engage the hand steering and steered SS on a new heading of about 287°T, in order to pass Koi 3's stern⁶¹ (see **figure 24**).

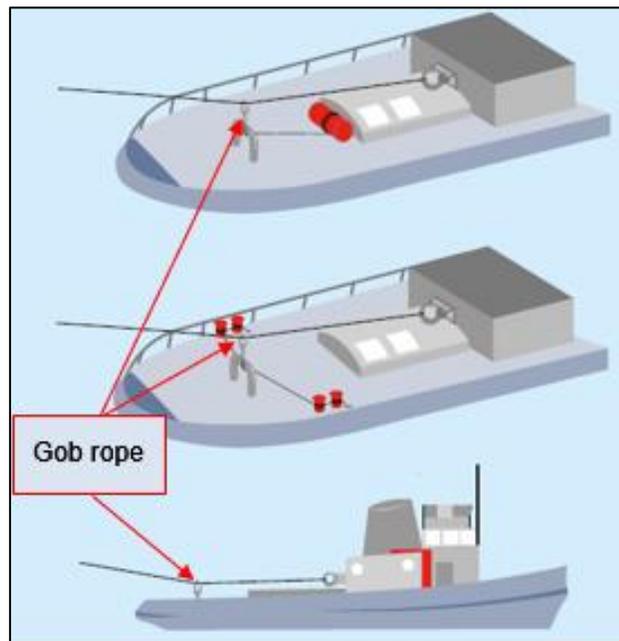
- 1.4.5 The crew also informed the investigation team that Koi 3 had a towing hook which was used for connecting the towing rope with Koi 5. When asked, the crew confirmed that there was no gob rope⁷⁰ fitted on Koi 3 (see **figure 28**).

Figure 28 - Illustration of a gob rope (Source: The Shipowners Club)

⁷⁰ A gob rope (gob wire), sometimes referred to as a guest rope or bridle, is a short wire or rope made fast to the towline at the aft end of a tug. In this way the use of the gob wire effectively moves the towing point aft, closer to the tug's stern. This gives the tug master greater control and allows more manoeuvrability to prevent girting when the tug is acting as a stern tug. Girting refers to the situation when a vessel, usually a tug, is pull broadside by a towline and is unable to manoeuvre out of this position which may result in higher risk of capsizing. Source: *The Shipowners Club*.
