FINAL REPORT

FATAL INJURY ON BOARD SG VICTORY IN HULHUMALE, MALDIVES ON 17 MAY 2016

MIB/MAI/CAS.001

**Transport Safety Investigation Bureau
Ministry of Transport
Singapore**

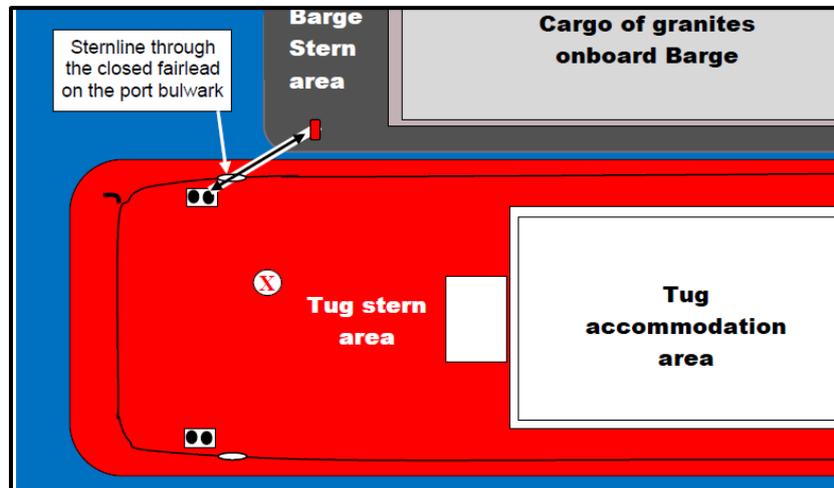
Fig. 2 – Stern line if passed through closed fairlead

- (b) The stern line should be passed through the closed fairlead (see Fig. 2), located about 4m forward of the aft end of the tug, and secured to a bollard on board the tug.

Closed fairleads are designed for stern line mooring, especially when there is a height difference between the tug and the barge (which was about 2 metres in this occurrence).
