Final Report

FATAL INCIDENT OF THIRD ENGINEER ON BOARD YUAN SUI HAI AT SEA 25 SEPTEMBER 2020

TIB/MAI/CAS.092

**Transport Safety Investigation Bureau
Ministry of Transport
Singapore**

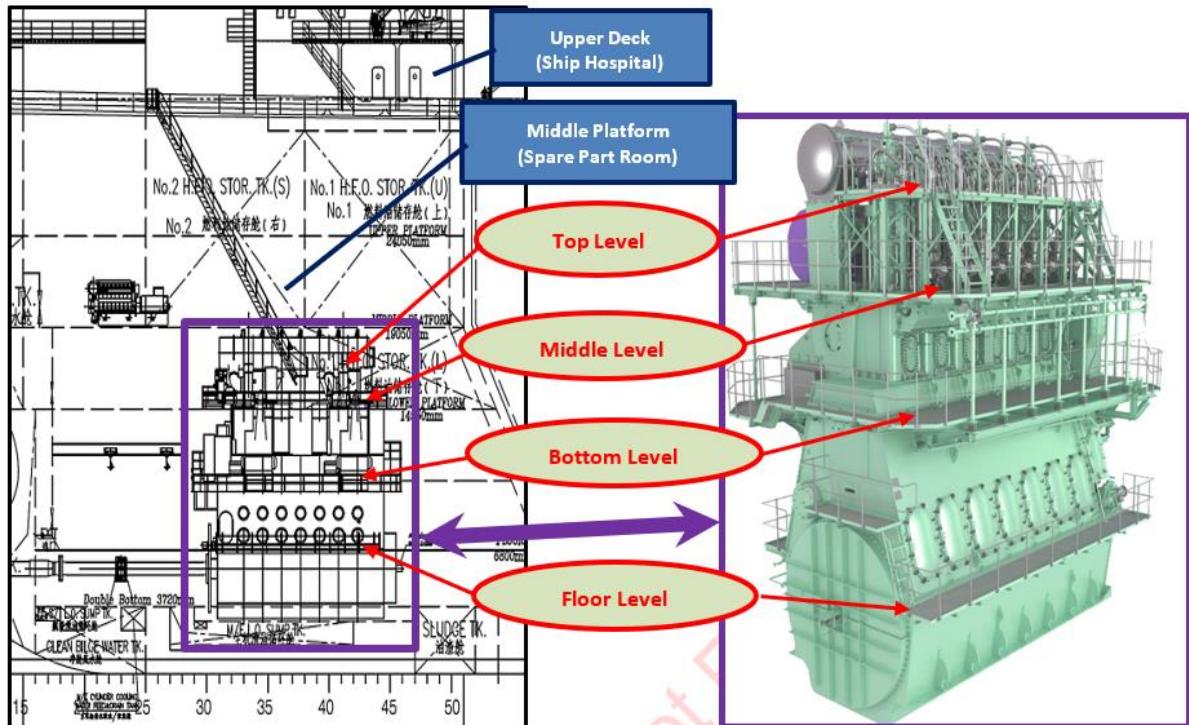
Figure 1: Illustration of the layout together with the upper deck, engine room and associated levels¹⁶ of the main engine—*not to scale*. (annotated by TSIB)

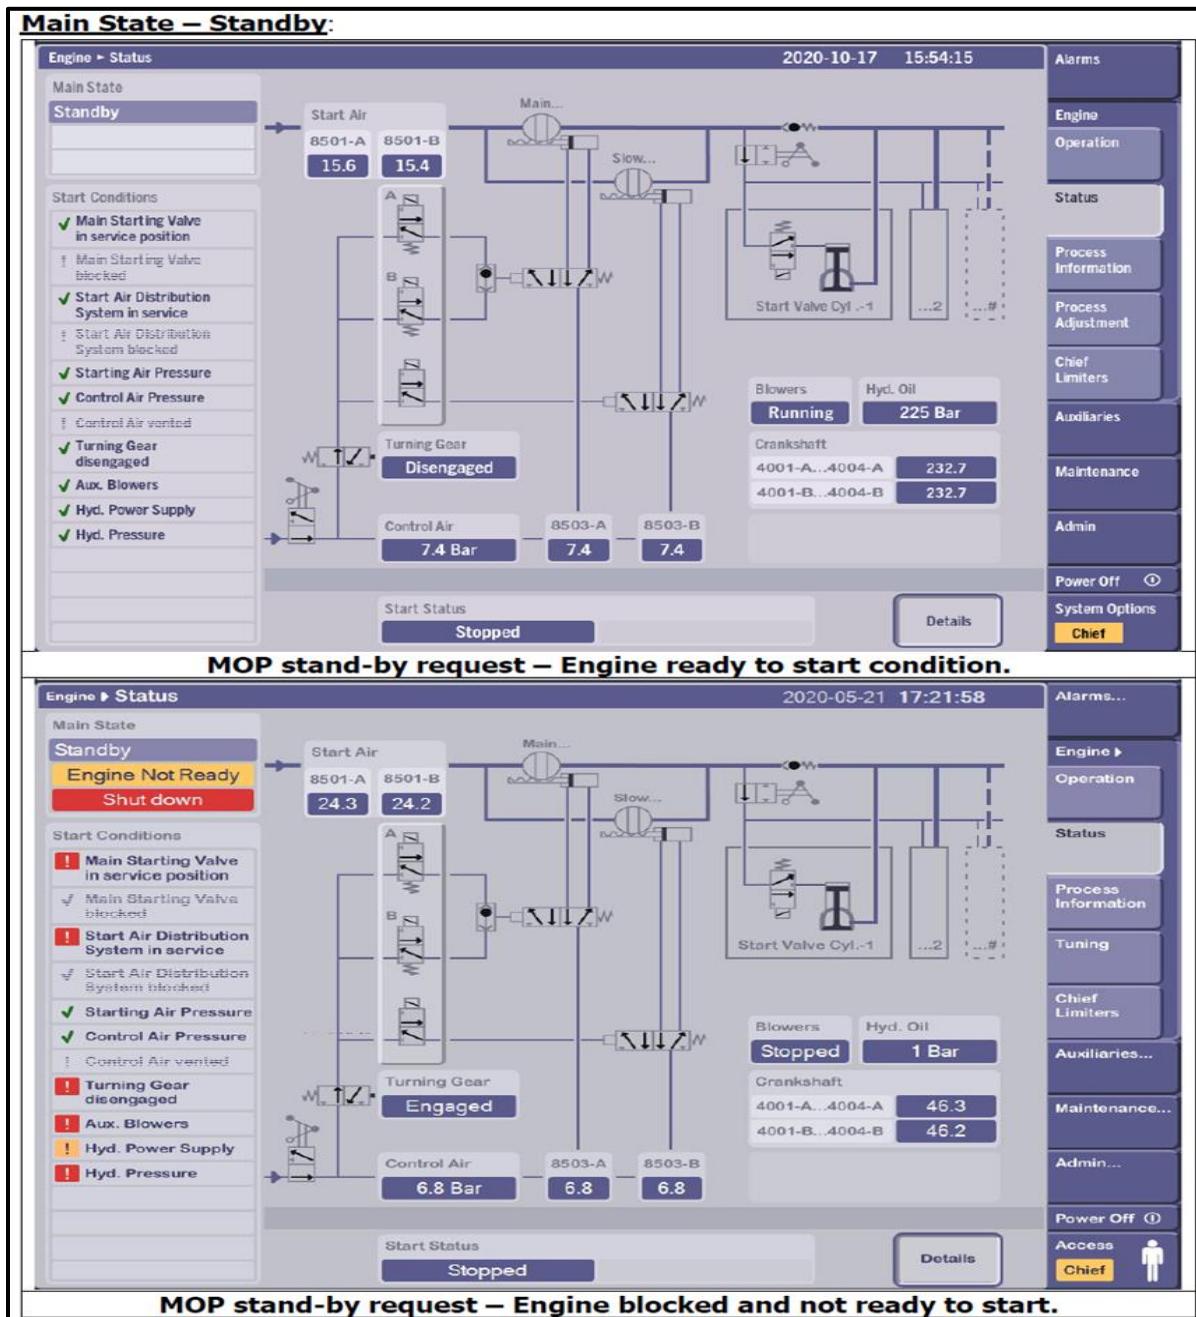
- I. the Main Operating Panel (MOP) at the ECR²⁹, which is the main information interface for the engineer to operate some components. In addition, the MOP displays (see **figure 5**) the status of some of the valves and components (as input by the engineer), i.e. allows the crew to monitor the status of the main engine, including the turning gear.
- II. the LOP at the aft end of the main engine, where the basic functions are available, such as main engine starting, engine speed, control, stopping, reversing, and relevant engine data is displayed.

Figure 5: Illustration of the MOP displays - when the “Standby”³⁰ mode for the main engine is selected (Top) and when “Standby – Engine Not Ready” mode is selected (Bottom). Source: The ED.

³⁰ Compared to the status of ‘Finished with engine’ or ‘Engine not ready’, which are generally known to be selected for repairs (i.e. after all moving parts of the main engine are confirmed isolated or secured), the ‘Standby’ status would mean that the main engine is ready to be started anytime.
