FINAL REPORT

FATAL INJURY ON BOARD THE BULK AND CONTAINER CARRIER PAC ALKAID AT THE PORT OF HOUSTON ON 20 AUGUST 2017

MIB/MAI/CAS.022

**Transport Safety Investigation Bureau
Ministry of Transport
Singapore**

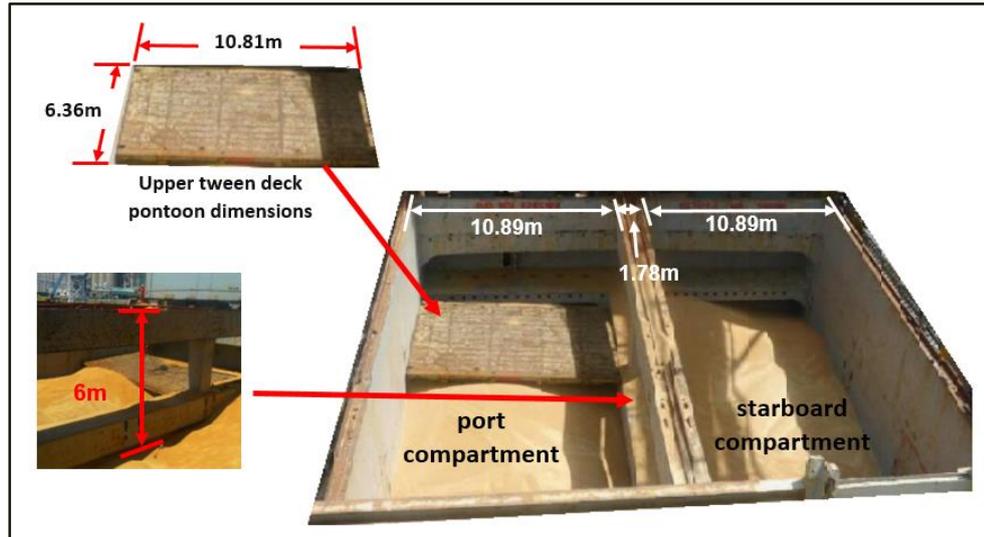
Figure 8 – Upper tween deck pontoon and no.5 cargo hold dimensions
(Photo source: the ISM Manager)

1.2.5 There were 14¹⁸ numbers of A-type and B-type tween deck pontoons used in no.5 cargo hold. At the time of the accident, the pontoon in use was the A-type, with dimensions 10.81m in width and 6.36m length. The cargo hold was separated into port and starboard compartments, each having the same width of 10.89m (see **Figure 8**). The pontoon had a clearance of about 8cm in each compartment. At the time of the accident, the pontoon to be closed was at the upper tween deck level in the port side compartment of no.5 cargo hold.

- 3.1 On completion of loading, the pontoon could not be closed due to piled up cargo in no.5 cargo hold. This was because the reference for loading limit in this hold was not marked and there was inadequate monitoring of the final cargo loading operation which resulted in piling of the cargo. Tasks were not properly planned and prioritised.

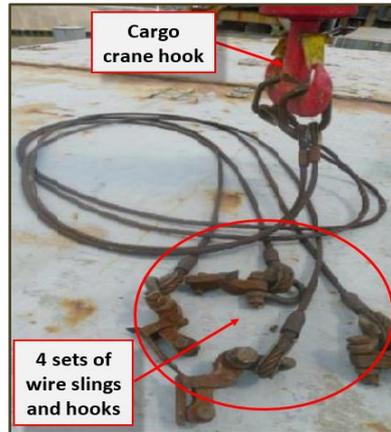
Figure 11a - Four wire slings and hooks secured on the cargo crane hook

1.9.1 The pontoon was typically lifted with four sets of wire slings with lifting hooks which were connected to the Rams horn hook of the cargo crane (see **Figure 11a**), in this case the no. 3 cargo crane. The lifting hooks were slotted into the tween deck pontoon (see **Figure 11b**).

- 3.2 The crew, without supervision, and in the absence of trimming methods, used the pontoon to trim the cargo by dragging it over the cargo surface. This caused one of the hooks to break and the other one slipped out of the pontoon securing point. The pontoon and its associated loose gears are not designed for such operations.

- Require the ship's Chief Officer or other competent persons to inspect conditions of all lifting gears and its associated accessories and check against with certificates before put into use.
- Prohibit use of ship's pontoons for sweeping or levelling of cargo.
- Require the use of pontoons using all four slings at all times for ensuring equal distribution of load.
- Prohibition of deviation from the company's established SMS procedures, unless in an emergency for safety of life as decided by the Master, in which case such deviation shall be reported to the company.

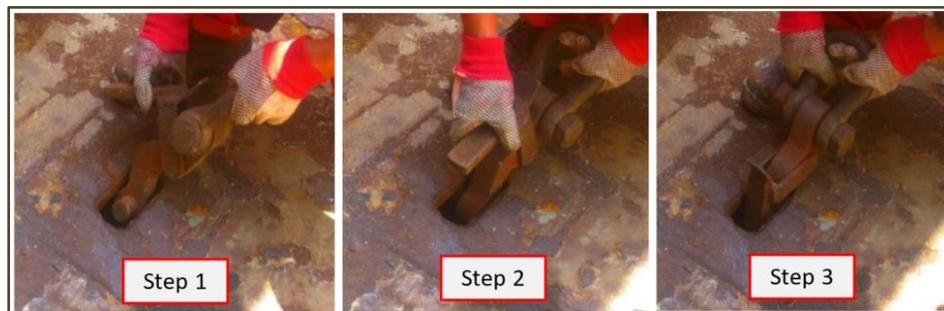
Figure 11b – Sequence of locking the lifting hook to the pontoon
(Photo source: the ISM Manager)

1.10.3 COSWP further highlights that accessories for lifting and loose gear, should be thoroughly examined by a competent person within 12 months immediately before using it. The four pontoon lifting hooks used on board Alkaid had no records of such examination being carried out in the last 12 months.

- 2.4.6 The SMS required lifting gears to be inspected and their results recorded. In this case, it was evident that the SWL of the hooks (loose lifting gears) in use for pontoon lifting were not known and recorded on board. The failure of such loose gears could pose a risk to the ship and its crew as the other lifting gears, they should be treated with equal importance. Proper certification and regular inspection is thus necessary.
