# **FINAL REPORT**

## **FATAL INJURY ON BOARD OCEAN GLORY EN-ROUTE FROM TAIWAN TO SINGAPORE ON 8 JANUARY 2017**

**MIB/MAI/CAS.008**

**Transport Safety Investigation Bureau  
Ministry of Transport  
Singapore**

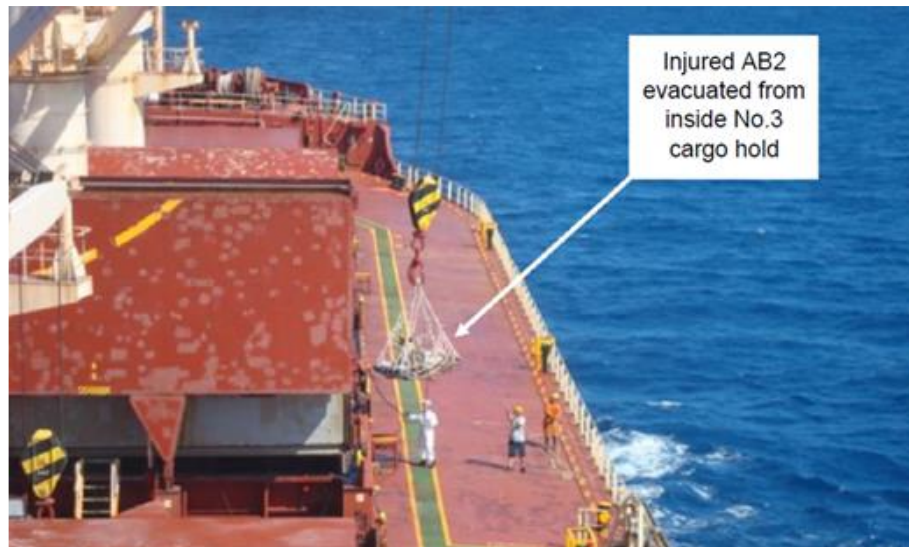
*Fig. 3 – Evacuation of AB2*

- 1.1.20 There were no signs of damage to the vertical ladder and its rungs. There was no report of anything unusual during the cleaning operation in the cargo holds the previous day.
- 1.1.21 At about 1030H, AB2 was evacuated from the cargo hold with the use of the ship's crane (See **Figure 3**) and was subsequently transferred to the ship's infirmary. The Master then reported the accident to the company's Designated Person Ashore<sup>11</sup> (DPA).
