FATALITY OF CREW AFTER FALLING OVERBOARD FROM EPIC BORACAY IN SOUTH ATLANTIC OCEAN, OFF BRAZIL 10 JUNE 2021

TIB/MAI/CAS.113

Transport Safety Investigation Bureau
Ministry of Transport
Singapore

5 April 2022

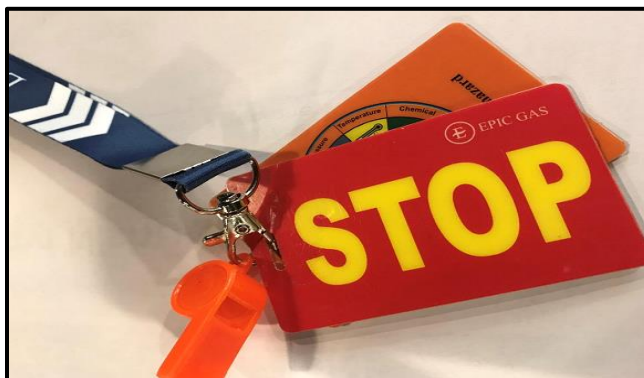
1.3.6.2 All personnel on board who had gone through the safety induction both ashore and when joining the ship, would be provided with a "STOP" card and a whistle, bound by a (neck) lanyard (see **figure 6**).

Figure 6: Provided to all ship's staff on board the fleet of the Company, a lanyard with a whistle, a "STOP" card and a "Take 5" card.
