**FINAL REPORT**

**CREW FATALITY**

**KOTA BAKAT AT**

MIB/MAI/CAS.046

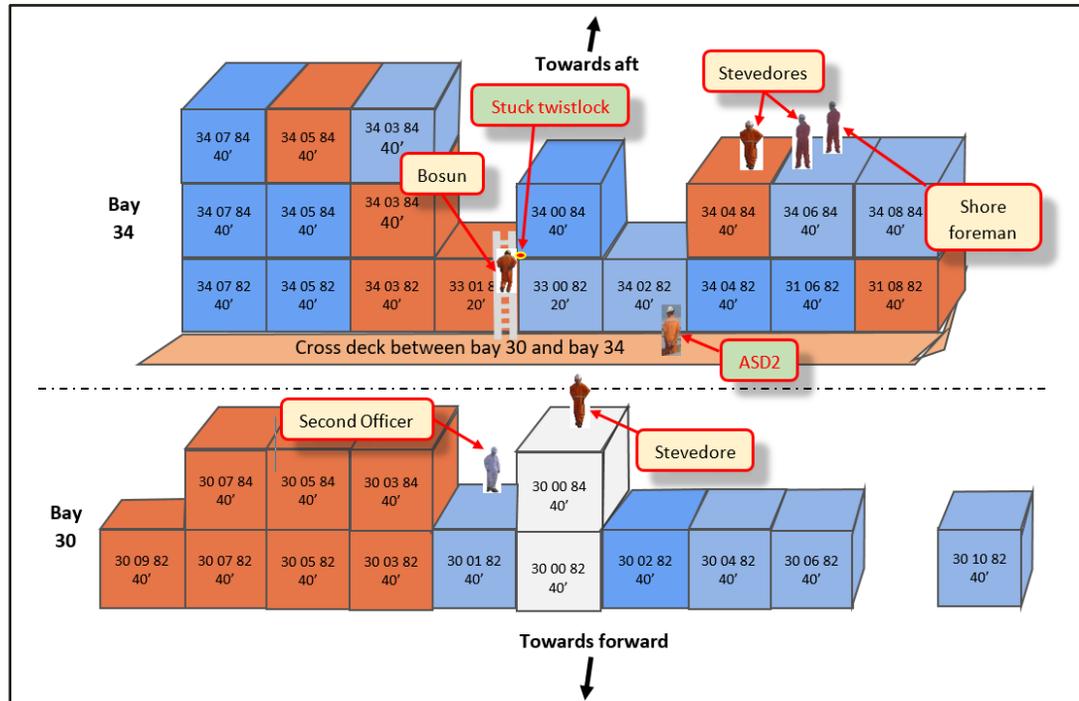
Figure 4A – Positions of relevant personnel prior to the accident  
(not to scale, side view for illustration purpose)

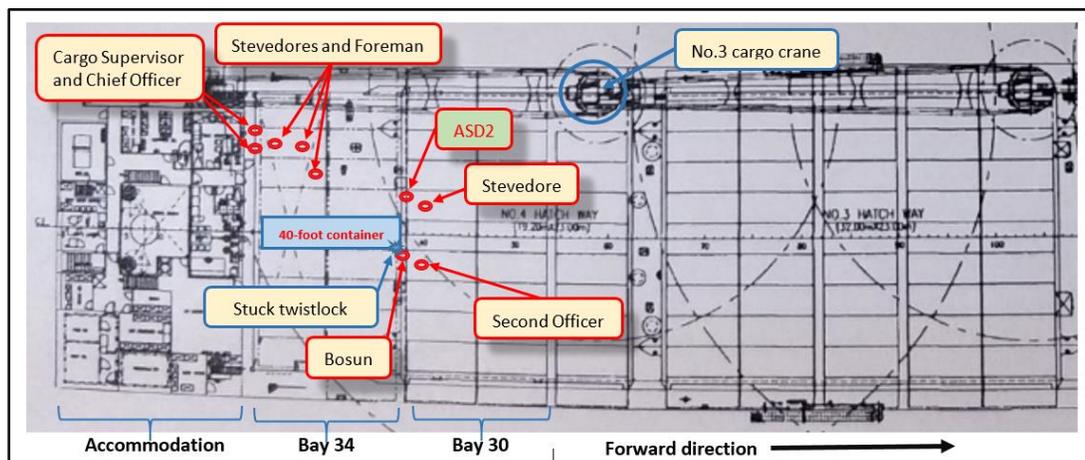
Figure 4B – Plan view of positions of relevant personnel  
(not to scale, for illustration purpose)

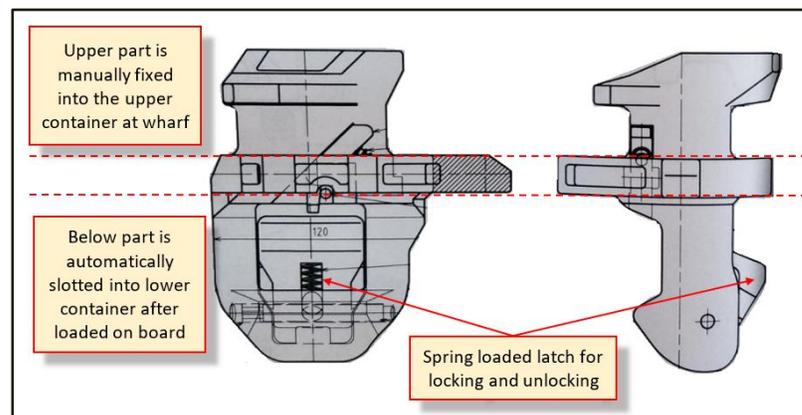
- 1.5.3 The second type (the same type as the one that was stuck) was the fully automatic twistlock (see **Figure 8**) for securing of the containers on the second tier and above on deck. Before a container was loaded onto the ship, the twistlock would be inserted in the container, prior to it leaving the jetty by the crane. Once lifted on board the ship, the container would be slotted on to the corner casting eye of the lower container. Once slotted, a spring loaded latch would automatically lock and secure both containers together.

Figure 8 – Drawing of the fully automatic twistlock

- a) The fully automatic twistlock was already in a poor or damaged status, and it had not been identified to be unfit for use (and thus not segregated from the last inventory check). As a result, the stevedores at the loading port, inserted it into the 40' container before it was loaded on board. Although the duty watchkeeping officer at the loading port would routinely check the fitting of the twistlock, because the twistlock did not have a handle fixed, knowing the internal condition would be difficult to ascertain visually after it was loaded on board above the first tier together with the container (34 00 84); or

- b) The fully automatic twistlock was in a working condition, but it got stuck due to improper discharging of the 40' container at Sao Tome and Principe. The container could have been lifted up at an angle as a result of the crane jib head not being vertically above the container.

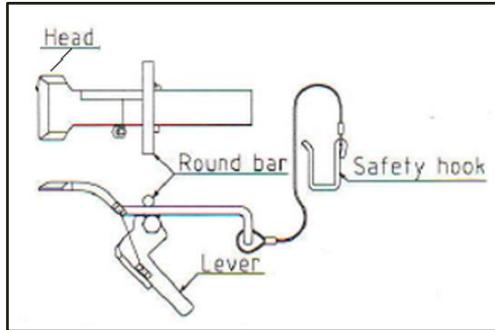
was simple and was meant to be operated<sup>28</sup> by a single person. The investigation team became aware that emergency tool was kept in the ship's store room. There was no record of any training session for the use of emergency tool conducted on board prior to the accident.

Figure 9 – Drawing of the emergency tool
