# **Final Report**

## **DEATH OF CREW DANUM 175 AT PASIR PANJANG TERMINAL, SINGAPORE ON 21 DECEMBER 2020**

TIB/MAI/CAS.098

Transport Safety Investigation Bureau  
Ministry of Transport  
Singapore

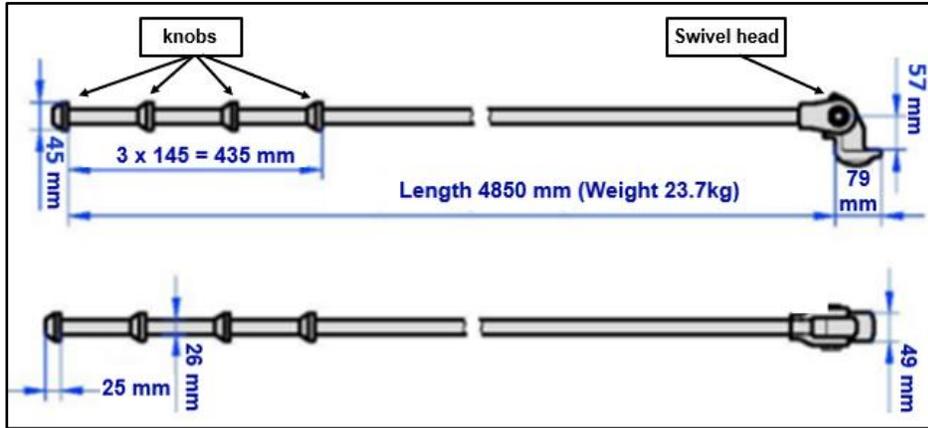
1.10.1.1.1 Lashing rods, made of hot treatable steel with hot dip galvanised finish, are devices used in combination with turnbuckles, to lash the cargo containers on deck. The swivel head is made to fit into the end of the container corner casting. The other end is attached to the appropriate turnbuckle (secured to the welded ship lashing plate). The type used on board D175 was of the 'knob and swivel head type' lashing rod which was used with the knob turnbuckle. See **figure 8** for the image with specifications of the long lashing rod.

Figure 8 – Image of long lashing rod used on board D175. (Not to scale)  
Source: Cargo Securing Manual of D175

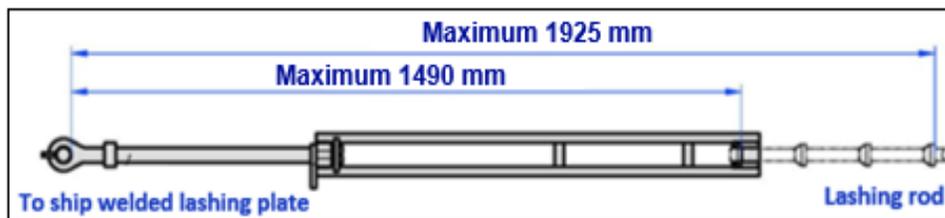
1.10.1.2.1 Turnbuckles, also made of hot treatable steel with hot dip galvanised finish, are used to tension a ship's cargo container lashing. The securing device has two screw ends, of which one is connected to the lashing plate welded to the ship's deck, while the other screw end is attached to a lashing rod, secured to the container corner casting. By rotating the frame of the turnbuckle, the tension can be adjusted. The type used on board D175 was of the knob (attached to the lashing rod) and the open body jaw type (which fits in the eye of a lashing plate). The turnbuckle can be tightened with a turnbuckle key. See **figure 9** for the image with the specification of the turnbuckle.

Figure 9 – Image of turnbuckle used on board D175. (Not to scale) Source: Cargo Securing Manual of D175

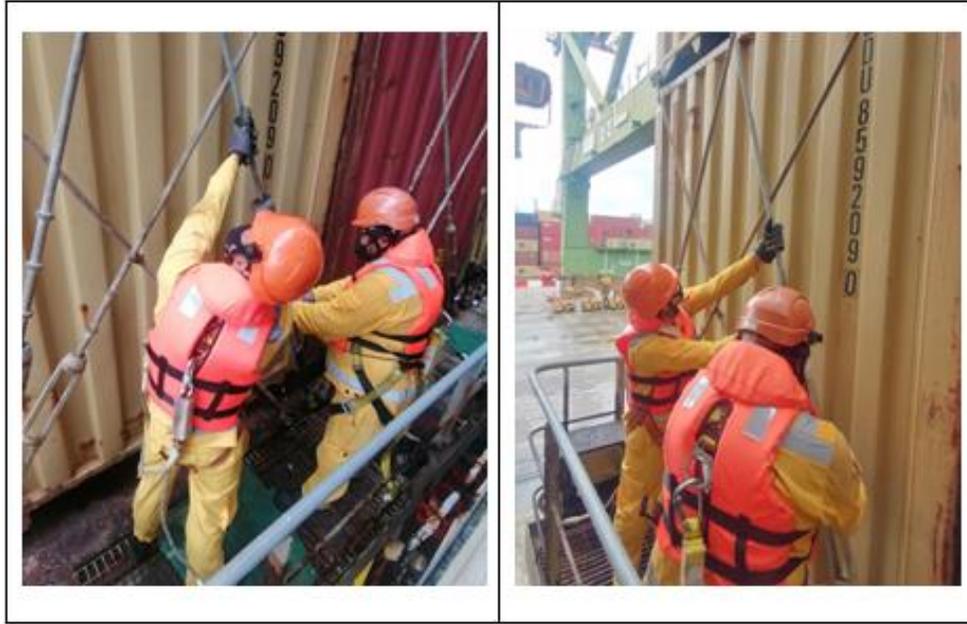
- 1.11.5 The investigation team also obtained additional information from the terminal on what constituted an adequate space for two-man to perform the lashing/ unlashings of containers. The following picture is provided as an example of the space, which also indicates how the LS typically perform the task at the outboard row (see **figure 10**).

Figure 10 – Pictures showing two-man operation for unlashings the containers  
(Source: *PSA Singapore*)
