FINAL REPORT

MAN OVERBOARD FROM THE CONTAINER SHIP MAERSK PATRAS IN ST. LAWRENCE RIVER ON 19 MAY 2019

MIB/MAI/CAS.065

**Transport Safety Investigation Bureau
Ministry of Transport
Singapore**

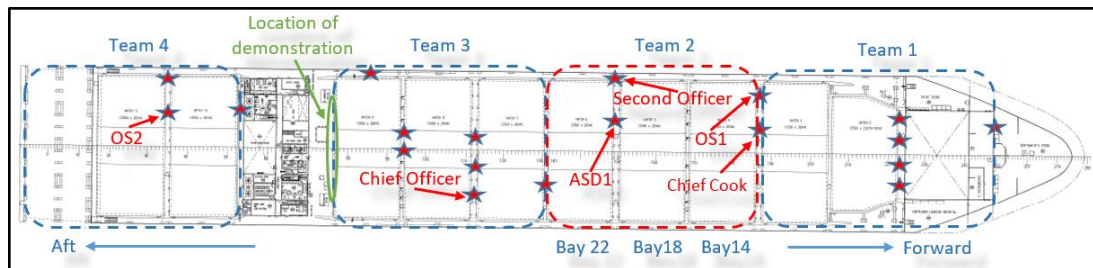
1.5.4 The 19 crew members were grouped into four teams, with a leader in-charge and a person designated to wear a set of fall arrestor (safety harness and lifeline) for removing the outermost lashing rods. The Second Officer was assigned to be in-charge of Team 2 (see table-2 and figure 5³⁹).

Figure 5 – Main deck view of ship's General Arrangement plan indicating: a) the location of the physical demonstration on 17 May 2019 indicated in green colour; and b) the positions of the relevant crew involved in unlash operation on 19 May 2019 indicated in red colour – annotated by TSIB
(Source: the Company)
