FINAL REPORT

FATAL INJURY ON BOARD THE BULK CARRIER CAPE INDIA AT SEA ON 28 OCTOBER 2019

MIB/MAI/CAS.073

**Transport Safety Investigation Bureau
Ministry of Transport
Singapore**

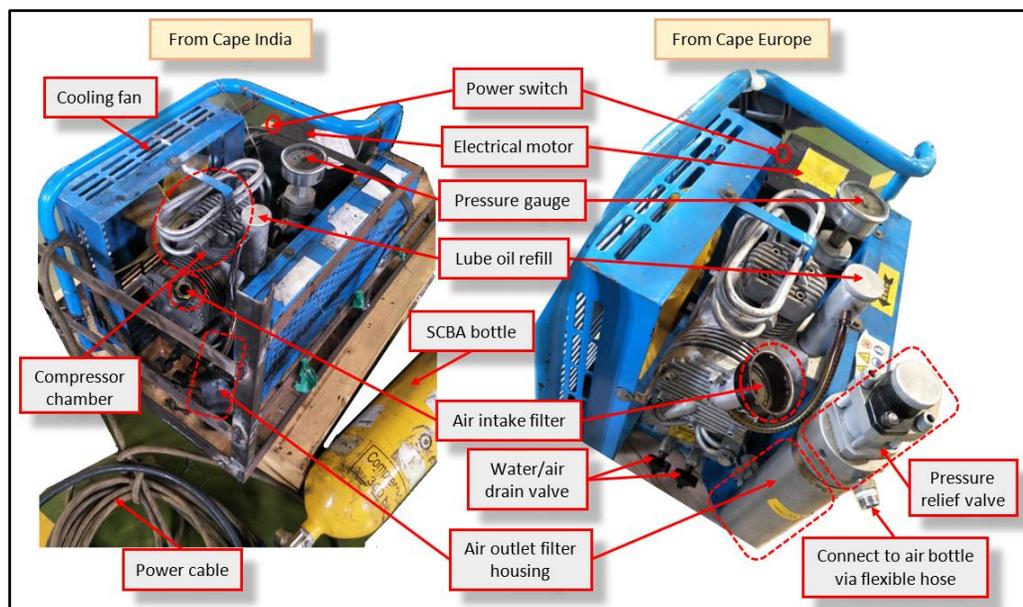
Figure 4a – View of the BA compressors from Cape India and Cape Europe

1.4.1 The BA compressor installed on Cape India had been on board since delivery of the ship in April 2014. Some ships managed by the Company also had the same make and model (see **figure 4a and 4b**), for instance, on Cape Europe⁴⁰.

⁴⁰ After the occurrence, the Company arranged for another compressor of the same model from Cape Europe for comparison and test as some of the components of the BA compressor from Cape India had been damaged as a result of the explosion.

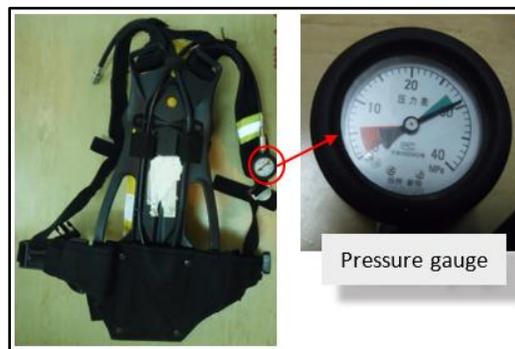
Figure 13 – Illustration of SCBA and pressure gauge
(Source: the ISM Manager)

1.5.10 Two sets of SCBA comprising six⁴⁸ air cylinders were carried on board. For verifying the pressure of the air cylinders, the cylinder could be connected to the SCBA and read out from the gauge (see **figure 13**).
