Final Report

Death of a crew

SRS Asian Triumph

TIB/MAI/CAS.140

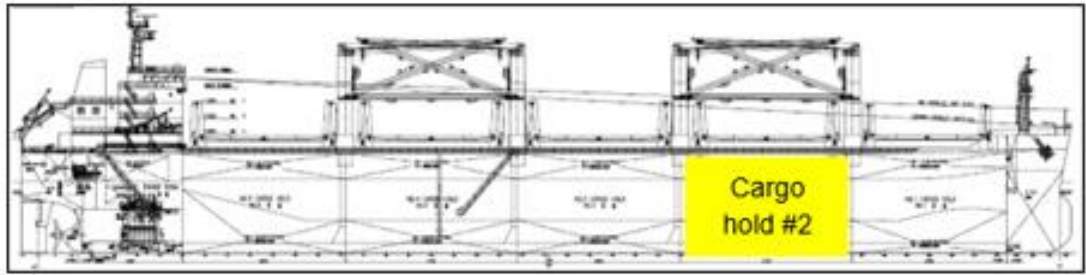
- 1.3.3 **Figure 7** shows the starboard side profile of the ship, also indicating the cargo hold #2 marked in yellow box – location where the incident occurred.

Figure 7 - Starboard side profile of the ship. *Source: The Company.*
Annotation by TSIB

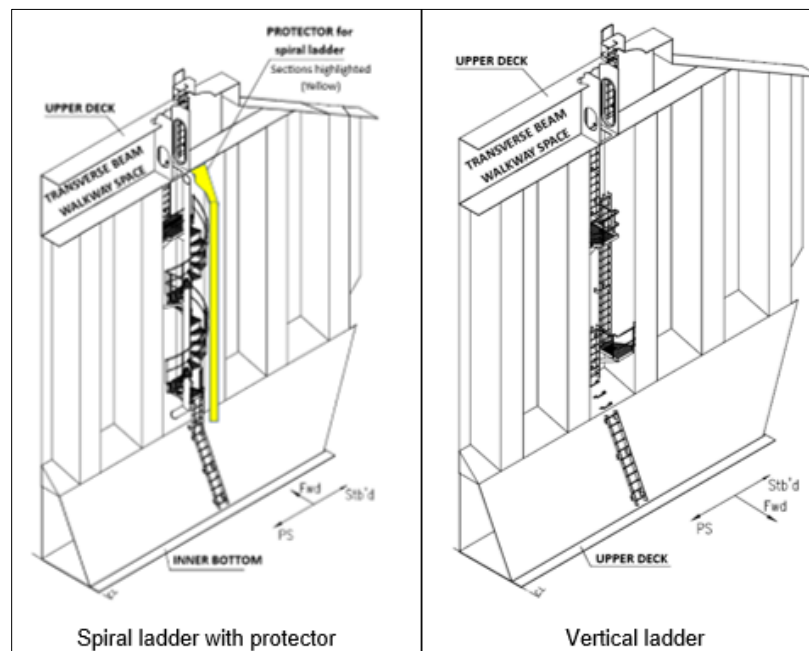
1.3.6 Both the ladders' designs, width and construction are accepted by the Administration¹⁸, see **figure 9** depicts both ladders inside the cargo holds.

Figure 9 - Depicting the two means of access inside the cargo holds. Source: The Company. Annotation by TSIB

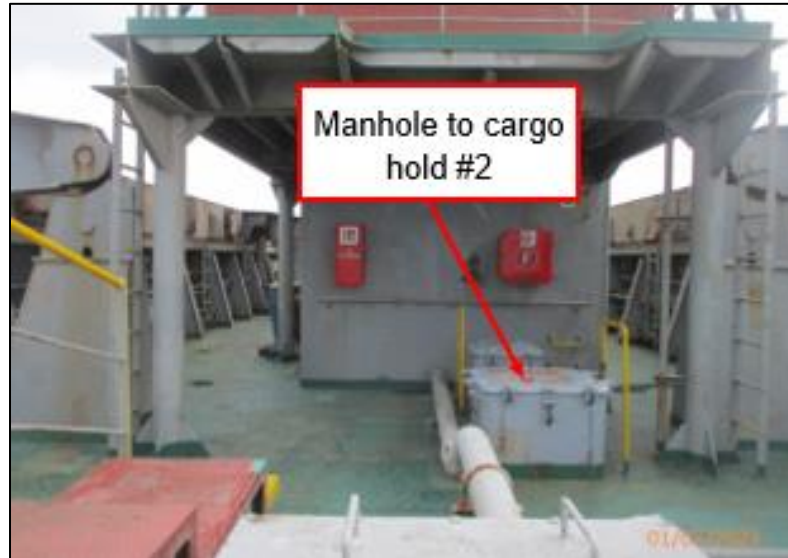
- 1.4 Access to the cargo hold
- 1.4.1 See **figure 11** for the location of the access manhole fitted with spiral ladder and located at the port side aft section of the cargo hold #2.

Figure 11 - Manhole to cargo hold #2 fitted with spiral ladder. *Source:* The Company. Annotation by TSIB.

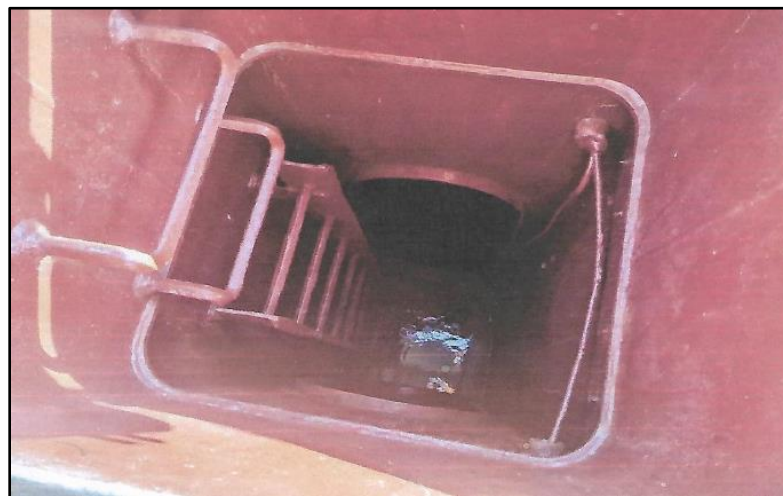
1.4.2 **Figure 12** shows the transverse beam walkway space at the bottom of the vertical ladder, as seen from the access manhole on the main deck.

Figure 12 - showing the vertical ladder to the transverse beam walkway space. *Source:* The Company.
