Final Report

COLLISION

**CRYSTAL SUNRISE
AND
ASTRO SATURN**

**SINGAPORE TERRITORIAL WATERS
17 APRIL 2018**

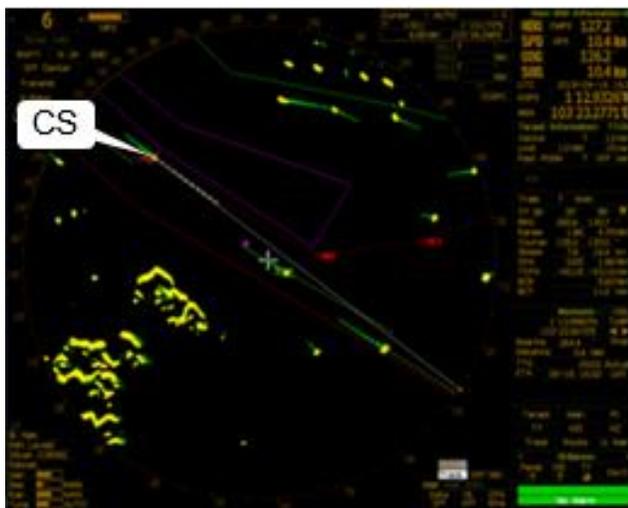
Figure 3 - X-band radar display²⁸ at 0030H

- 1.1.6 On 17 April 2018, at about 0030H, CS passed waypoint (WP²⁵) 61²⁶ and was about 7.7nm southwest of Tanjung Piai light beacon, on a course of 127°True (T) at 10.4 knots. About the same time, the Master reported CS' position in the eastbound lane of the Singapore Strait TSS to VTIS West (W) on VHF Ch.73 upon entering Sector 7 as required by STRAITREP²⁷ (see **figure 3**).

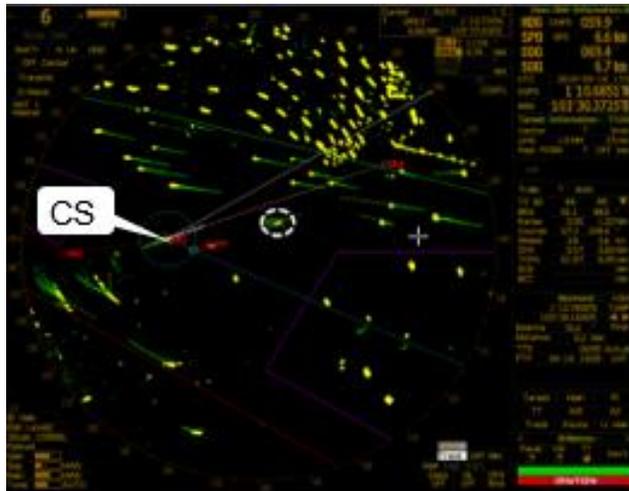
Figure 4 - X-band radar display at 0130H
(Note: Most westbound targets were not acquired)

- 1.1.9 At about 0130H, CS was steering 060°T headed for the PWBGA (about 6.2nm right ahead at WP 64) with a course made good (CMG³³) 069°T and a speed made good (SMG³⁴) at 6.6 knots passed WP 63. At that time, the Master noticed one target proceeding on the same way towards PWBGA (target 44 on the X-band radar), circled in white (see **figure 4**), about 3nm at two points³⁵ on the starboard bow, later identified as the JBB Yu Hang 259.

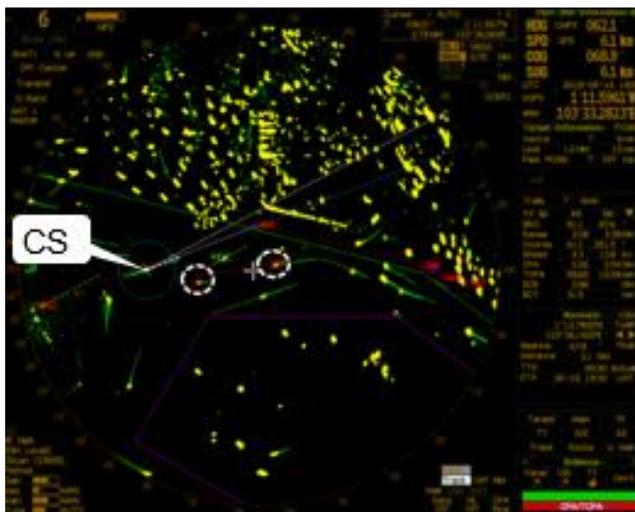
Figure 5 - X-band radar display at 0200H

- 1.1.11 At about 0200H, CS was steering 062°T with CMG of 069°T and SMG 6.1 knots. The Master noted JBB Yu Hang 259 was still about two points on the starboard bow at about 2.1nm. At that time, the Master recalled noticing several westbound vessels on the starboard side but confirmed (to the investigation team) that none of them were acquired on the X-band radar. Two other targets circled in white were heading towards CS (see **figure 5**). The Master further added that the S-band radar was also being used to acquire targets.

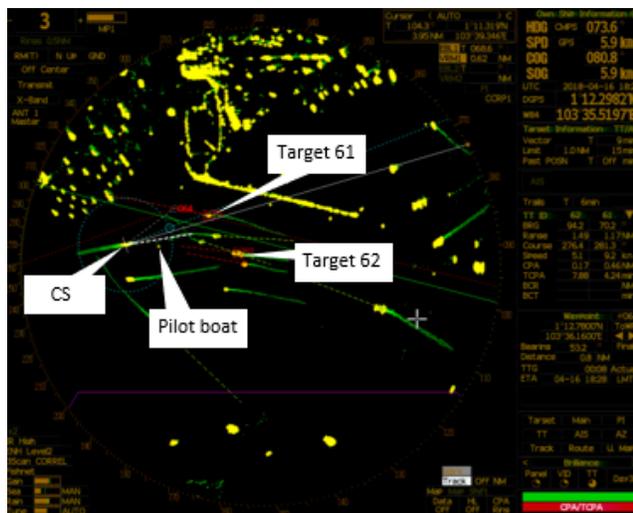
Figure 6 – X-band radar display at 0220H

1.1.19 In addition, the Master also instructed⁴¹ the 2M to “...*watch out for target 59...*”. The investigation team could not see target 59 on X-band radar. However, during the interview, the Master was shown the X-band radar image and the Master mentioned that it is possible that target 59, which was heard in the VDR audio recording, could be acquired on S-Band radar. He further mentioned that this target 59 (allegedly on S-band radar) should be corresponding to target 61 on X- band radar. (see **figure 6**).

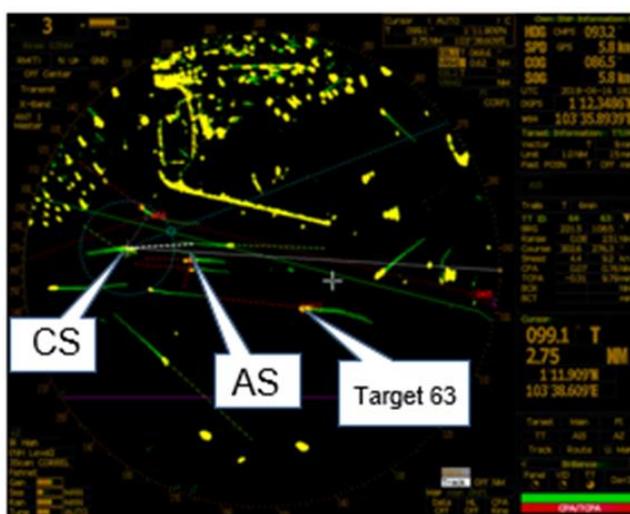
Figure 7 – X-band radar display at 0224H

- 1.1.21 At about 0222H, the Master enquired⁴⁵ and was responded by the 2M, that the ship on the starboard side with its deck lights⁴⁶ lit was stopped and was not at anchor⁴⁷. The Master further enquired⁴⁸ the distance of the ship (with deck lights lit) from CS' bow, but before being responded by the 2M, the Master reduced the helm angle from starboard 15° to starboard 10°, and finally to midship⁴⁹.
- 1.1.22 By about 0224H the pilot boat was alongside CS which was at the edge of the Precautionary Area (0.5nm south of PWBGA) and CS' heading was turning clockwise from 090°T to 102°T, as she proceeded towards the westbound lane (see **figure 7**).

of CS which was on a starboard to starboard passing with AS (see **figures 7, 17 and 22**), had evolved into a crossing situation, where CS' bow was now showing an aspect of crossing the path of AS (see **figures 18 and 24**).

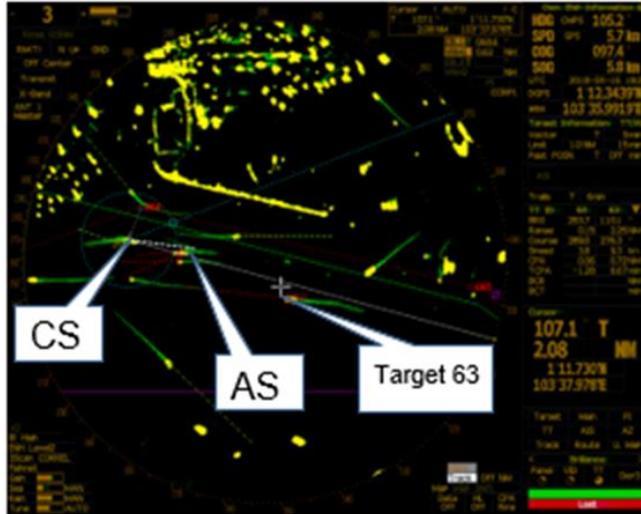
Figure 8 - X-band radar display at 0225H – Pilot boat alongside CS

- 1.1.23 At about 0225H⁵⁰, the Master enquired the CM, “...whether the Pilot was coming up (referring to the Pilot boarding CS) or not...”. The CM responded that the Pilot was on the gangway and that the pilot boat had not cleared the ship’s side (see **figure 8**).

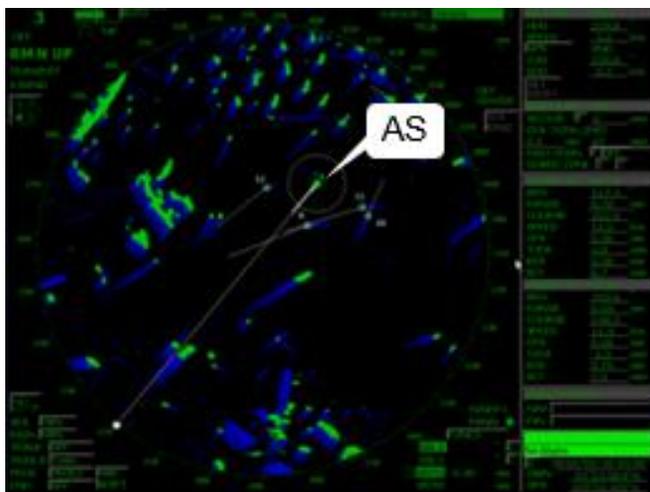
Figure 14 – X-band radar display at 0030H

- 1.1.34 Following the passage plan, with Raffles lighthouse bearing 247°T at 9.76nm, AS was being steered at 219.8°T, with CMG 220°T and SMG 5.2 knots (see **figure 14**).

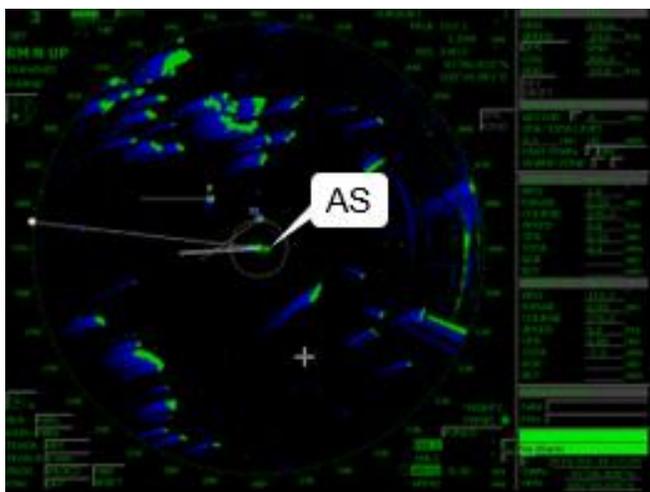
Figure 15 – X-band radar display at 0130H

- 1.1.35 At about 0130H, AS was about 1.2nm south of Raffles Lighthouse, steering 277°T, with CMG 266°T and SMG 10.8 knots, AS entered Sector 7 of the STRAITREP (see **figure 15**) and reported to VTIS (W) on VHF Ch.73.

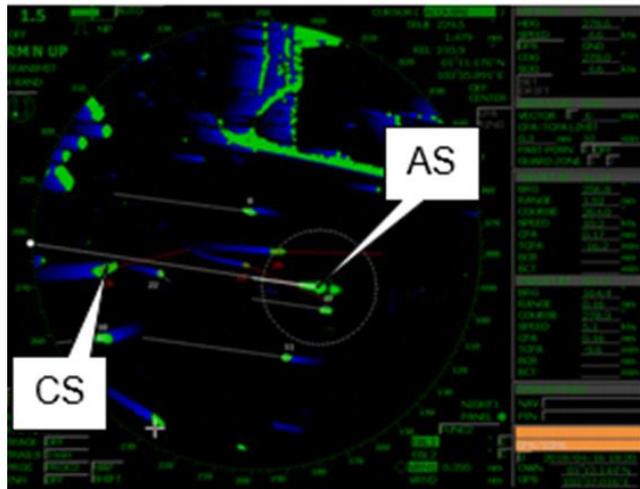
Figure 16 – X-band radar display at 0220H

1.1.43 At about 0220H, with the AS' speed about 4.6 knots, the Master tested AS' engine with ahead and astern movements satisfactorily. At that time, the bridge team noted the following targets on the X-band radar (see **figure 16 and table 5**).

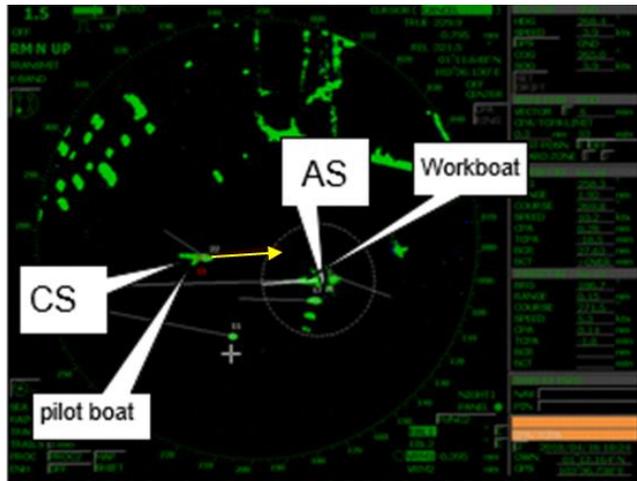
- 1.1.44 By about 0224H, AS was steering 268°T, with CMG 265°T and SMG 3.9 knots, passing⁷¹ CS' starboard to starboard at a CPA of about 0.16nm. At about this time, the workboat was alongside AS to embark the Mooring Master. The 2M(B) was sent on deck to receive the Mooring Master (see **figure 17**).

Figure 17 – X-band radar display at 0224H – Approximate vector of CS Indicated by yellow arrow (annotated by TSIB)

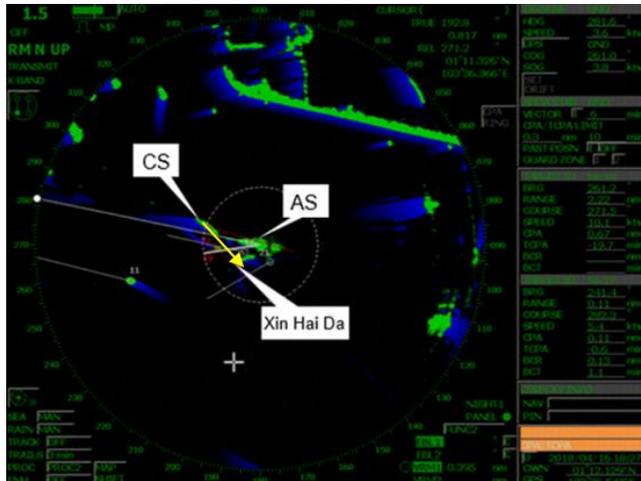
- 1.1.45 At about 0226H, AS was steering about 272°T, with CMG 259°T (setting towards south) and SMG 3.7 knots, the Master moved the engine telegraph to slow ahead. At that time, CS which was initially passing starboard to starboard, was now at one point on AS' starboard bow at about 0.5nm away, and with a reduced CPA of about 0.15nm.
- 1.1.46 By about 0227H, AS was at a CMG of about 261°T when CS was observed to be about 0.4nm away, and the bridge team noted that CS' aspect had changed progressively, i.e. the masthead lights and sidelights (from green sidelight changing to both red and green and finally displaying a red sidelight), indicating that CS was now in a crossing situation with AS from starboard to port (see **figure 18**).

Figure 18 - X-band radar display at 0227H – Approximate vector of CS after changed, annotated by TSIB

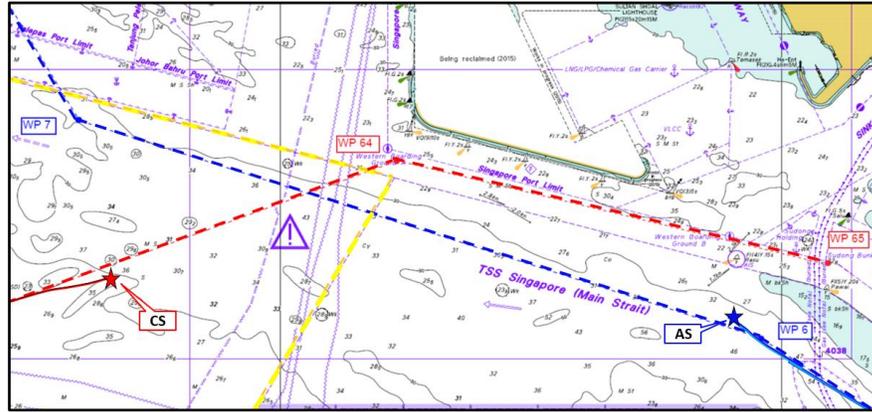
Chart 4040 showing PWBGA at WP 64 with the bund for the Tuas Mega port and yellow flashing buoys in front. The red and blue dashed lines are the courses as per the passage plan for CS and AS respectively. The yellow dashed lines indicate the northern and eastern extent of the Precautionary Area (see **figure 21**).

Figure 21 - At 0200H CS was within the Precautionary Area and AS was in the westbound lane (distance between CS and AS was about 6nm) – annotated by TSIB

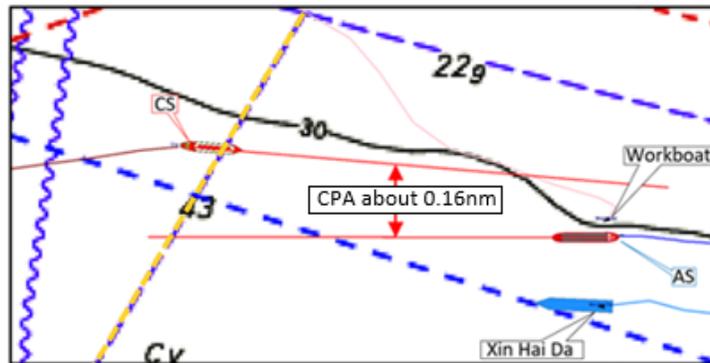
1.2.2 By about 0224H, when CS was at the edge of the Precautionary Area with the helm at midship, CS still had a rate of turn (RoT) of about 12°/min to starboard, while AS was on a westerly heading. At that time both vessels were about 0.65nm away and appeared to be passing starboard to starboard of each other at a CPA of about 0.16nm or less than two cables⁷⁶ (see **figure 22**).

Figure 22 – At 0224H the distance between CS and AS was about 0.65nm (1204m). Approximate vectors showing vessels' heading annotated by TSIB for clarity.

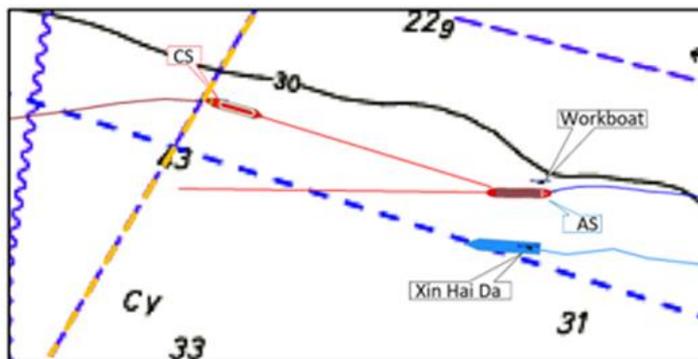
starboard, with a decrease in distance to AS from five to three cables at 0226H and two cables at 0227H (see **figures 23, 24 and 25**).

Figure 23 - At about 0225H, CS entered the westbound lane of the TSS. The distance between CS and AS was about 0.5nm

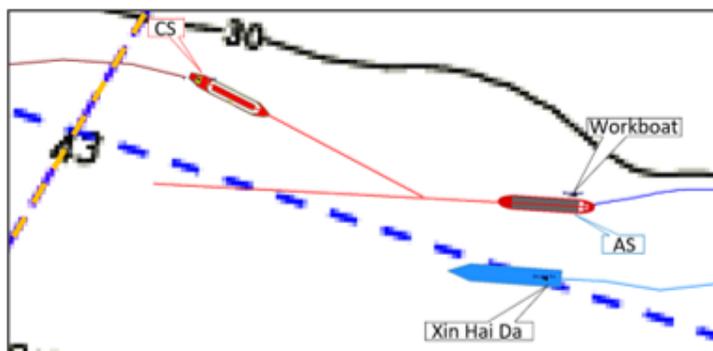
Figure 24 – At about 0226H the distance between CS and AS was about 0.34nm

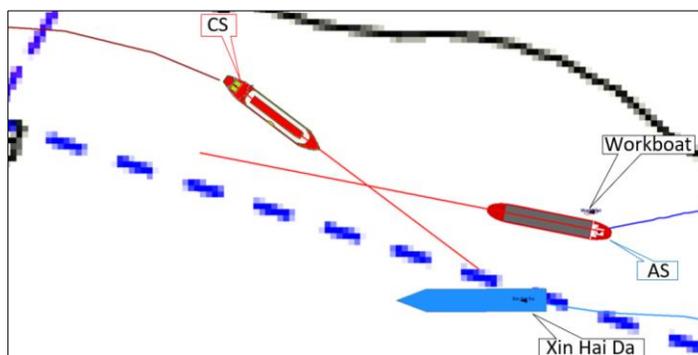
Figure 25 – At about 0227H the distance between CS and AS was about 0.19nm. AS' heading indicating a turn to starboard.

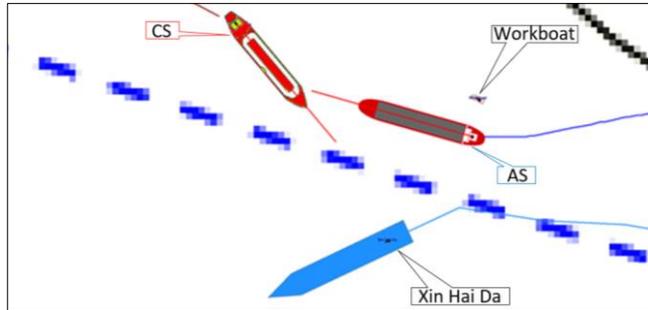
Figure 26 – Positions of CS and AS at 0228H before the collision

1.2.4 Before the collision, both vessels were approaching each other with the following configuration (see **figures 26 and 27**)

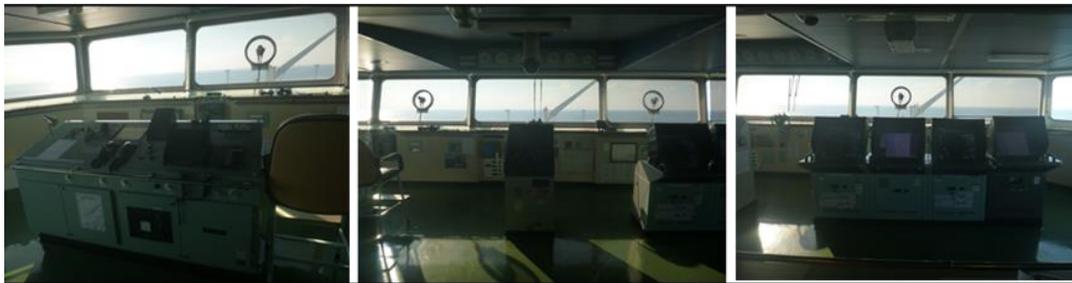
1.4.1 CS had a traditional bridge layout, with the steering column behind the conning position. To the left of the steering column was the engine telegraph control console and to the right of it were the two radars and ECDIS (see **figure 28**). During the passage, the Master was toggling among acquiring and plotting targets on the radar, taking collision avoidance measures, looking out, as well as operating the telegraph and the 2M was assisting with communications, radar and ECDIS & occasionally the telegraph.

Figure 28 - From left to right – Telegraph console, steering column (with RoT indicator) and radar/ECDIS consoles

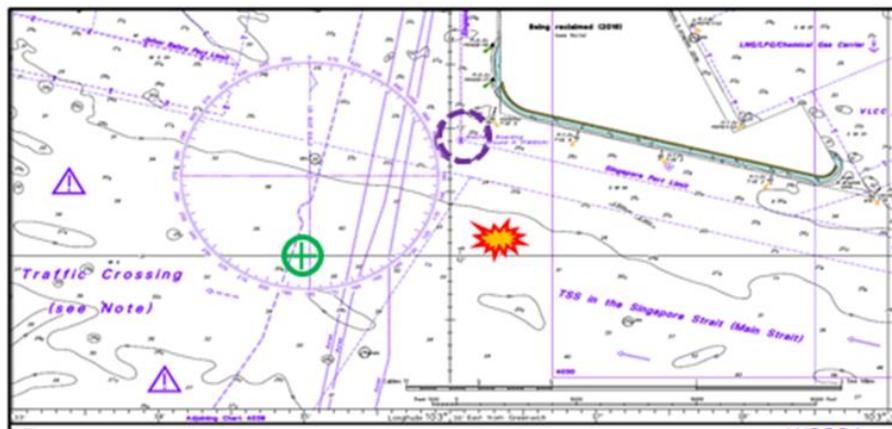
1.6.1 The incident occurred⁹¹ about 0.75nm south by southeast of PWBGA i.e. within the westbound lane of the Singapore Strait TSS in Singapore territorial waters.

Figure 31 - Location of occurrence. Green crosshair indicates intended Fendercare Mooring Master boarding position. Purple dashed circle indicates PWBGA – annotated by TSIB

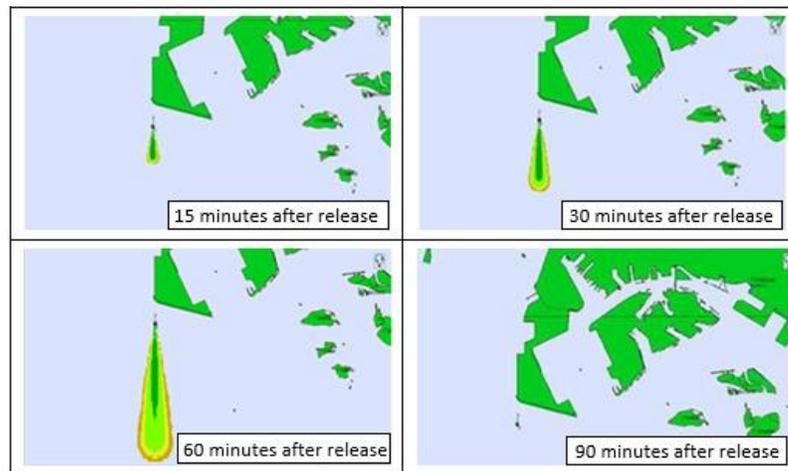
the gas plume (see **figure 32**) was conducted after the incident and it was assessed to have dissipated away from Singapore, below flammable level, within an hour.

Figure 32 – Plume modelling after the occurrence (Source: MPA)
