Final Report

CREW MISSING AT SEA FROM THE CONTAINER SHIP KOTA LAZIM ON 12 SEPTEMBER 2020

TIB/MAI/CAS.091

Transport Safety Investigation Bureau
Ministry of Transport
Singapore

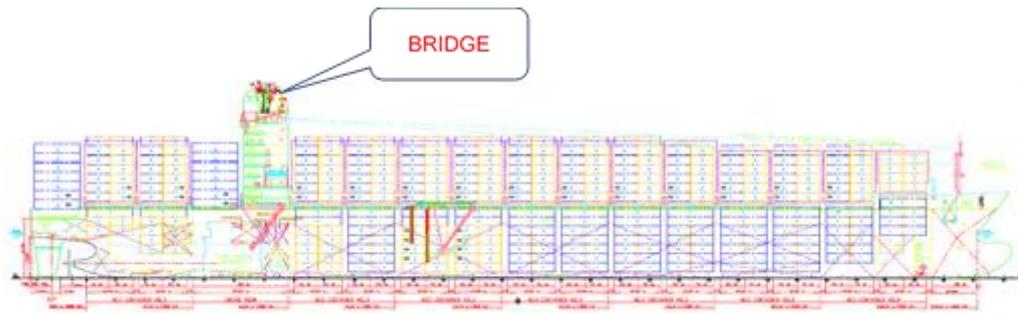
- 1.2.1 KL was a fully cellular container ship, with seven cargo holds and on a trade route between the west coast of Mexico & South America and the far east region.
- 1.2.2 The bridge was located seven decks above the upper deck (see **figure 1**). The height of the bridge above the sea was about 30m.

Figure 1 – Profile view of KL indicating location of the bridge – Source: The Company

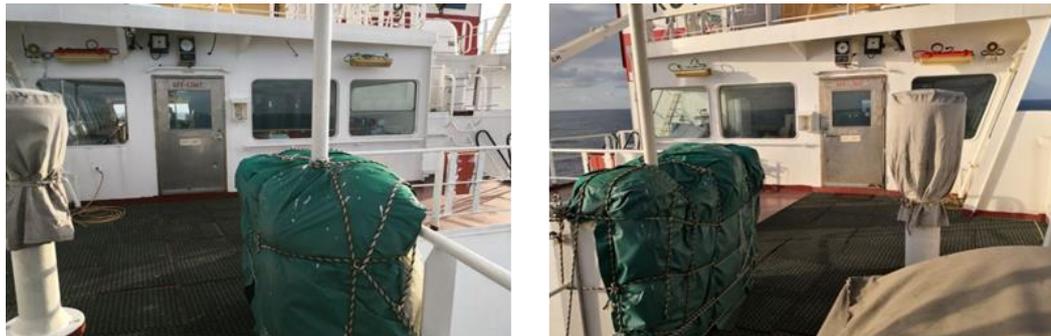
- 1.2.3 The layout of the bridge on Kota Lazim is typical of a ship of this size. The navigational equipment such as radars and the electronic chart display information system (ECDIS) are fitted in the forward part of the bridge while the global maritime distress safety system (GMDSS) related equipment are located at the aft part of the bridge, separated by curtains, drawn during the hours of darkness (see **figure 2**). When the Bosun came to the bridge the GMDSS was found undisturbed and in normal condition.

Figure 2 – View of the forward part of the bridge (left image) and the aft part (right image) – Source: The Company
