# **FINAL REPORT**

## **COLLISION BETWEEN BULK CARRIER EIRINI P AND OIL TANKER VIKTOR BAKAEV IN SINGAPORE STRAIT ON 24 JANUARY 2017**

**MIB/MAI/CAS.011**

**Transport Safety Investigation Bureau  
Ministry of Transport  
Singapore**

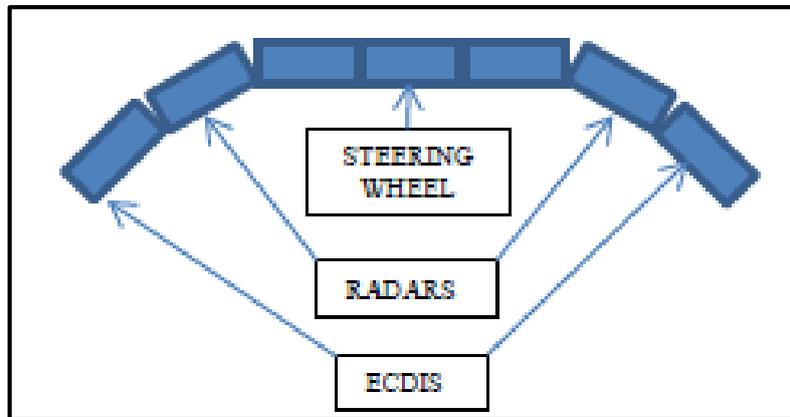
Figure 11: Illustration of Viktor Bakaev's bridge layout.  
Source: LISCR

1.6.2.6 VB's primary means of navigation was Electronic Chart Display Information System (ECDIS). The steering console separated two sets of radars<sup>17</sup> and ECDIS (see Figure 11).
