COLLISION

EXPLORER

A WOODEN COASTER

MIB/MAI/CAS.039

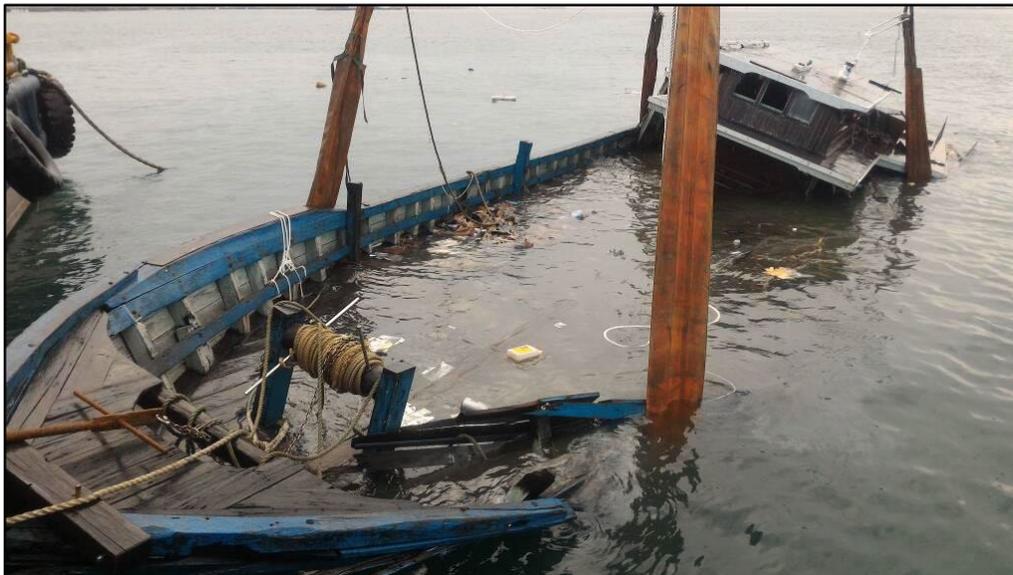
WOODEN COASTER (Being Salvaged)

1.6.1 After the WC was salvaged, the investigation team examined the wreck and noted signs of a hole²⁵ on the port side (see **figure 2**, below the waterline – circled in yellow).

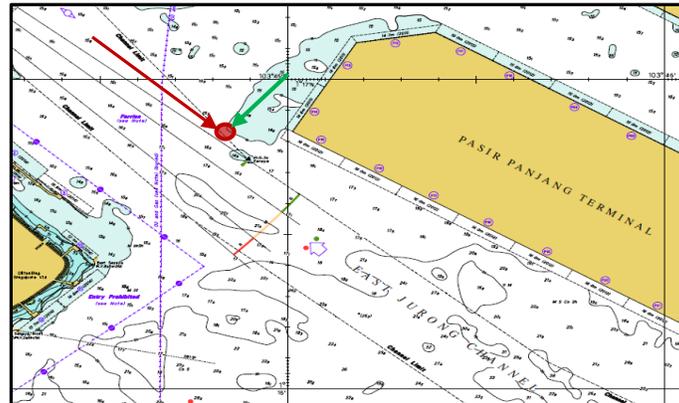
Figure 7 – Relevant section of chart 4034 (not to scale) - annotated by TSIB

1.8.1 The incident occurred about 0.1nm west of Pasir Panjang container terminal at the eastern edge of the East Jurong Channel, near Seraya buoy, indicated by a red circle below. The red arrow is the approximate route of the WC and the green arrow indicates the approximate route of the EXP.

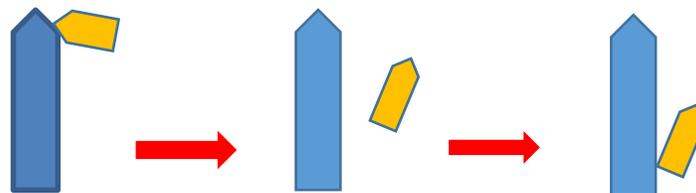
Figure 8 – Angle of Impact (not to scale) – *For illustration only*

1.8.2 According to the crew of the EXP, the angle of impact and subsequent movement of the WC was as follows. The EXP is depicted in blue and the WC is depicted in orange.
