FINAL REPORT

**MAN OVERBOARD (LOSS OF LIFE)
FROM OCEAN SUCCESS
WITHIN SINGAPORE TERRITORIAL WATERS
ON 4 MARCH 2018**

MIB/MAI/CAS.034

**Transport Safety Investigation Bureau
Ministry of Transport
Singapore**

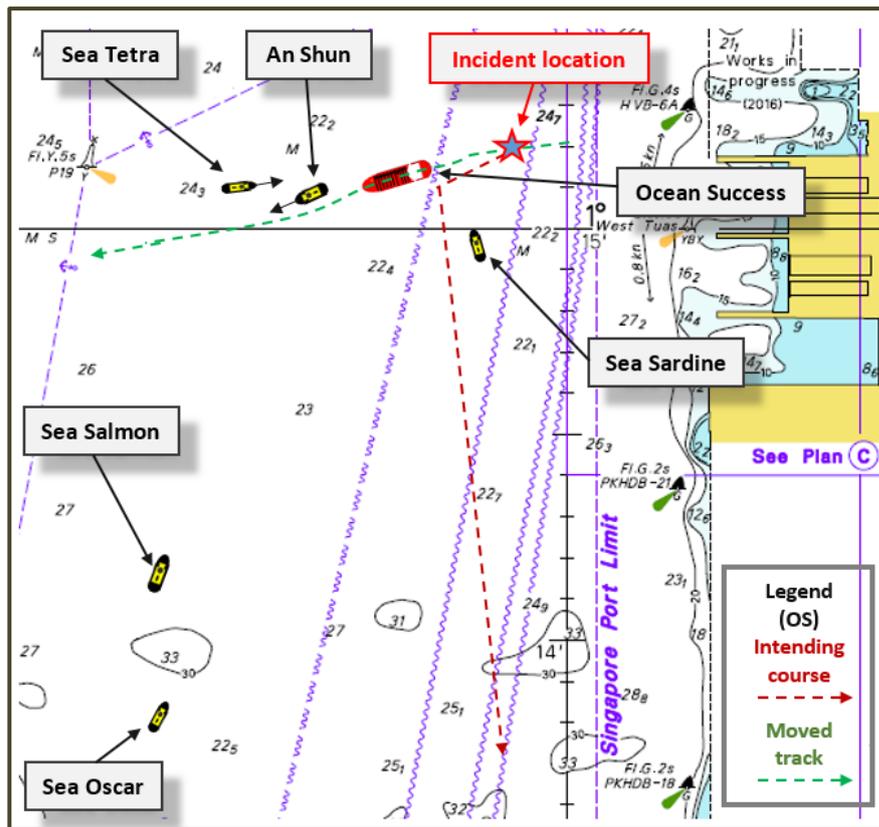
- 1.1.14 Within a minute of the occurrence, Sea Tetra, a tug boat in the vicinity, proceeded to the reported incident location. Four other tugs (see **Figure 2**) in the vicinity also responded to the incident location, one after another.

Figure 2 – At 0640H, positions of OS and tugs in the vicinity (Not to the scale, for illustration purpose)
