FINAL REPORT

**MAN OVERBOARD (LOSS OF LIFE)
FROM SUPPLY VESSEL
COASTLINK 8
IN THE SINGAPORE STRAIT
ON 26 AUGUST 2017**

MIB/MAI/CAS.023

**Transport Safety Investigation Bureau
Ministry of Transport
Singapore**

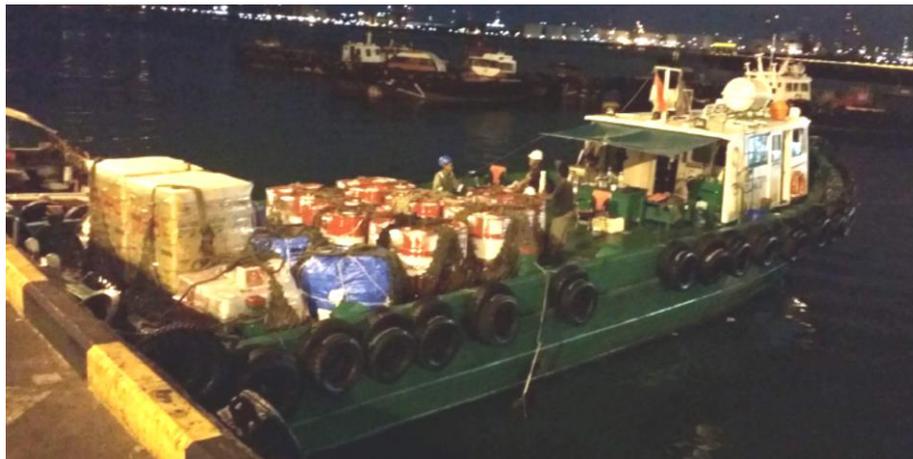
Fig.1 - C8 loaded with stores at Penjuru wharf

1.1.2 At about 1900H, the fully loaded C8 (see **Fig.1**), manned as per its safe manning requirements, by three Indonesian crew comprising the Master, Engine Officer (EO) and Able Seafarer Deck (ASD), departed Penjuru wharf in Singapore with an estimated time of arrival (ETA) of about 2200H at the rendezvous position.

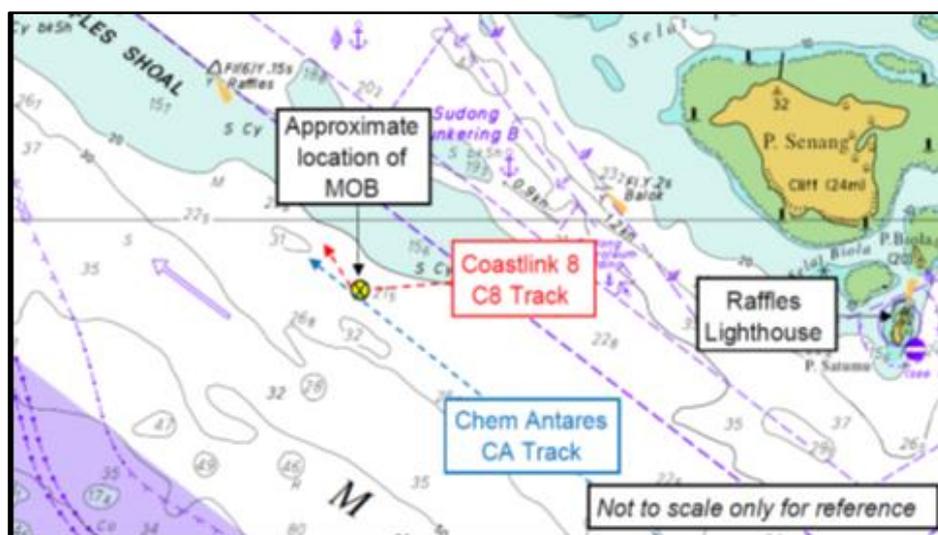
Fig.8 – Approximate location of MOB

- 1.3.1 The accident occurred at about 1.4 nm west of Raffles Lighthouse, within the westbound lane of the Singapore Strait TSS (see **Fig.8**).
