FATAL INJURY ON BOARD MATHU BHUM AT GULF OF MARTABAN ON 3 DECEMBER 2016

MIB/MAI/CAS.005

**Transport Safety Investigation Bureau
Ministry of Transport
Singapore**

13 February 2018

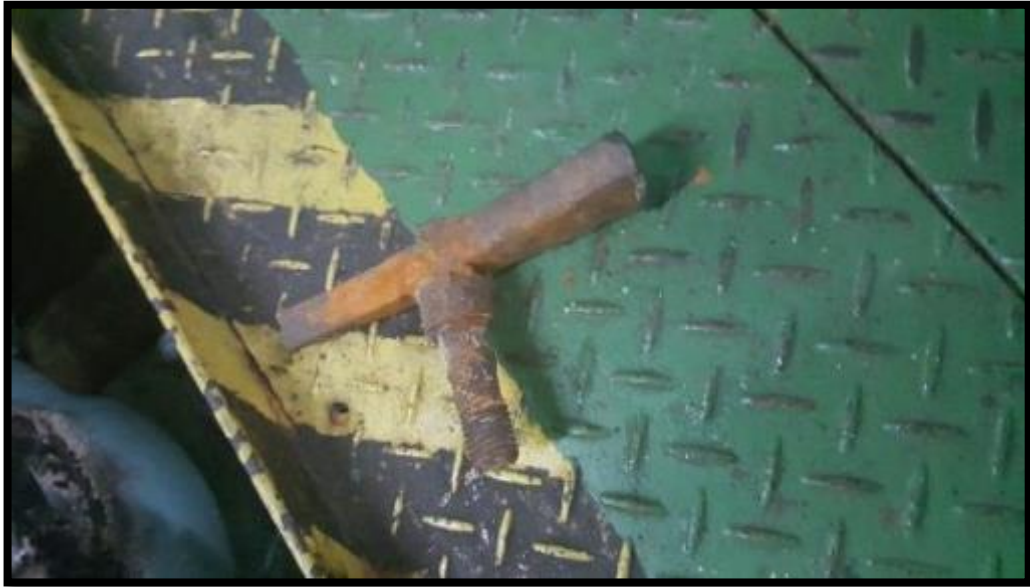
Fig. 2 – Illustration of a metal piece welded to a bolt head

- 1.1.10 At about 1400H, with OL holding the metal piece with a leather glove, 4E began to weld the metal piece on to the bolt. Noting that there was no power to the electrode, 4E instructed EC to go to the engine room workshop to switch on the welding machine.
- 1.1.11 According to OL, while waiting for EC to turn on the welding machine, 4E was standing in the engine room tank top and holding the electrode holder in his right hand, with his back leaning against the engine room floor plate (see **Figure 3**). His left hand was resting on the adjacent floor plate. While OL was aware that insulated gloves should be used welding, he did not raise his concern to 4E, as he assumed that 4E, as an officer, knew what he was doing

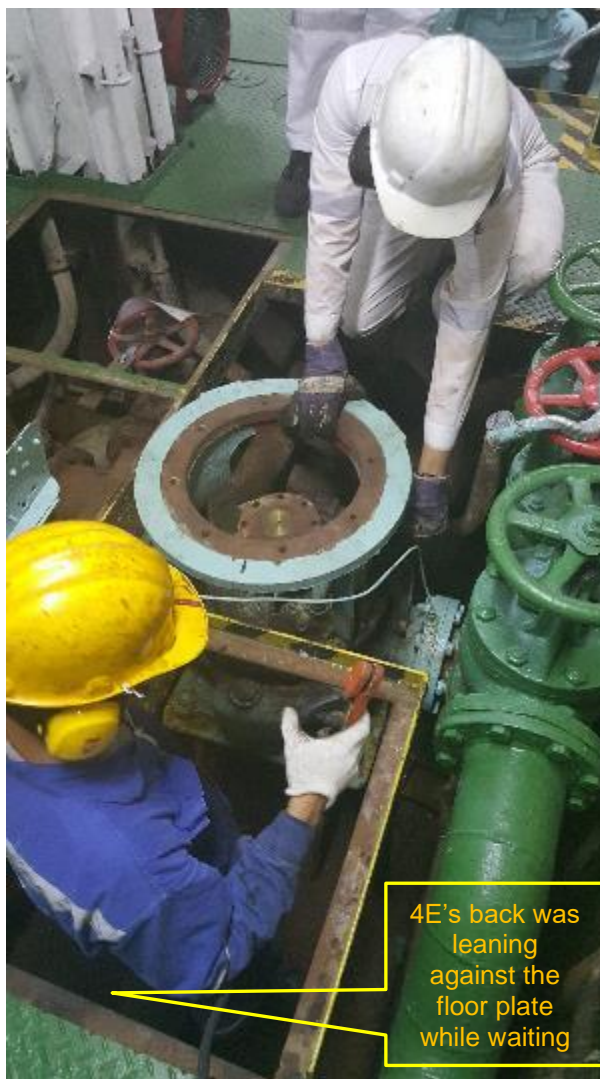
Fig. 3 – Illustration of 4E's approximate position at the start of welding work

- 4E's wet right hand's contact with the "electrically hot" part of the electrode holder (see Fig. 3 in paragraph 1.1.13); and
- 4E's left leg's contact with the foundation of the FBB pump's base²².

- 4E was using cotton gloves²⁴ to handle the non-insulated portion of the electrode holder;
- The tank-top had some puddles of water where he was standing;
- The working environment of a typical engine room had caused his boiler suit to be wet due to sweating (thus reducing his body's electrical resistance);
- The limited workspace around the FBB pump (see Figure 5 in paragraph 1.3.4); and
- Absence of a low voltage shock preventer that could reduce the welding machine's No-Load Voltage of 80 volts to not more than 25 volts.

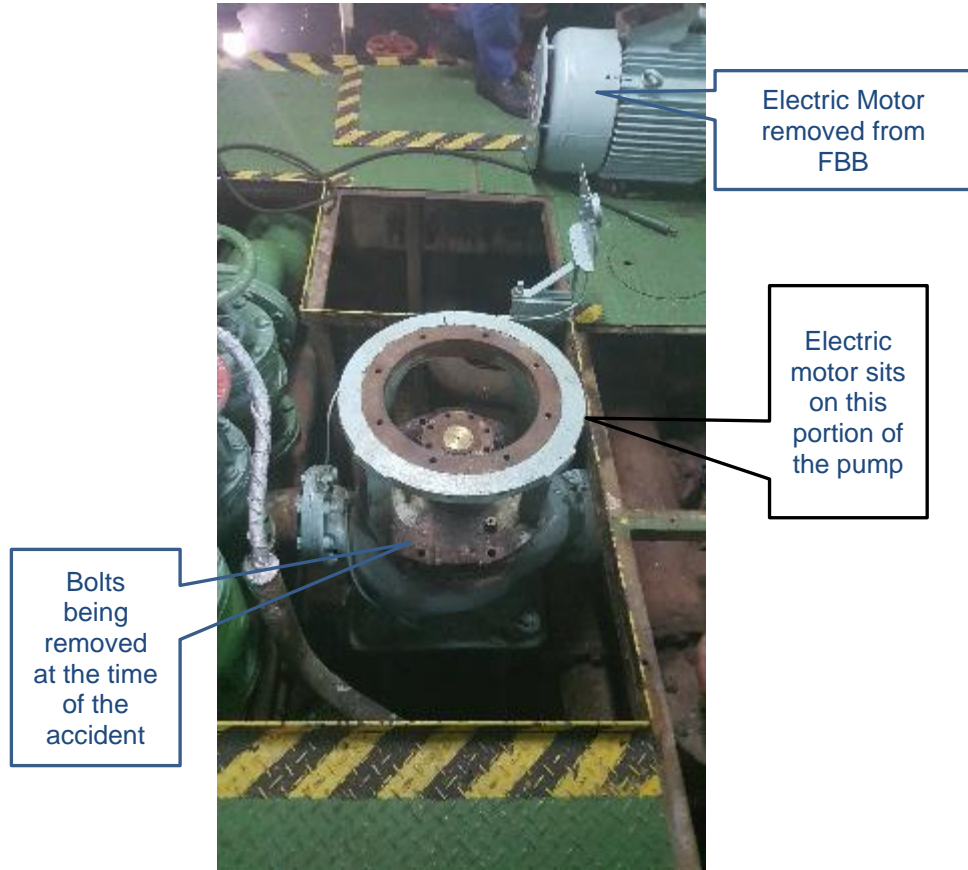
Fig.5 – Sections of the FBB pump

- 1.2.1 The FBB pump was amongst the machinery items in the engine room that were were subject to the CSM programme. The CSM was to be carried out whilst the vessel was en-route to the next port and photographs of the machinery were to be sent back to the attending Class surveyor for his assessment.
- 1.2.2 The FBB pump was an electric motor driven centrifugal pump. It was divided into three sections (see **Figure 5**), viz. the motor, the shaft and

coupling, and the impeller casing. For a comprehensive inspection, these three sections are to be separated from each other, hence the need for removal of the bolts and nuts.

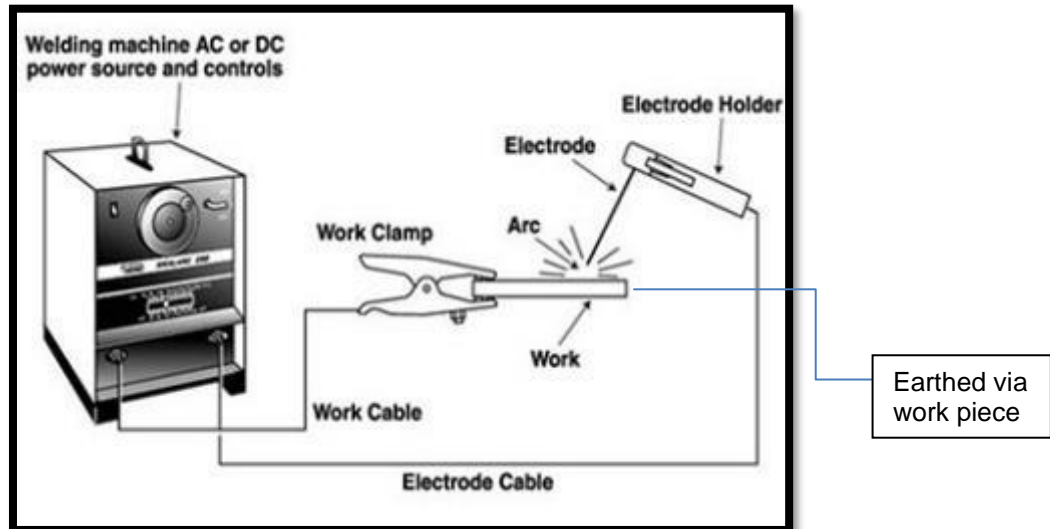
Fig. 8 – A typical welding machine set-up

1.3.3 However, the welding machine set-up on board Mathu Bhum was different from a typical welding machine set-up in that the machine was earthed directly to the ship's hull (see **Figure 9**), thus dispensing with the need of using a welding clamp to clamp the workpiece and then earthing the work piece.

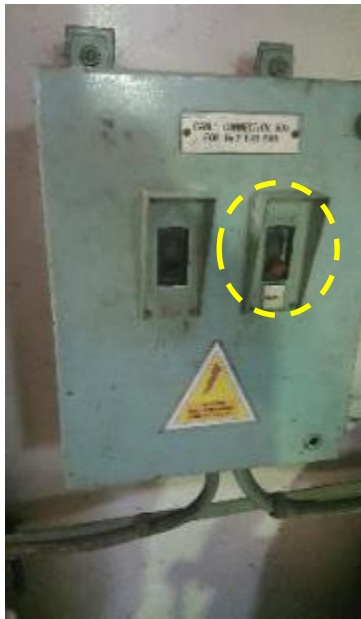
Fig. 10 - Power source in the engine room workshop

1.3.4 The welding machine itself did not have an ON/OFF switch. It had three cables with connectors. One cable was connected to a power source in the engine room workshop (see **Figure 10**) and the other two welding job cables could be connected to the welding electrode holder.

- 1.3.5 The AC supply to the welding machine was stepped down to a lower voltage through a transformer. It had a Non Load Voltage¹⁰ of 80 volts as indicated on the welding machine name plate.
