T-50 RUNWAY EXCURSION DURING TAKE-OFF FROM CHANGI AIRPORT

6 February 2018

AIB/AAI/CAS.156

Transport Safety Investigation Bureau
Ministry of Transport
Singapore

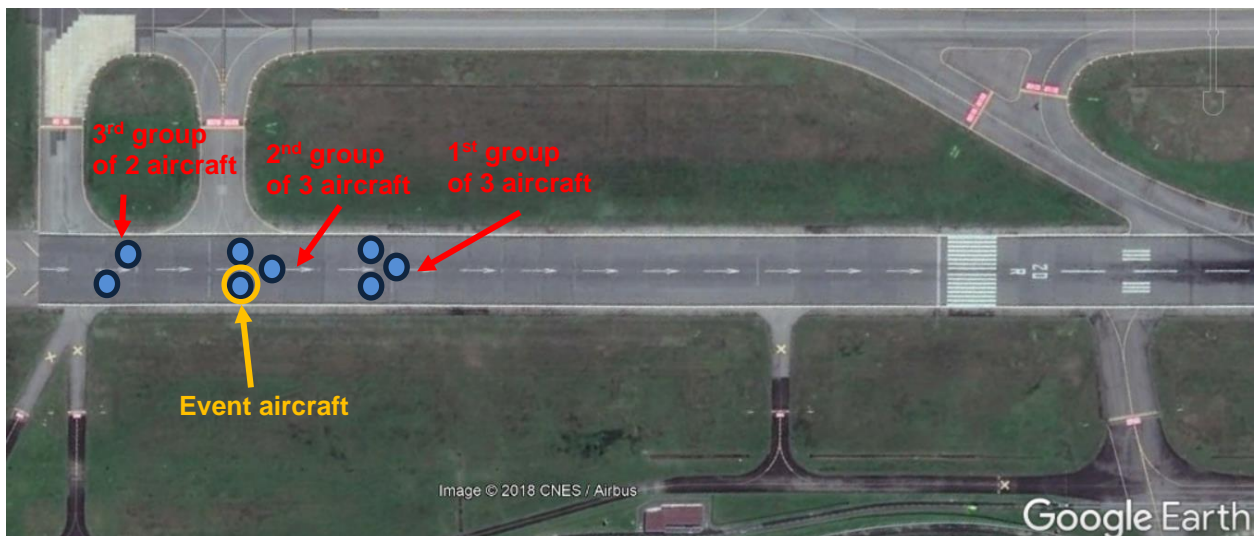
1.1.2 The team received clearance at 13:18 hours from Changi Tower to line up on Runway 20R of Changi Airport, in preparation for take-off. The team planned on a formation take-off in three groups. The first two groups comprised three aircraft each, while the last group comprised two aircraft (see **Figure 1**).

Figure 1: Approximate position of aircraft before take-off
