Final Report

Man Overboard

Supply Vessel LEO 38

And Tanker AGIOS NIKOLAS

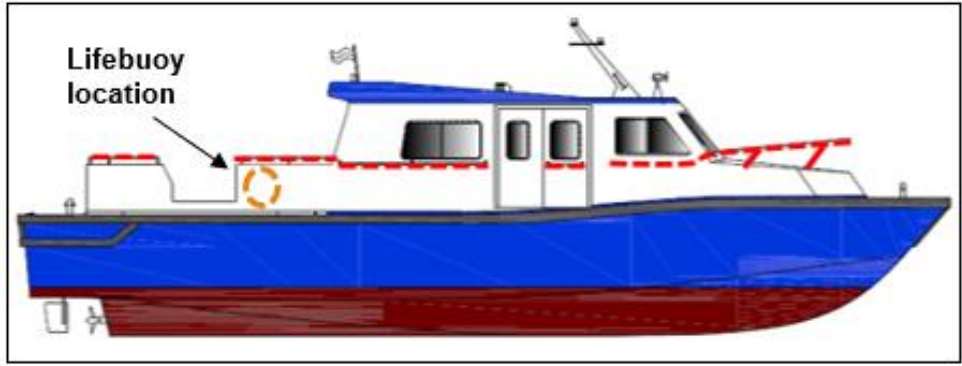
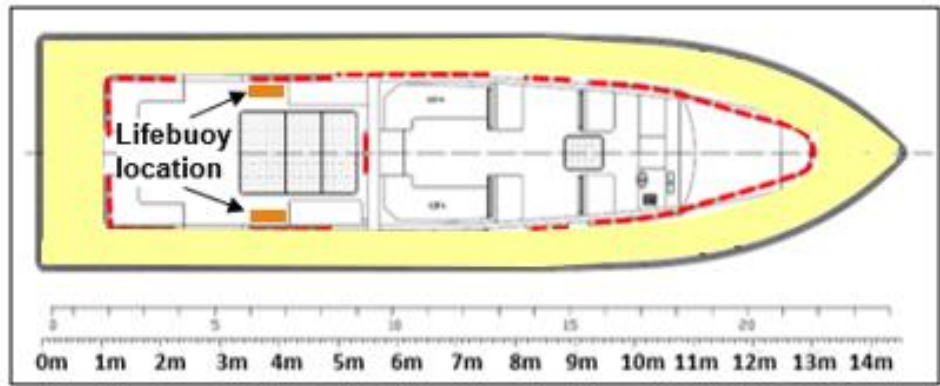
1.3.1.2 The investigation team boarded LEO 38 at Marina South Pier and noted that, for access and to move around the boat, continuous handrails are provided in most areas, see **figures 9, 10 and 11** – depicting the location of two lifebuoys²¹, red dashed line indicating handrails and highlighted yellow indicating the main deck of the boat being coated with anti-slip paint.

Figure 9 – Bow and stern view. (Source: Owner of LEO 38 — annotation by TSIB)

Figure 10 - Starboard side view of LEO 38 (Source: Owner of LEO 38 - annotation by TSIB)

Figure 11 - Plan view of LEO 38 with highlighted yellow indicating the main deck coated with anti-slip paint (Source: Owner of LEO 38 – annotation by TSIB)

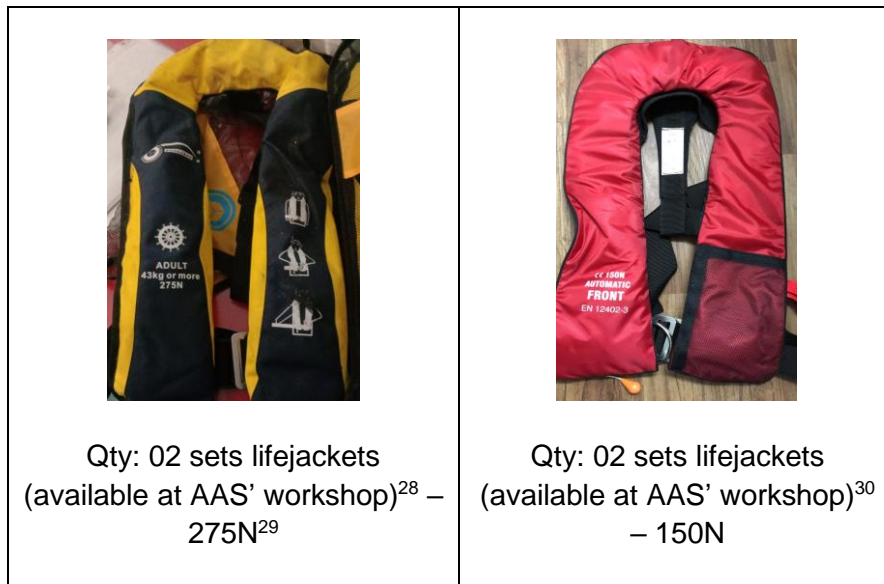
- 1.6.2 The three technicians were provided with PPE by AAS, which included safety helmet, shoes, gloves, and goggles.
- 1.6.3 The investigation team gathered that other than the one donned by TECH-2, there were four other inflatable lifejackets of different make and model available at AAS' workshop for use when performing jobs at the anchorage. (See **figure 15**). Technicians reportedly would collect them before boarding the vessel at anchorage.

Figure 15 – The different types of lifejackets in AAS' inventory

- 1.6.4 AAS clarified the reason for the different types of lifejackets, i.e. they catered to the individual's preference for the size and weight of the lifejackets and that they were procured at different times. The investigation team further gathered that AAS was not aware of the difference in activation method of the lifejackets in their inventory.
- 1.6.5 On the day of the occurrence, TECH-1 and TECH-3 did not take any lifejackets with them from the workshop. All three technicians were carrying a backpack

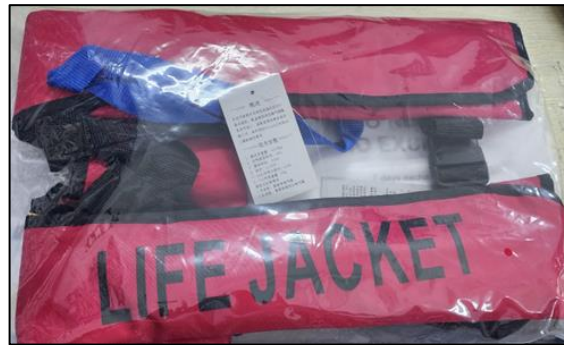
- (i) The local seller kept only manual lifejackets (see **figure 17**), and the method of inflation would be made known to the buyer at the point of sale.

Figure 17 – Lifejacket⁴⁰ sold by the local vendor (current stock)
