FATALITY OF HARBOUR PILOT AFTER FALLING INTO WATER DURING TRANSFER IN SINGAPORE ON 11 FEBRUARY 2023

TIB/MAI/CAS.139

Transport Safety Investigation Bureau
Ministry of Transport
Singapore

22 April 2024

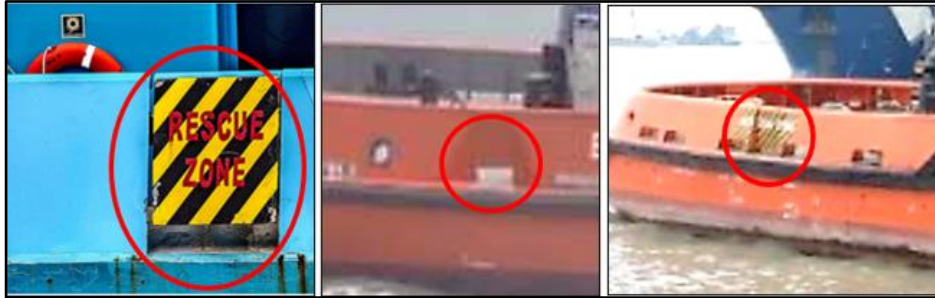
1.3.4 The operator of KR explained to the investigation team that there was no explicit boarding point, material arrangements or required provisions for crew or other personnel including pilots, to board KR. KR was not constructed with bulwark hinged door(s) (see **figure 7**) and access to the deck had to be carried out by climbing/going over the bulwark.

Figure 7: Examples of bulwark hinged doors on some tugboats (of a similar size). Some tugboats demarcated this access area as the rescue zone.

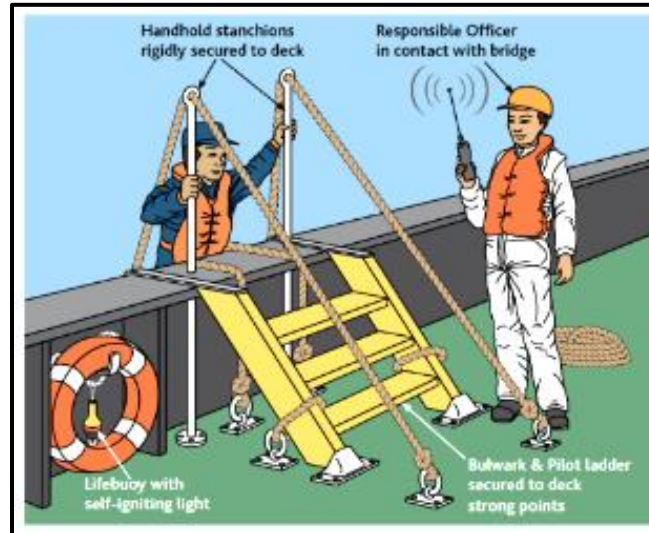
1.8.5 The investigation team noted that the International Maritime Pilots' Association (IMPA) produced a 'Required Boarding Arrangements for Pilot' poster which details the requirements of SOLAS and IMO Resolution A.1045(27). The poster does not depict the amendments in Resolution A.1108(29) and it does not explicitly require the same for vessels, especially non-convention vessels, to have the same arrangements. One guidance which was however related is shown in **Figure 11**.

Figure 11: Boarding arrangement for safe pilot transfer with the need to climb over a bulwark or railing(s) to the deck. *Source – IMPA.*
