Final Report

FATALITY OF DECK CADET ONBOARD SRS BAO SUCCESS AT SEA ON 25 NOVEMBER 2022

TIB/MAI/CAS.134

Transport Safety Investigation Bureau
Ministry of Transport
Singapore

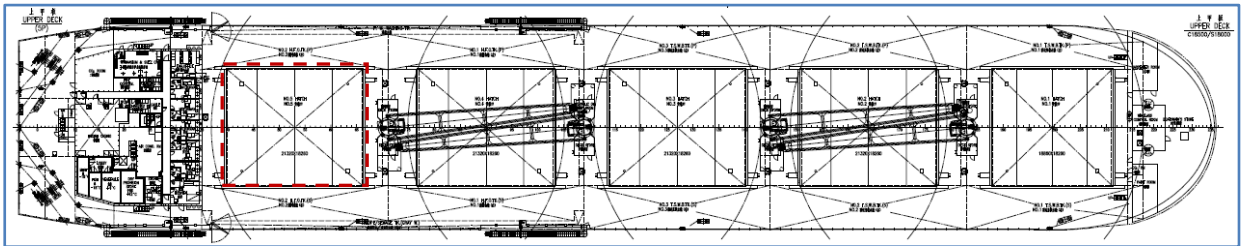
- 1.2.1 Bao Success is a bulk carrier with five cargo holds. At the time of the incident, she was partially loaded and carrying about 46000 MT of Nickel Ore in bulk in all cargo holds loaded from San Pedro, Ivory Coast on 8 November 2022. No. 5 cargo hold was loaded to about 47% with about 9778 MT of Nickel Ore (see figure 1).

Figure 1 – Plan view of Bao Success – red dashed line indicates no. 5 cargo hold (Source: The Company – annotated by the TSIB).
